Bunbury Coastal Protection

Part A – Koombana Beach Coastal Erosion and Design Report

Seashore Engineering Pty Ltd August 2013

Report SE001-01-Rev0

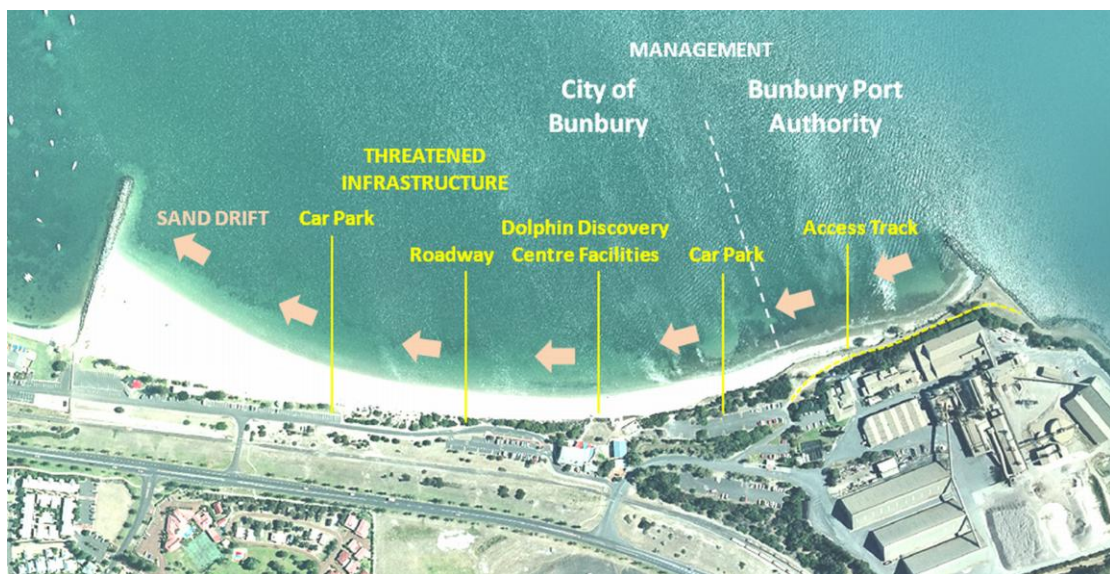
Figure 2-1: Koombana Beach Management and Threatened Infrastructure

The westward sand drift has caused erosive pressure on the eastern and central parts of the beach, with a limited dune buffer of roughly 10m or less width remaining in front of most of the existing foreshore infrastructure. The threat is more strongly advanced adjacent to the Port Authority access track, where a near-vertical scarp of more than 1m is present. The existing buffers represent minimal protection to the infrastructure, and are barely adequate for erosion impact of a strong storm, without further progressive change. Based upon previous rates of erosion, there is less than 10 years before infrastructure will be impacted.

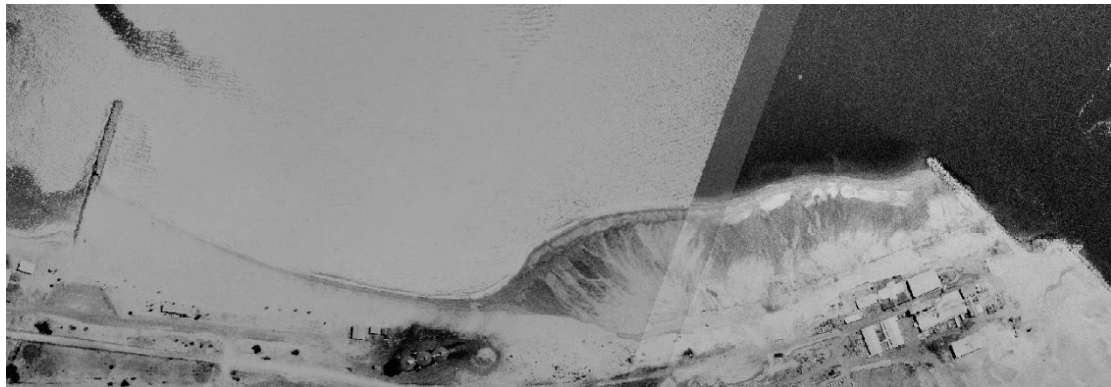
Figure 3-3: Dredged Spoil at Koombana Beach in 1974

In approximately 1974, a significant volume of dredged material consisting of sand, silt and rock fragments from the Inner Harbour was placed on the beach (Figure 3-3). Assessment of aerial imagery from 1974 suggests volumes were in the order of 100,000m³. The material was rapidly redistributed resulting in an accretion of about 50m over the entire length of the beach (DMH 1989), with accretion particularly evident adjacent to the Koombana Yacht Club groyne.

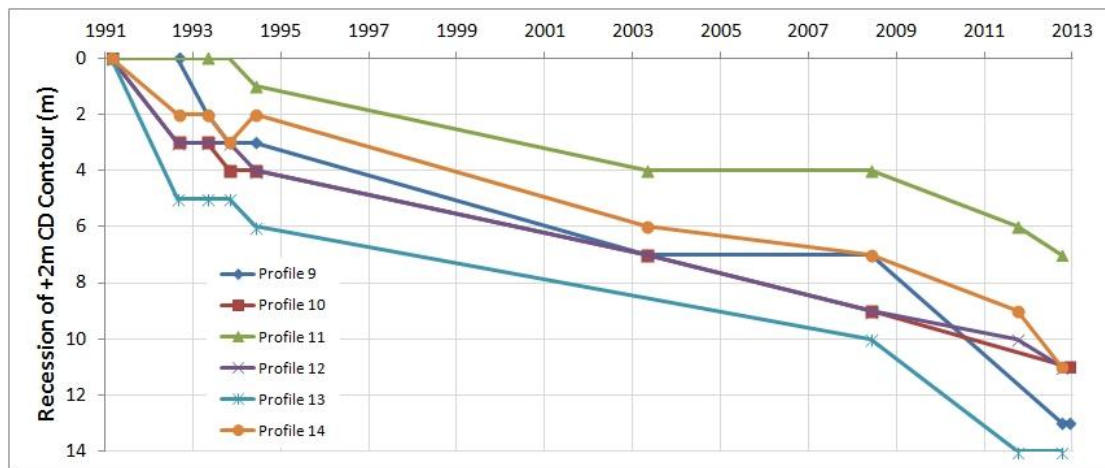
Figure 4-8: Scarp Erosion on the Eastern Beach Relative to March 1991

Comparison to rates defined prior to 1991 based on coastline movements (refer to Section 3.5) suggest that rates of recession significantly reduced as the available material from the placement of dredged spoil in 1974 reached a more stable configuration.

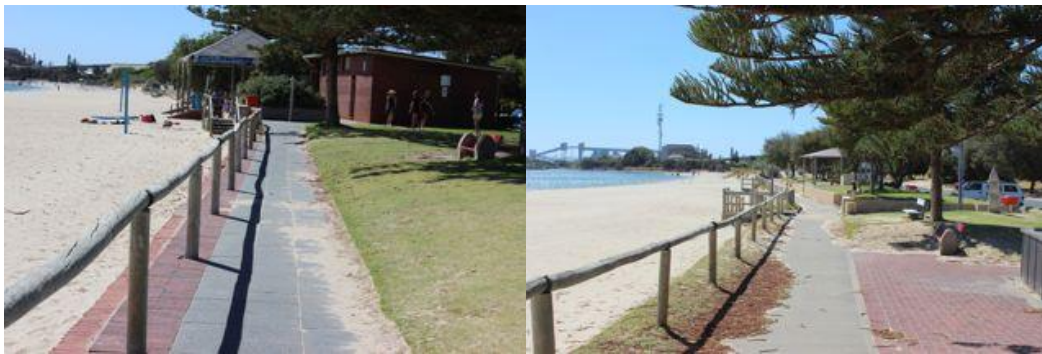
Figure 5-2: Western Section – Coastal Infrastructure

This is an area of mainly public infrastructure (Table 5-2, Figure 5-2). Structures including a toilet block, kiosk, surf club, paths, barbecues and car parks are generally located immediately behind a small revetment at the back of the beach, typical of public beaches in Western Australia. Relocation of these assets is potentially feasible, due to the presence of undeveloped unallocated Crown land behind the beach; however this would be a major foreshore redevelopment project, with cost-benefit issues beyond the scope of this study. The width of the beach at this location presently provides reasonable protection to existing assets.

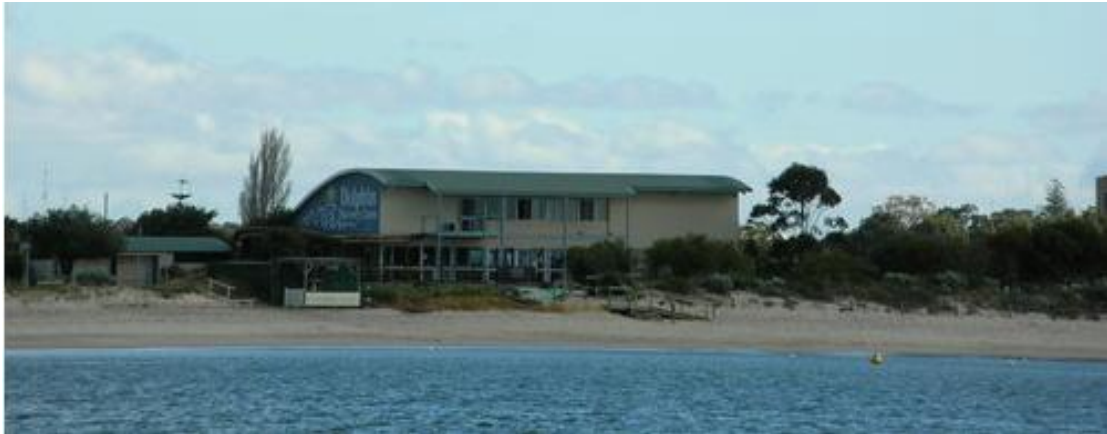
Figure 5-3: Central Section – Coastal Infrastructure

The Dolphin Discovery Centre requires a beachfront location and relocation of assets to the long term target of 50m is not practical. Major infrastructure is set back more than 20m from the existing vegetation line, with smaller infrastructure presently exposed. However, there are opportunities through this central section of this beach to establish and maintain a 10m natural dune buffer to provide greater coastal resilience. In particular, this could involve removing some bays or redesigning the car park immediately east of the Centre, and ensuring future infrastructure within the Centre is appropriately set back from the coast. Beach access would still be required through the dunes.

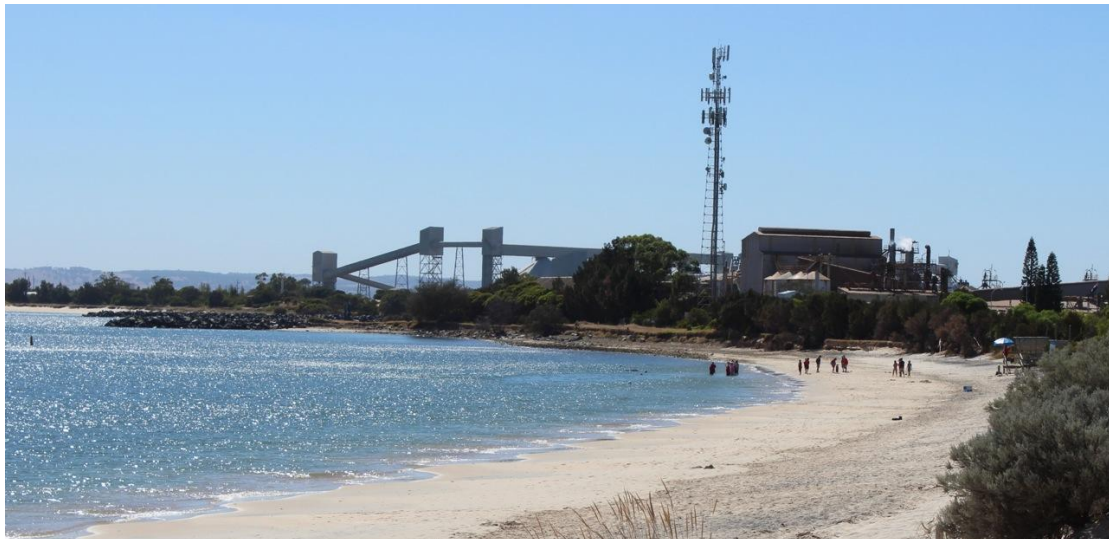
Figure 5-4: Eastern Section – Coastal Infrastructure

Relocation of these assets is unlikely to be either practical or cost effective. Due to ongoing erosion, narrow buffers and the high value of the infrastructure at risk, the BPA are planning construction of a revetment along this section of the beach.
