**Copy of Land Assessment March 26 Report
to Peter Webb & Associates**

RE: LOT 54 WOLFE ROAD, BANJUP

**SUPPLEMENTARY REPORT ADDRESSING
LOT 54 WOLFE ROAD, BANJUP**

in relation to matters before the State Administrative Tribunal
(SAT DR 12 and 69 of 2013, Sader and City of Cockburn)

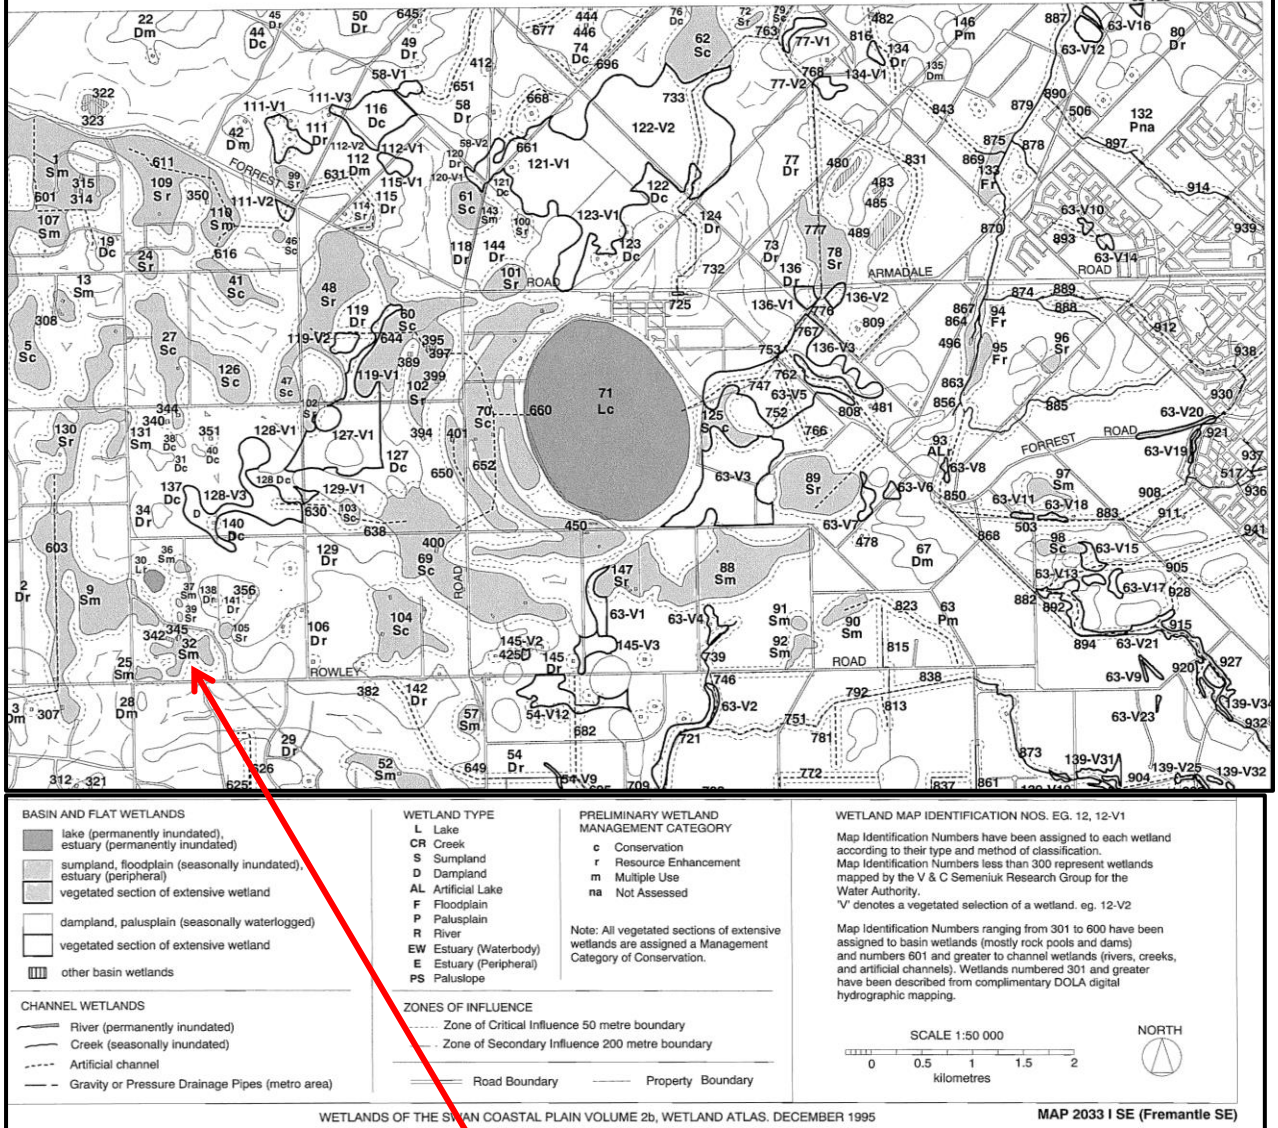
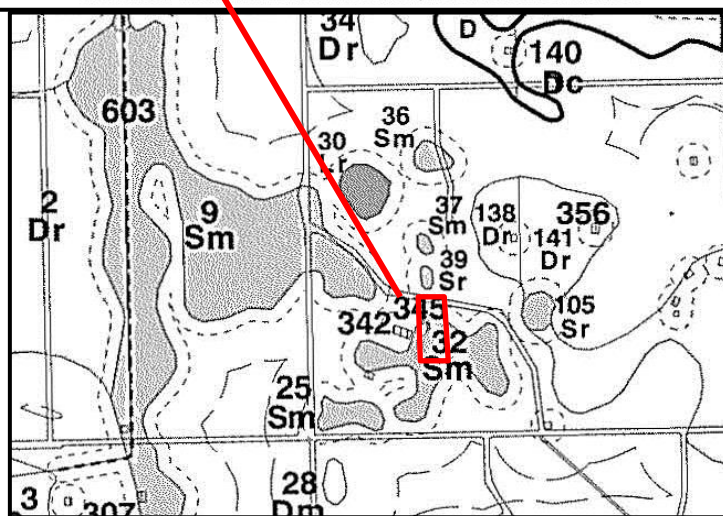
FIGURE 2: ORIGINAL WETLAND MAPPING (HILL ET AL 1996)

Figure 2 shows the relevant portion of the original mapping. Lot 54 occurs within map sheet 2033 -1 SE and is shown as containing part of a ‘**Sumpland**’ wetland with a ‘**Multiple Use**’ management category. The wetland is identified within Figure 2 as **32 Sm**.

The sumpland wetland type within Lot 54 was assigned a 'Multiple Use' management category in the original (1996) mapping. This category describes wetlands at the most degraded end of the spectrum, with the least potential for meaningful restoration, and hence the least value for conservation purposes. As described in Table 2, wetland **32 Sm** was (in 1996) *a wetland with few important ecological attributes and functions remaining*.

(Lot 54 is part of Wetland 32 Sm –a ‘Multiple Use ‘ category Sumpland)

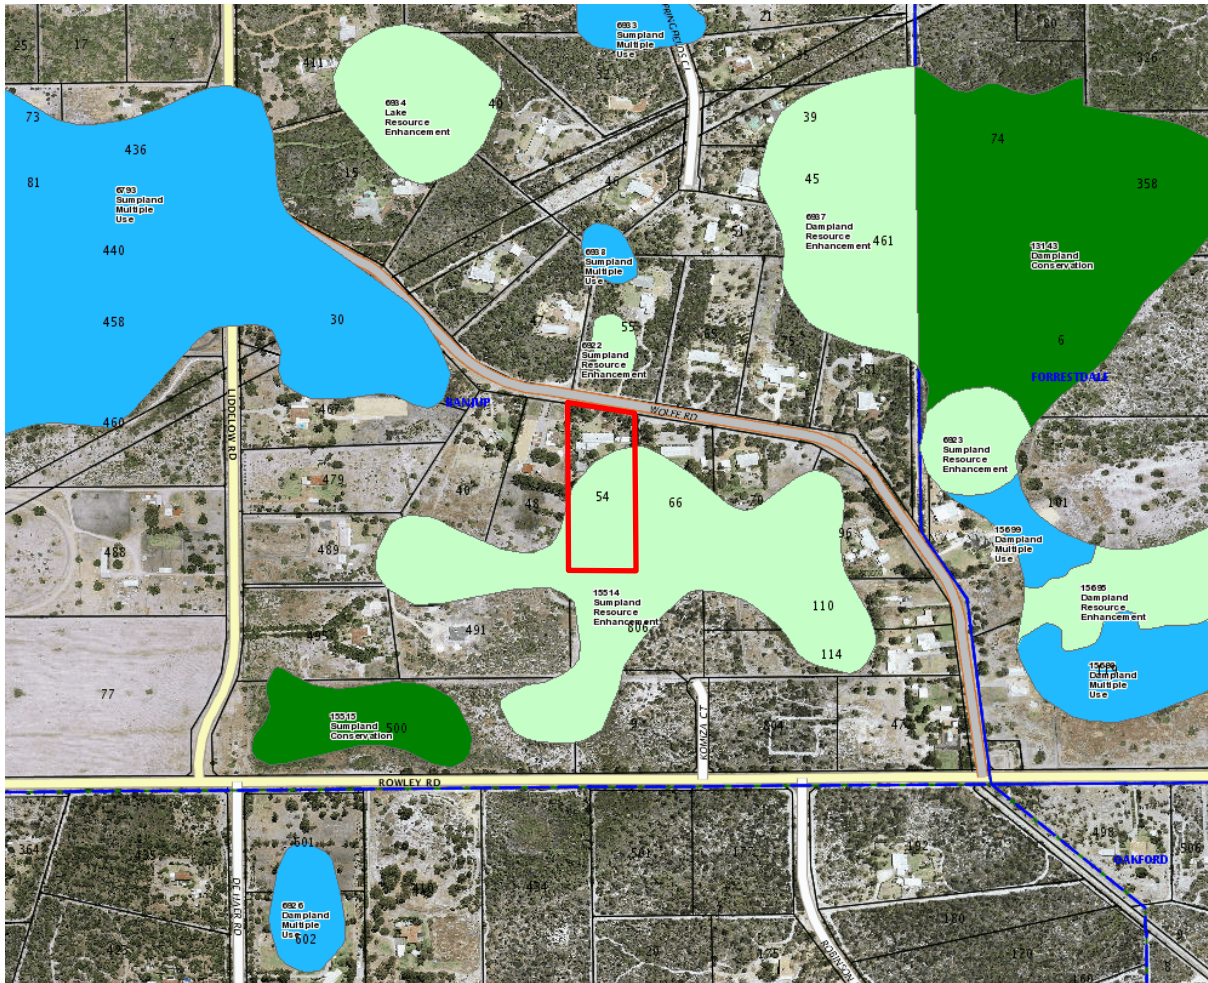
FIGURE 3: DEC WETLAND DATABASE EXTRACT (March 12 2013)

DEC's SCP geomorphic wetland database was accessed via Landgate's online Map Viewer program on March 12 of this year. The resulting mapping is shown in Figure 3 and depicts the wetland within Lot 54 (ID No 15514) as a Sumpland with a 'Resource Enhancement' management category. This 'new' management category differs from the 'Multiple Use' originally assigned and reported by Hill et al (1996) in that it represents an upgrading of its value for preservation.

(Lot 54 is part of Wetland ID 15514 –a ‘Resource Enhancement’ category Sumpland)

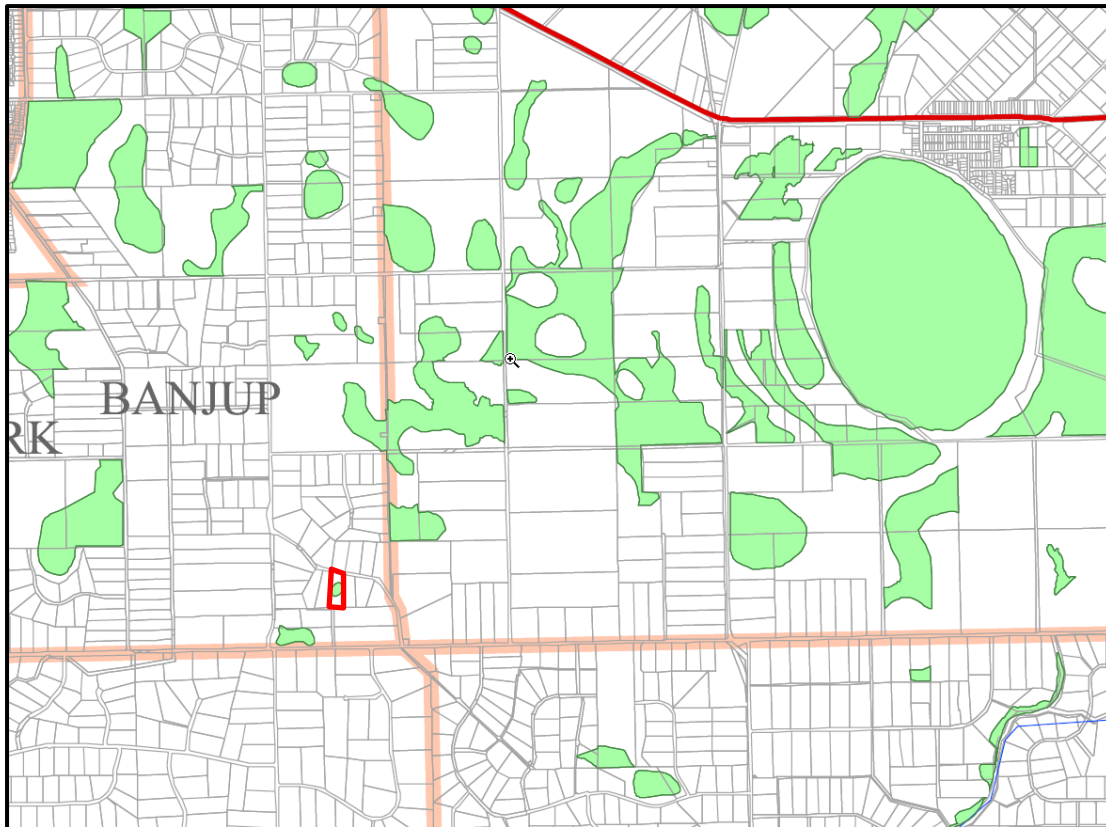
FIGURE 4: WETLANDS FORMING PART OF REVISED DRAFT ENVIRONMENTAL PROTECTION (SWAN COASTAL PLAIN WETLANDS) POLICY 2004.

Figure 4 shows the relevant portion of the wetland mapping that was proposed to accompany the *Revised Environmental Protection (Swan Coastal Plains Wetlands) Policy* in 2004. It shows the extent of the original wetland 32 Sm (refer Figure 1) reduced to only a small remnant, being the clearly inundated portion within Lot 54. This draft 2004 mapping also proposed to assign a significantly higher 'conservation' management category to that remnant.

(Portion of Map Sheet 2033 showing remnant portion of Wetland ID 15514 within Lot 54 as a proposed 'Conservation' category wetland).

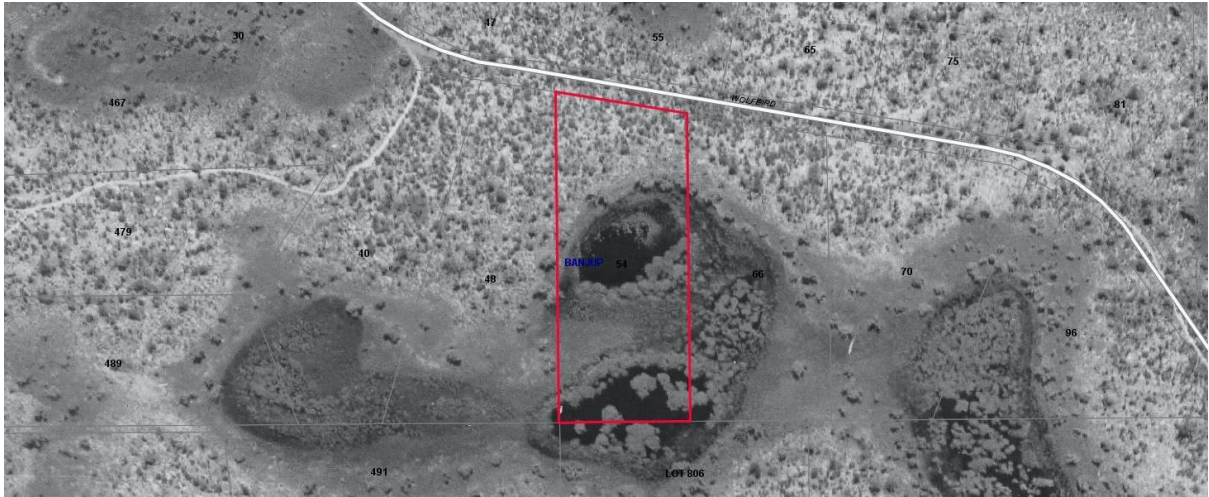
In 1953 (photo 1) the inundated depression appears to support an extensive fringe of hydrophytic "water loving" vegetation. By 1965 however (photo 2) the fringing vegetation had been largely depleted, but began to show signs of some regeneration by 1995 (photo 6), and by 2000 (photo 7) was substantially re-established.

Photo 1: 1953 (INUNDATED – Extensive Fringing Vegetation)

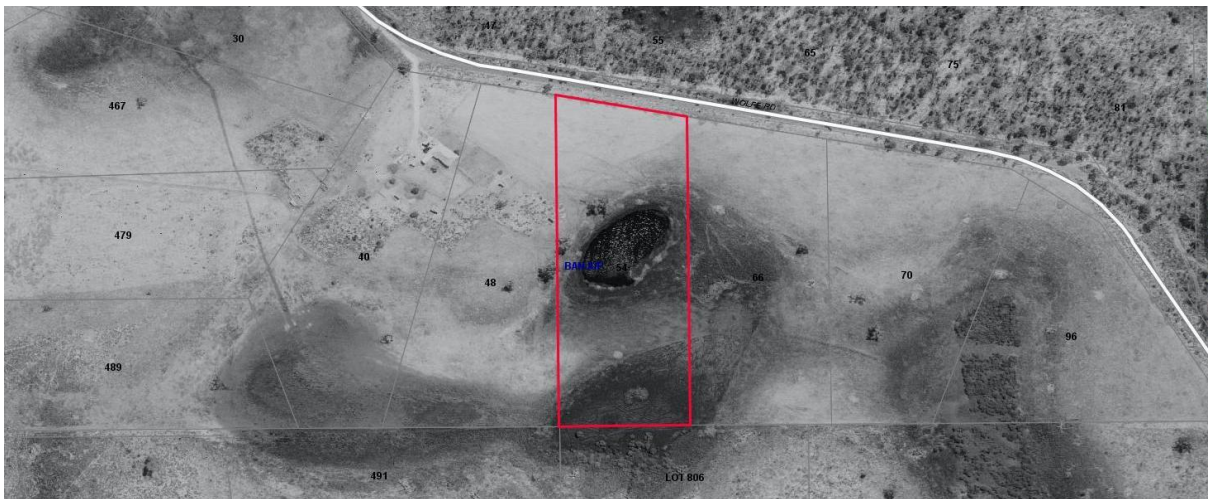
Photo 2: 1965 (INUNDATED – Depleted Fringing Vegetation)

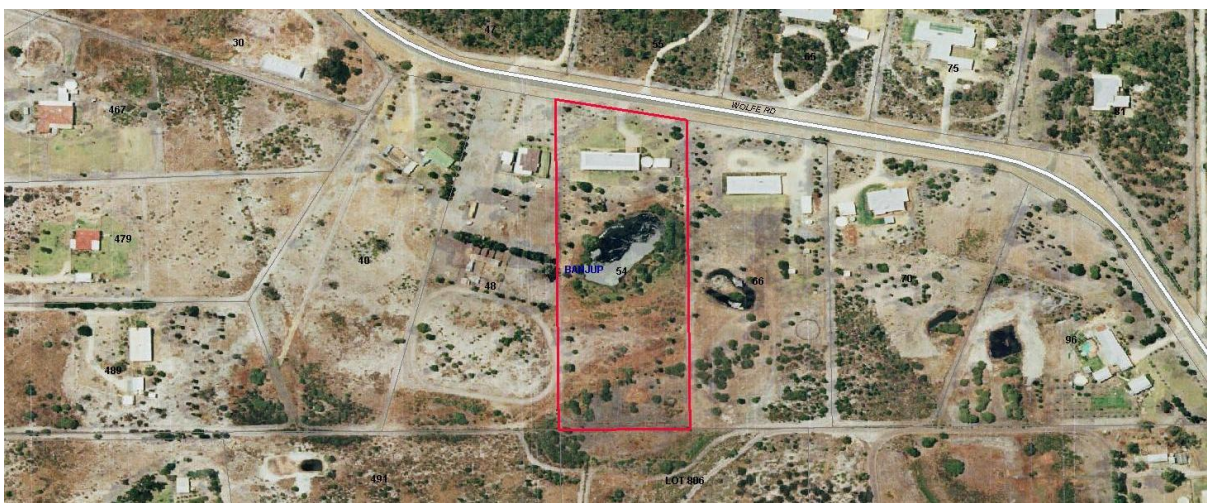
Photo 6: 1995 (INUNDATED – Recovering Fringing Vegetation)

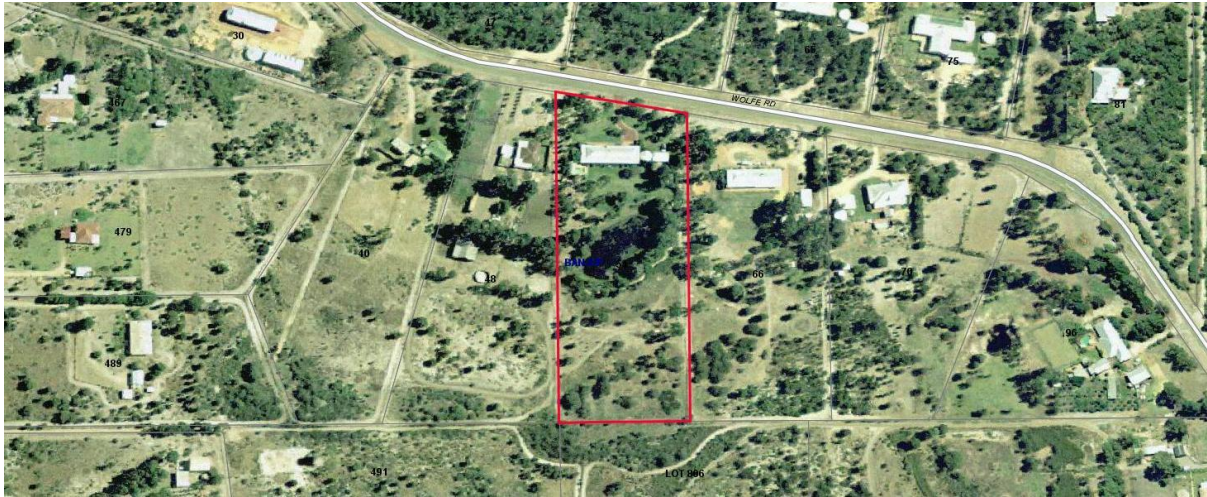
Photo 7: 2000 (INUNDATED – Re-established Fringing Veg)

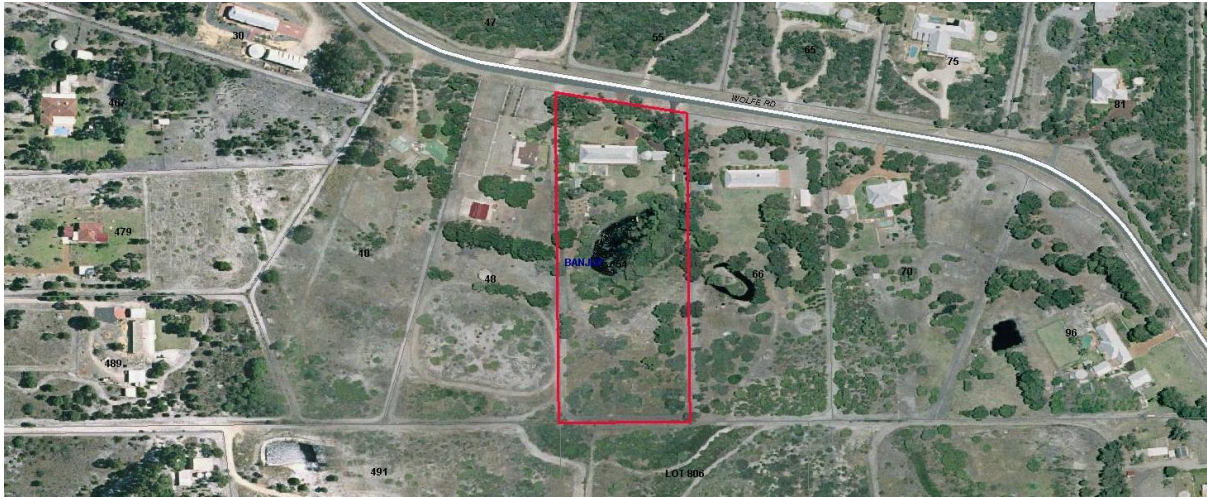
As shown in Attachment A, the depression within Lot 54 is inundated (under water) within aerial images extending for just over fifty years from 1953 (photo 1) up until December 2004 (photo 10).

Photo 10: December 2004 (Inundated, and good fringing vegetation)

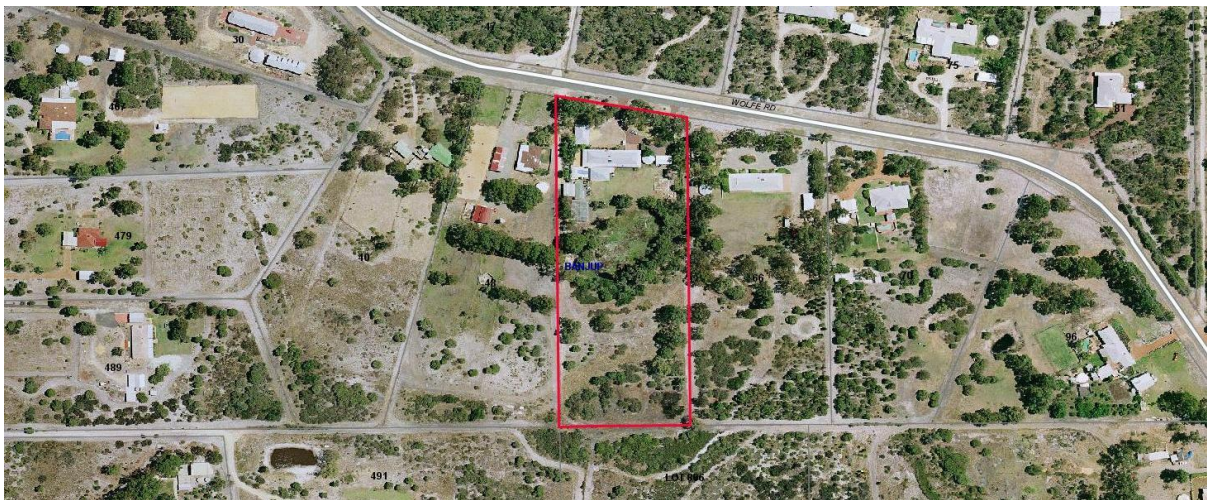
For the next six years, from December 2005 (photo 11) up until March 2011 (photo 17) the depression appears to be dry, including even during the winter / wet period of July 2008 (photo 13).

Photo 11: December 2005 (START LOSS OF INUNDATED WATERBODY)

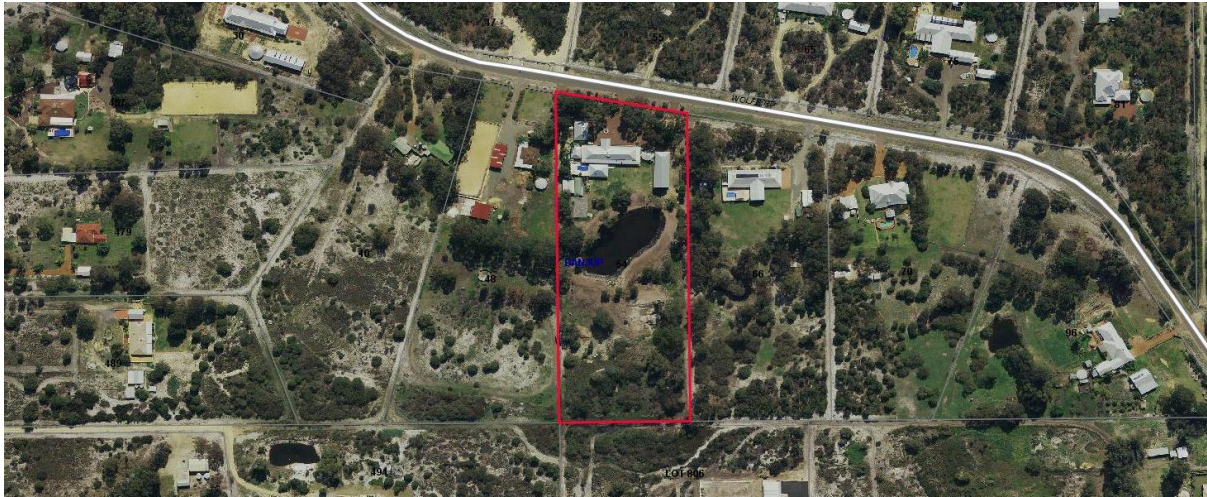
The aerial image of August 2011 (photo 18) shows depletion of the fringing vegetation, presumably the result of excavation activity designed to restore surface water.

The aerial image of August 2011 (photo 18) suggests the return of inundation was the result of some excavation which either increased the exposure to the underlying shallow watertable, or enabled installation of liner to contain water being supplied from an external source. The latter has subsequently been established to have occurred.

Photo 18: August 2011 (RETURN TO INUNDATION but depleted Fringing Vegetation)

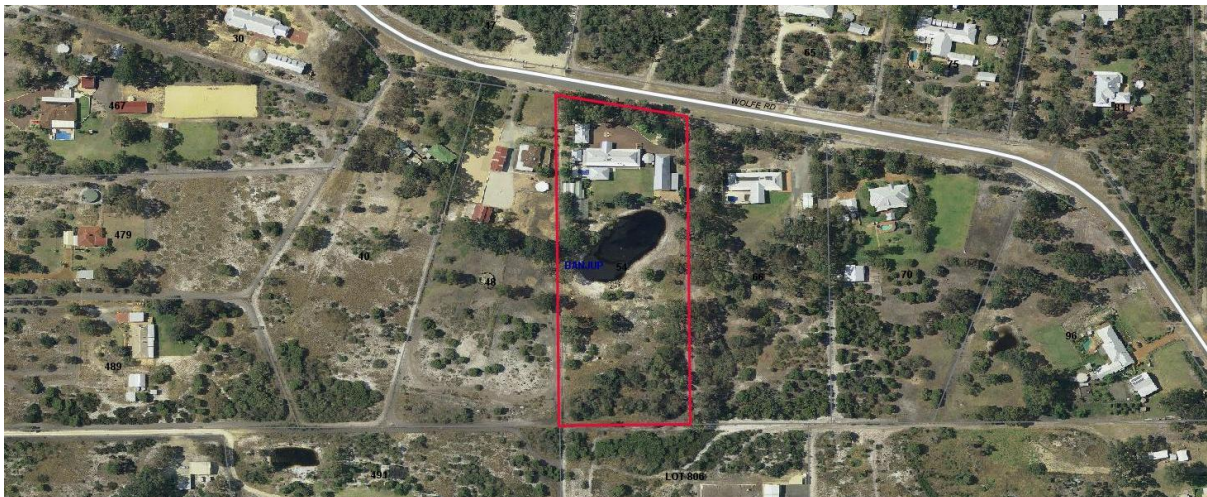
The most recent image of November 2012 shows no significant change in the fringing vegetation since August 2011.

The aerial image of November 2012 (photo 19) shows no significant change in the extent of fringing vegetation after just over a year since disturbance in August 2011 (photo 18). This, in combination with photos from 1981(photo 5) through to 2000 (photo 7) suggest that re-establishment of fringing vegetation will be slow to occur without replanting.

Photo 19: November 2012 (CURRENT CONDITION)

In relation to the fringing vegetation the historical (aerial photo) evidence shows that it can be expected to regenerate particularly if aided by replanting and with a renewal of the adjacent waterbody.

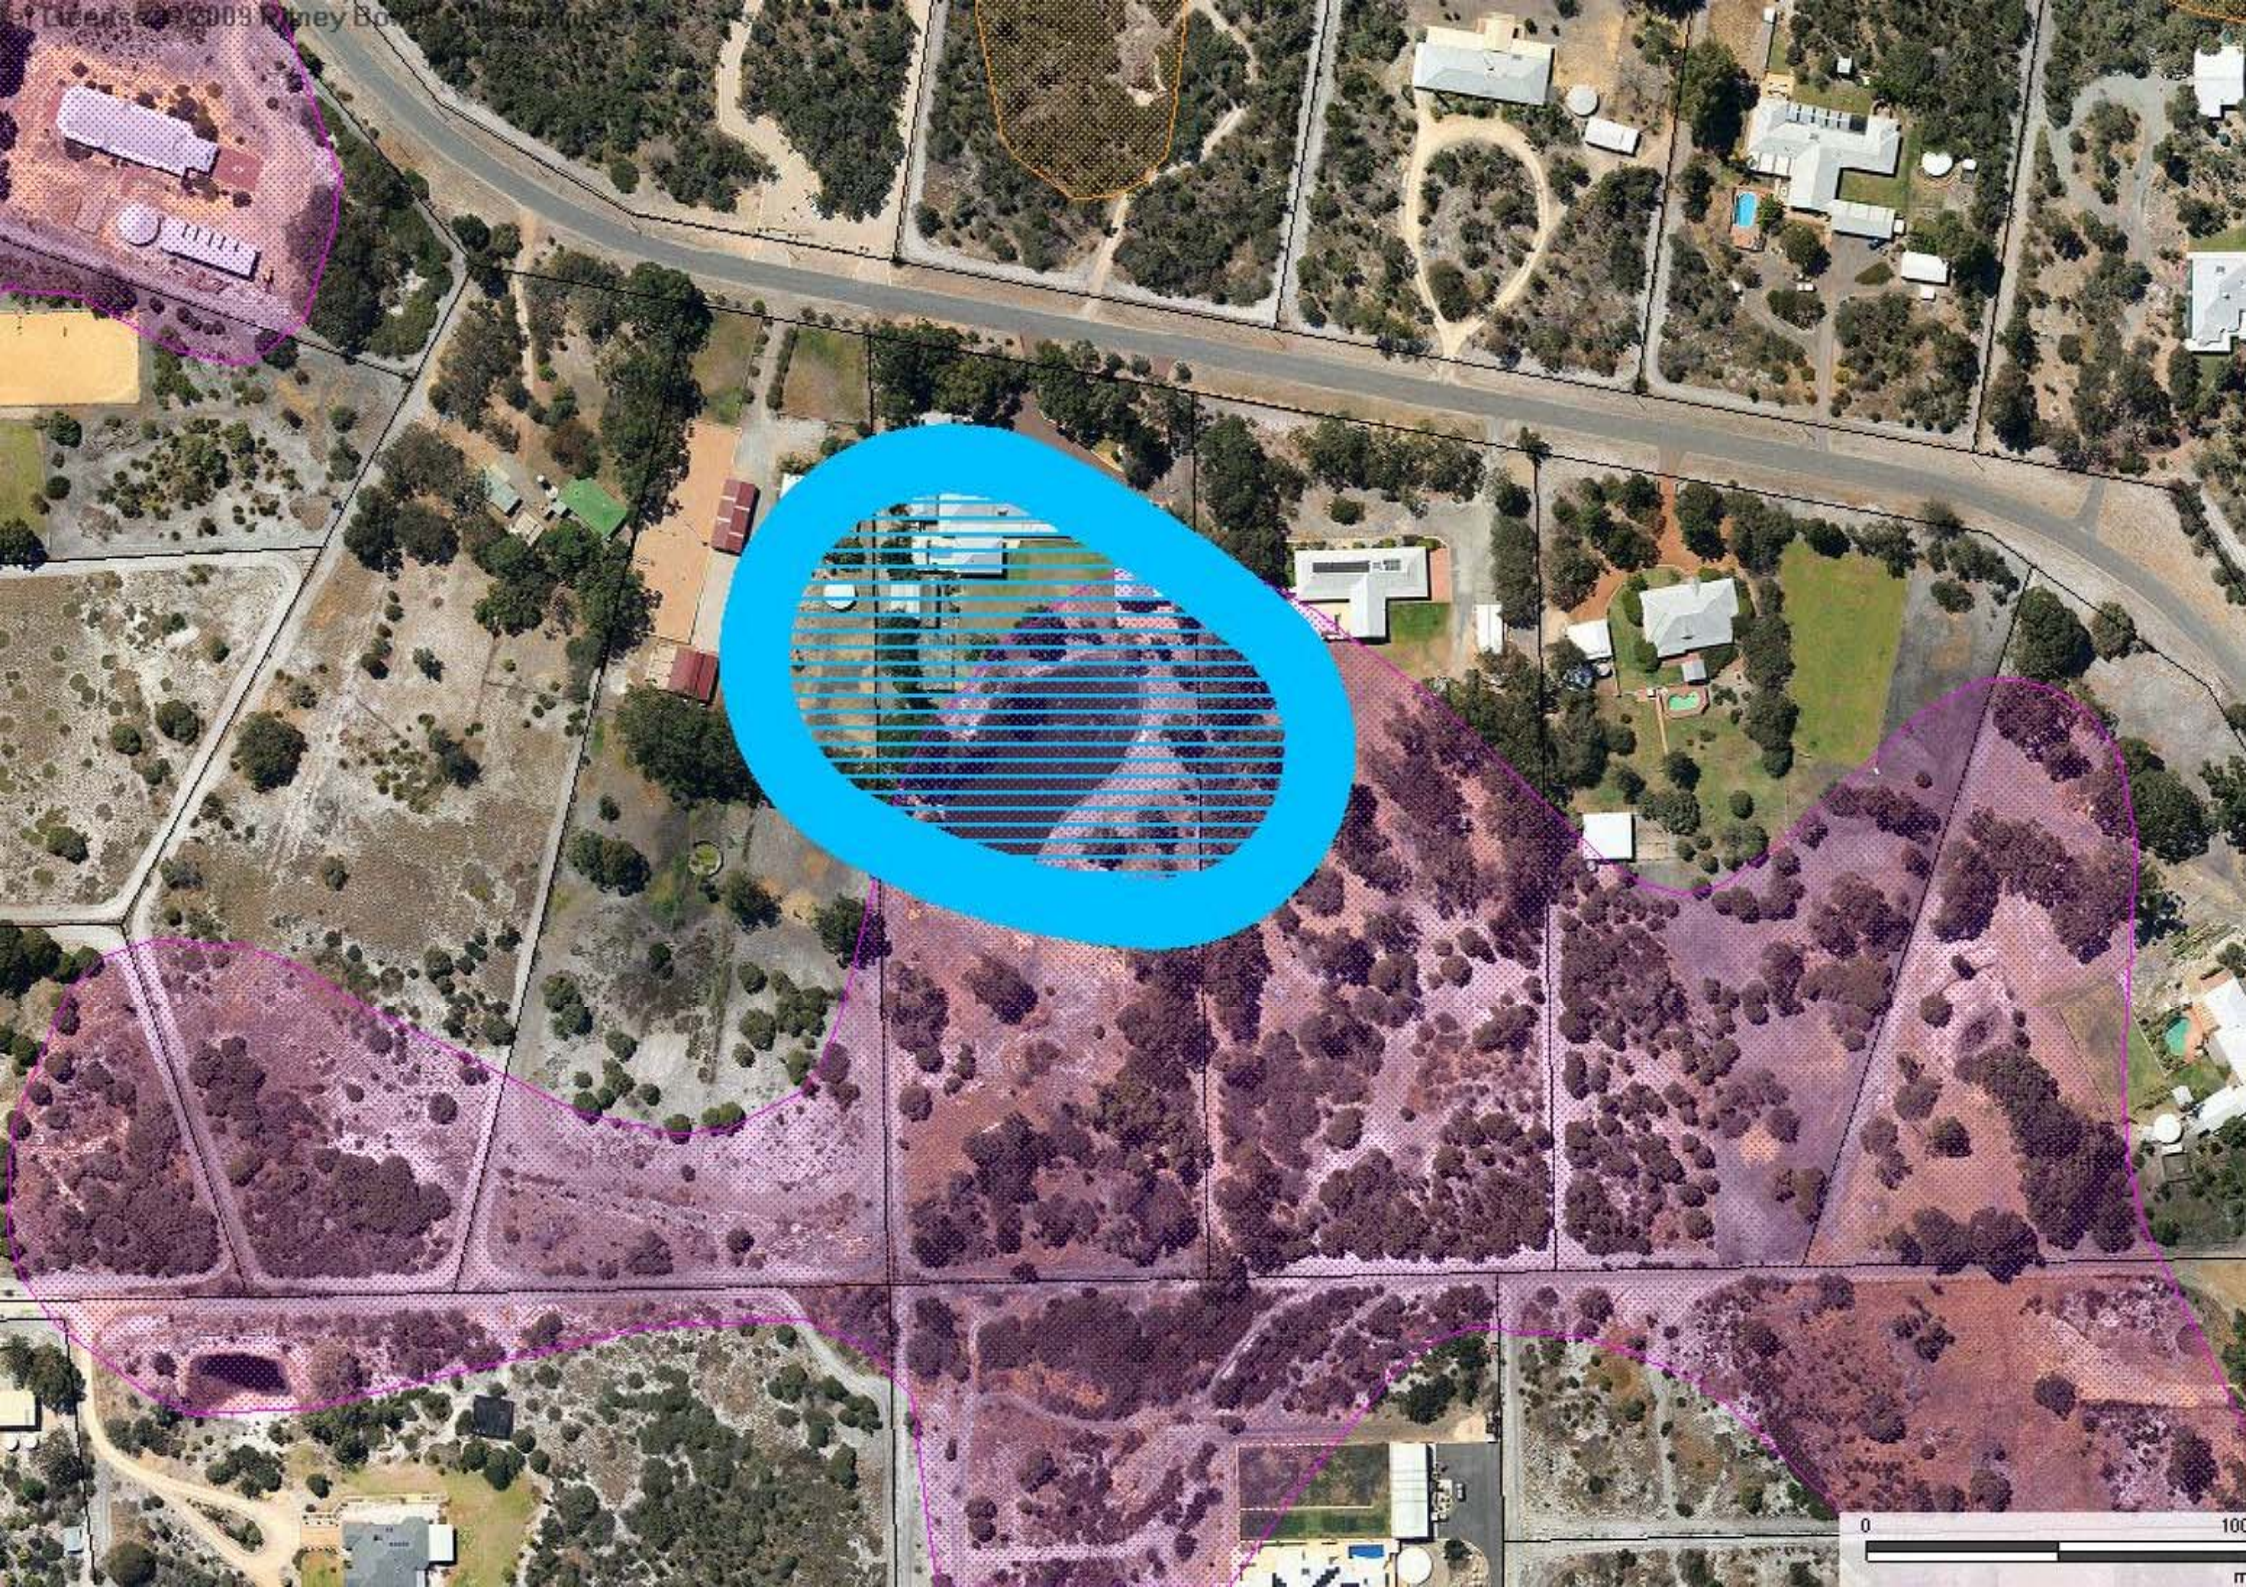
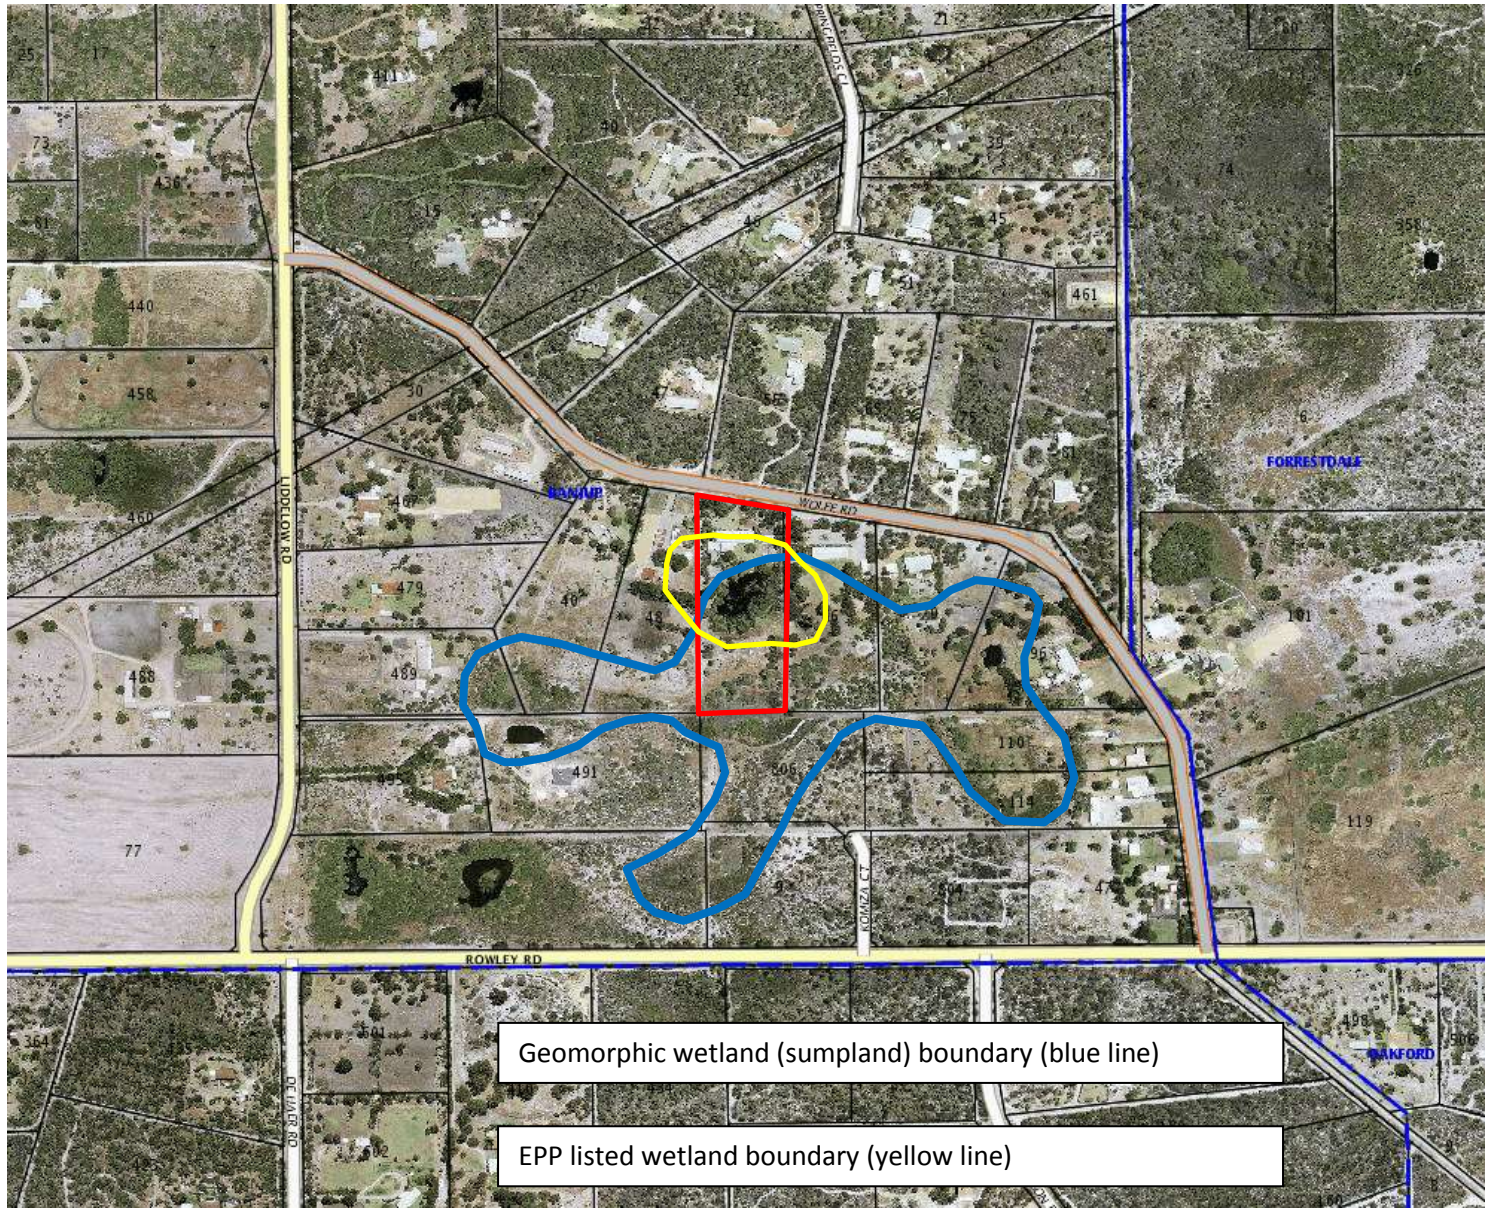
ATTACHMENT A
ENVIRONMENTAL PROTECTION (SWAN COASTAL PLAIN LAKES)
POLICY - DESIGNATED AREA

In between preparation of the March 26 letter and this Supplementary Report, it has been pointed out by the City of Cockburn that the lower-lying portion of Resource Enhancement Wetland 15514 within Lot 54 is identified as a protected wetland under the 1992 Environmental Protection (Swan Coastal Plain Lakes) Policy (refer **Attachment A**).

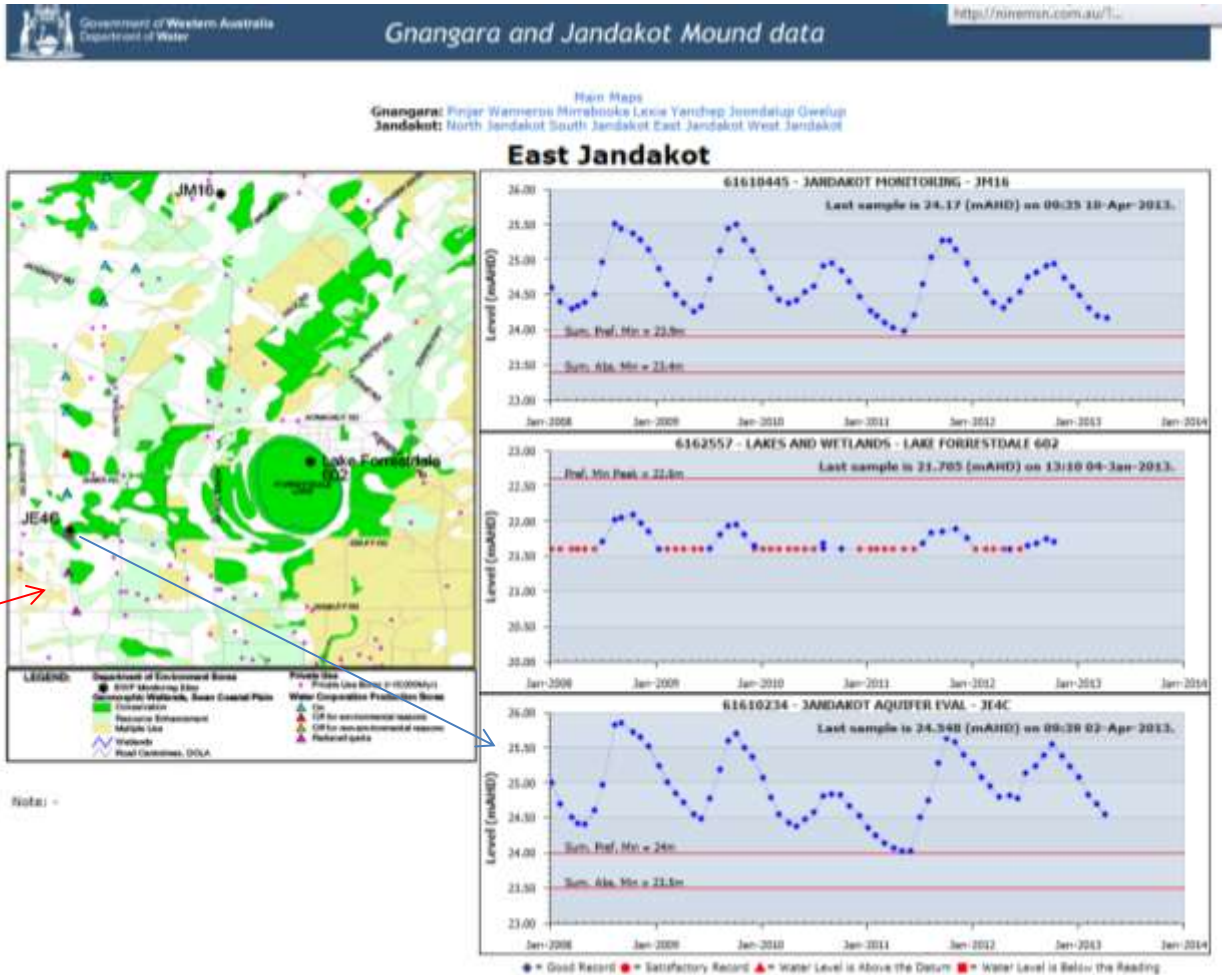
HYDROGRAPH DATA FROM NEARBY DEPARTMENT OF WATER BORE

- Depth to groundwater on April 16 was 5.95 m below the natural land surface as measured within the bore adjacent to the north eastern end of the constructed lake. Given a likely seasonal fluctuation in the watertable level of around 2m* this suggests the watertable and associated waterlogged, anoxic soil conditions would not have been intercepted.

Note: Topographic data contained within Landgate’s on-line WA Atlas and Map Viewer indicate the natural land surface in vicinity of constructed lake is at about 26 m AHD. Depth to groundwater determined on-site (April 16) was 5.95 m below surface (i.e. around 20 m AHD) which is about 4 m lower than the comparable level at DoW bore JE 4C. Even allowing for spatial variation in depth to the superficial aquifer this anomaly suggests that the snap-shot measurement from the on-site bore may not be a true reflection of watertable below the constructed lake, and possibly due to bore casing or local drawdown effects of nearby bores. Notwithstanding this, the fact remains that this portion of the sumpland has remained dry (i.e. above seasonal watertable levels) since 2005.

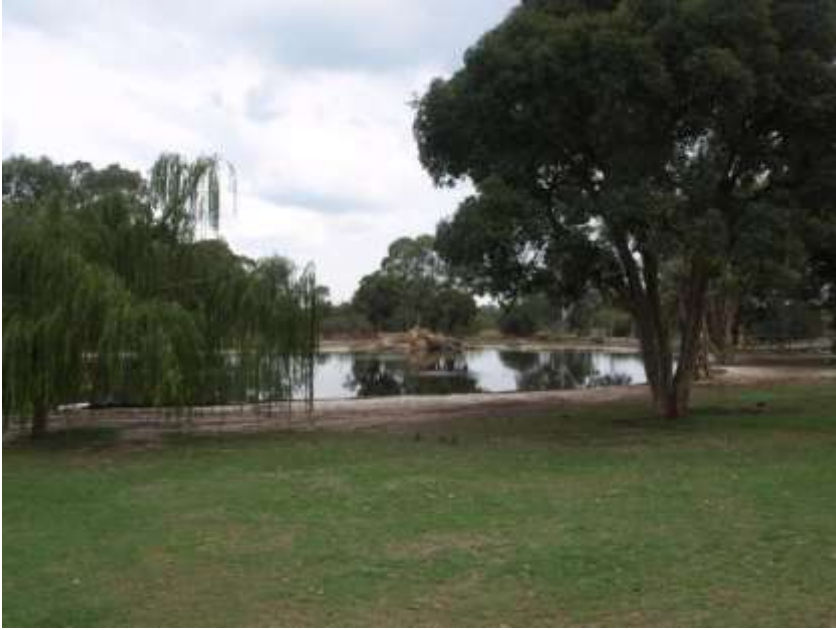
1. View southwards from residence across lawn to constructed lake.

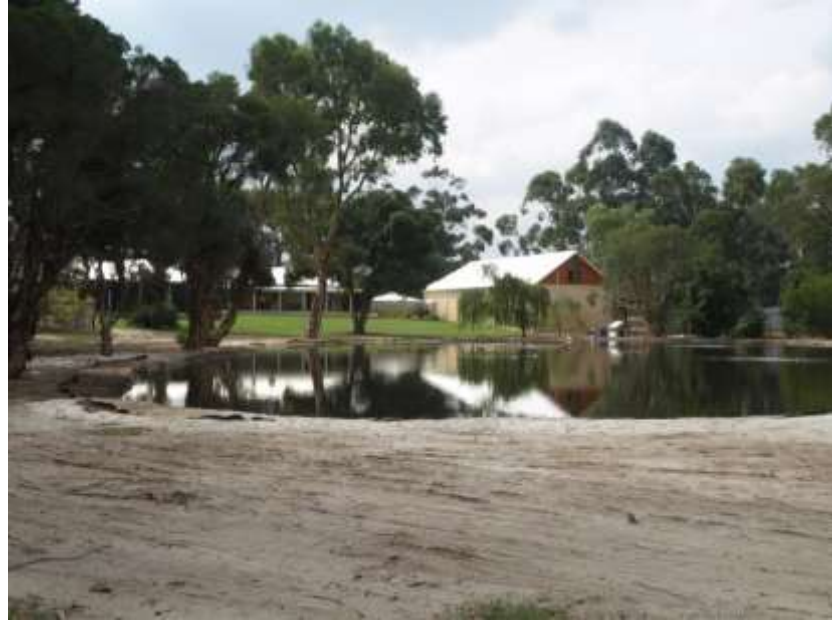
3. View to north east across lake with workshop shed which provides roof runoff.

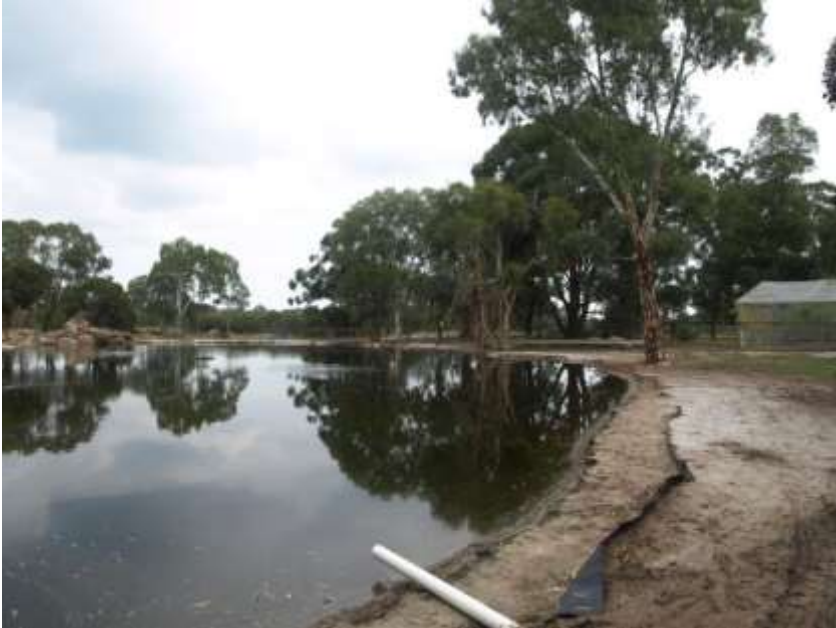
2. View to south west across lake and showing plastic liner.

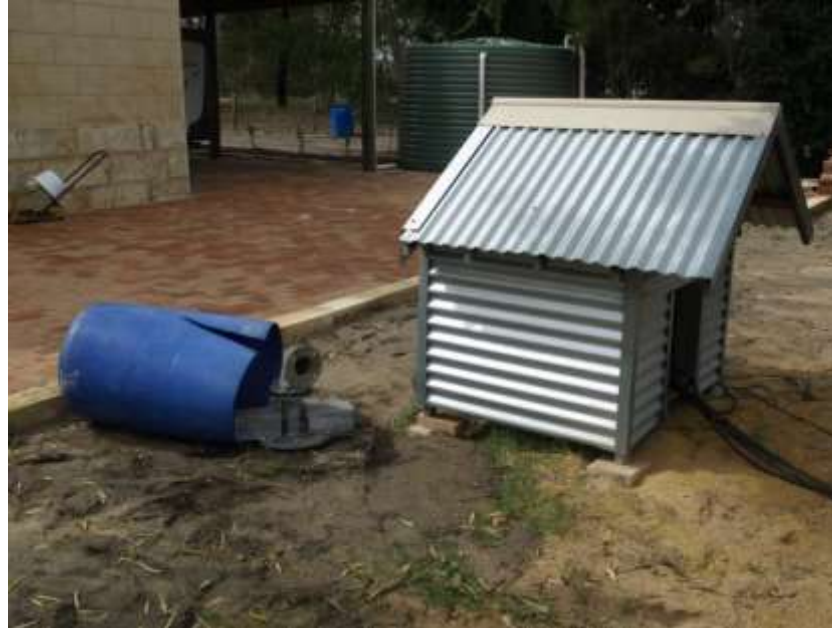
4. Bore and pump near workshop shed provides groundwater for lake input.
