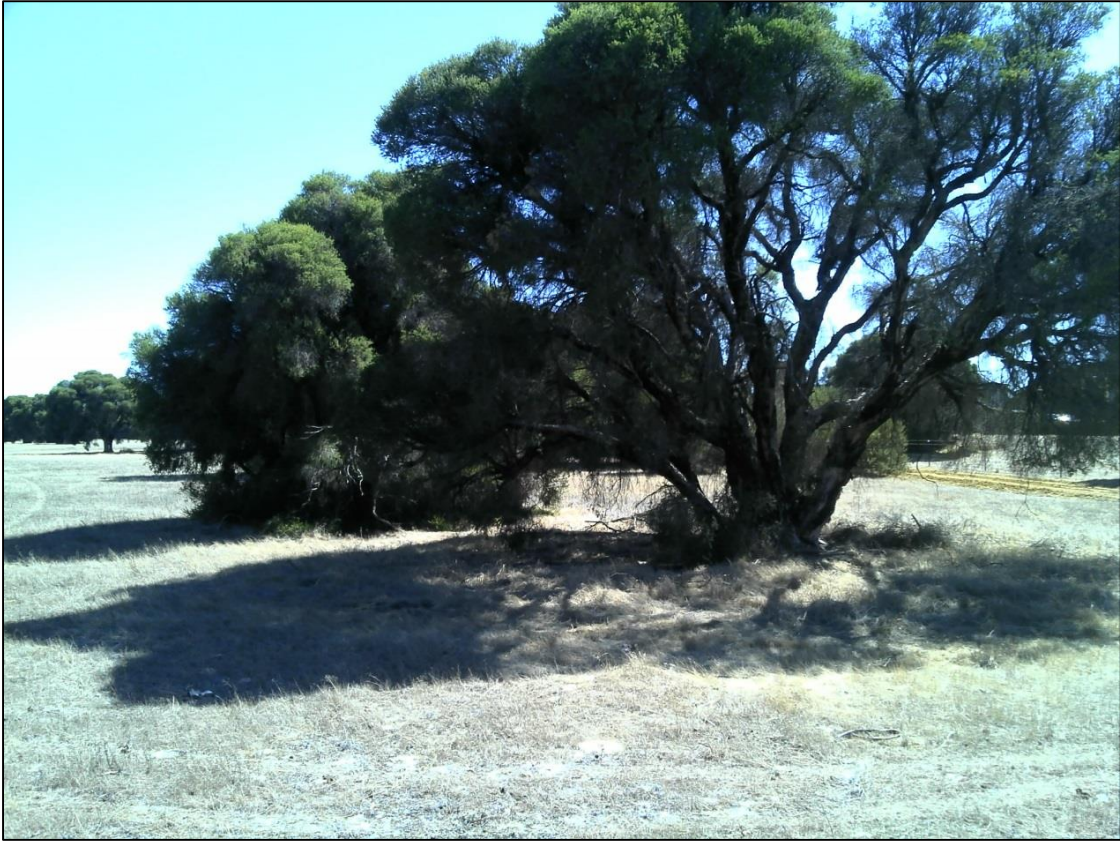
The majority of the assessment area, 97% (241.2ha), has been categorised as Excluded (**Figure 2** and **Figure 3**). These areas are predominately comprised of agricultural land, but also included areas of native vegetation in Degraded or Completely Degraded condition (**Plate 1**).

Plate 1: Excluded area, due to a vegetation condition

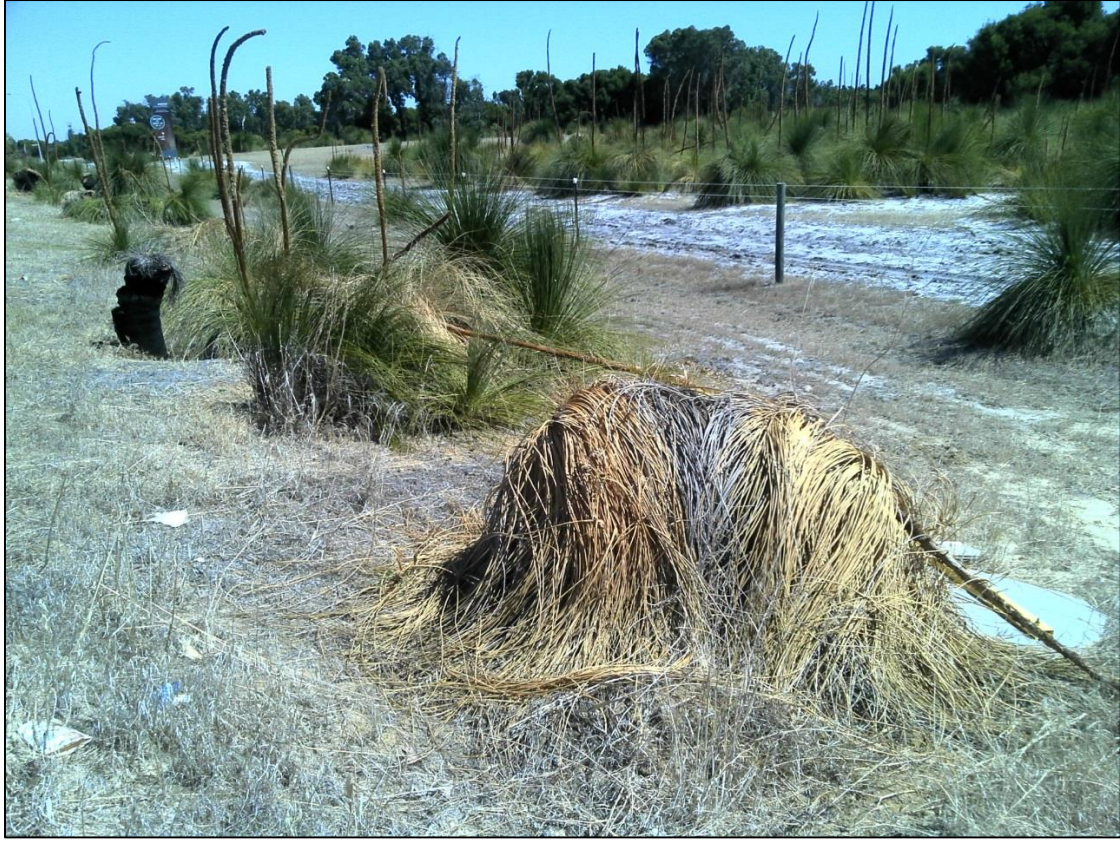
Although two samples returned negative results, the areas from which the samples were taken were Degraded and are therefore categorised as Excluded (**Plate 2**). Due to a lack of susceptible species, poor vegetation condition and the presence of numerous disturbance impacts, a determination on disease status is not possible for these areas.

Plate 2: Sample site ETCS03 in Excluded area due to Degraded vegetation condition

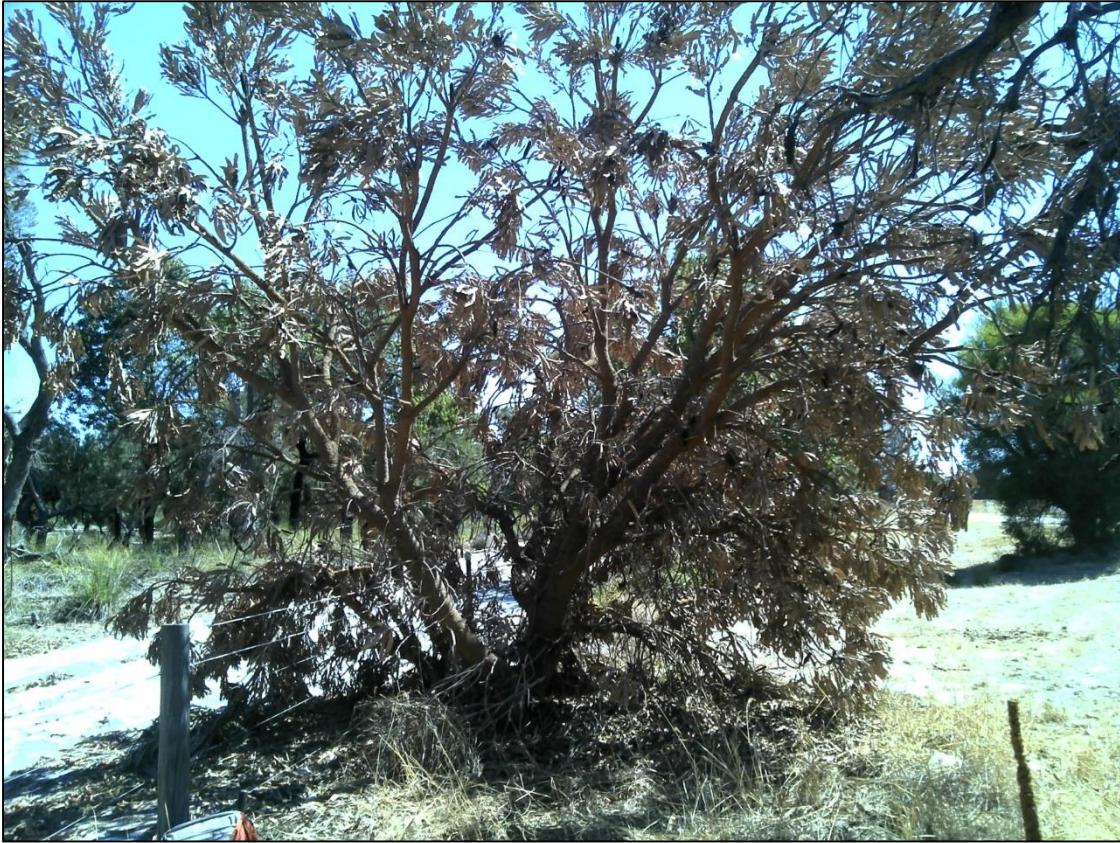
Plate 3: Infested sample site ETCS02

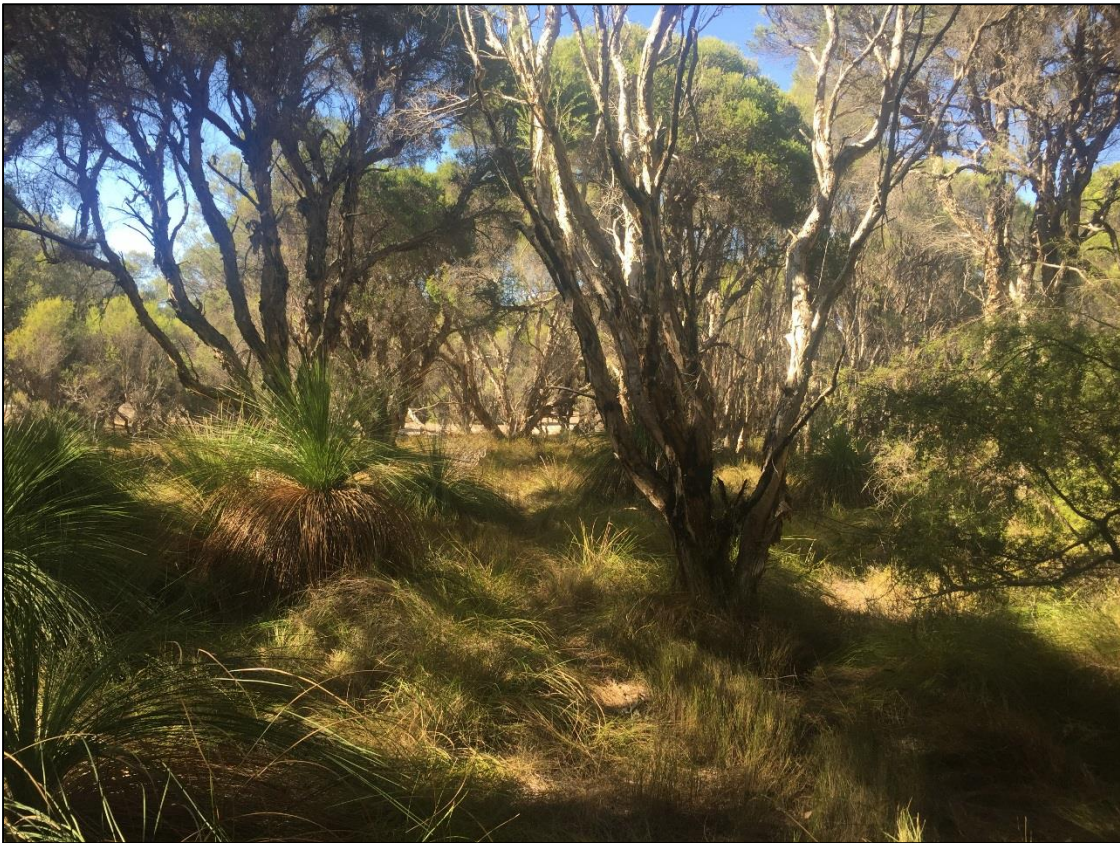
Plate 4: Uninterpretable vegetation, due to a lack of Disease Indicator Species

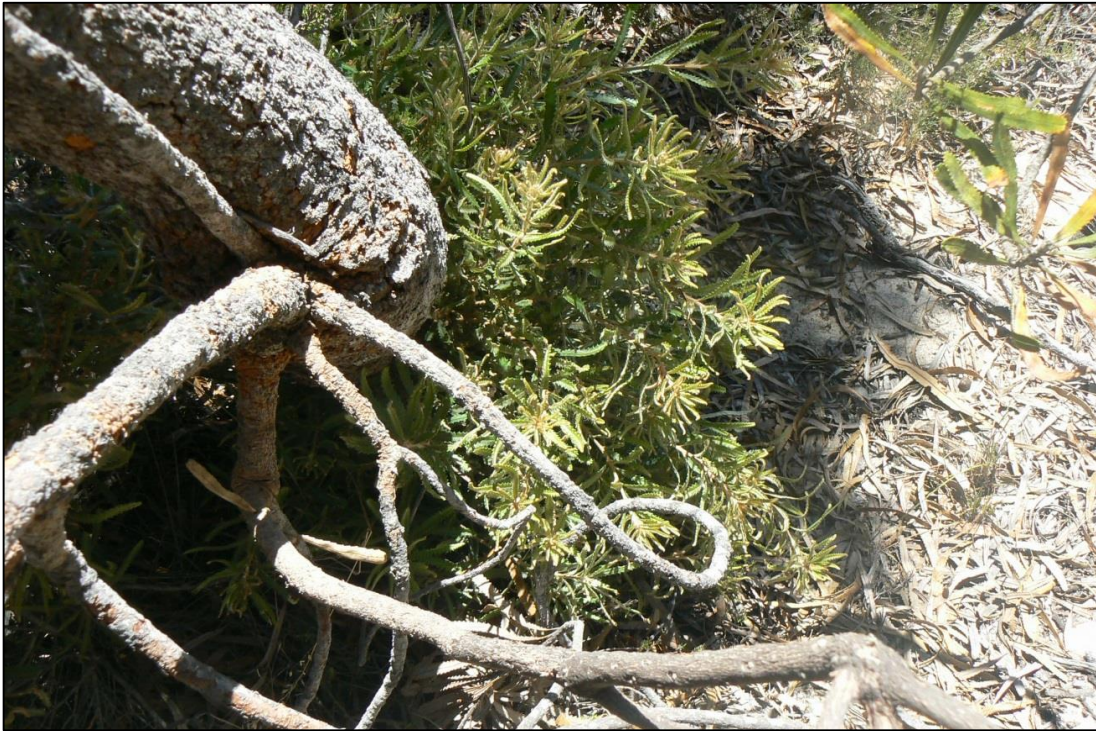
Drought impacts were observed throughout the assessment area, especially in areas with a shallow soil profile. However due to the high rate of *P. cinnamomi* recovery from samples taken, the dry conditions did not affect recovery of the pathogen or lead to false negative results.

Plate 5: Epicormic re-shooting on a *Banksia attenuata* is evidence of senescence due to drought

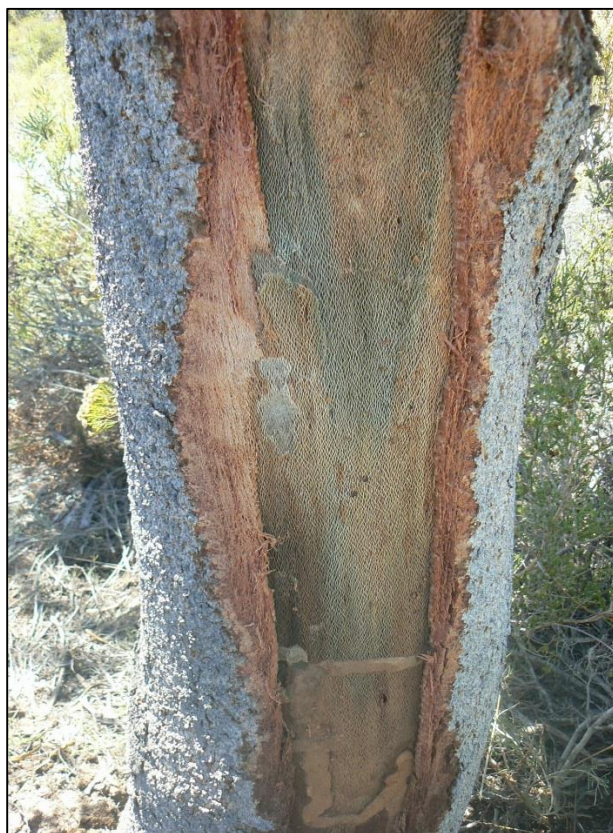
In addition to the impact of drought the possibility also exists that cankers caused by aerial fungi are having an impact on *Banksia* species in particular (**Plate 6**). The impact of cankers caused by pathogenic fungus on Proteaceous species was examined by Crane and Burgess (2012) in coastal vegetation between Esperance and Cervantes. The study demonstrated pathogenicity in seven *Banksia* spp. over a wide geographic range. The pathogenic fungus was identified as a new genus and species within the *Cryphonectriaceae* (*Diaporthales*) and is described as *Luteocirrhus shearii* gen. sp. nov. The fungus causes the death of single branches. However, it can lead to multiple branch deaths or cause complete crown Dieback as occurred with some of the *Banksia baxteri* and *B. verticillata* sampled (Crane and Burgess 2012).

Some visual evidence of canker or other pathogenic fungi were observed within the assessment area with single limbs of *Banksia* species being dead while the remainder of the tree is healthy.

Plate 6: Example of canker lesion on a *Banksia* sp.
