OPAL VALE PTY LTD	
PROPOSED CLASS 11 LANDFILL	
LOT M2027, CHITTY ROAD, TOODYAY	
<b>LOCATION - LAND USES AND BUFFERS</b>	
Landform Research	December 2011
Basemap LANDGATE	1 : 22 500

**OPAL VALE PTY LTD**  
 PROPOSED CLASS II LANDFILL  
 LOT 11 CHITTY ROAD, TOODYAY  
 LINER DETAILS - SHEET 1 OF 2

**OPAL VALE PTY LTD**  
**PROPOSED CLASS II LANDFILL**  
**LOT 11 CHITTY ROAD, TOODYAY**  
**LINER DETAILS - SHEET 2 OF 2**

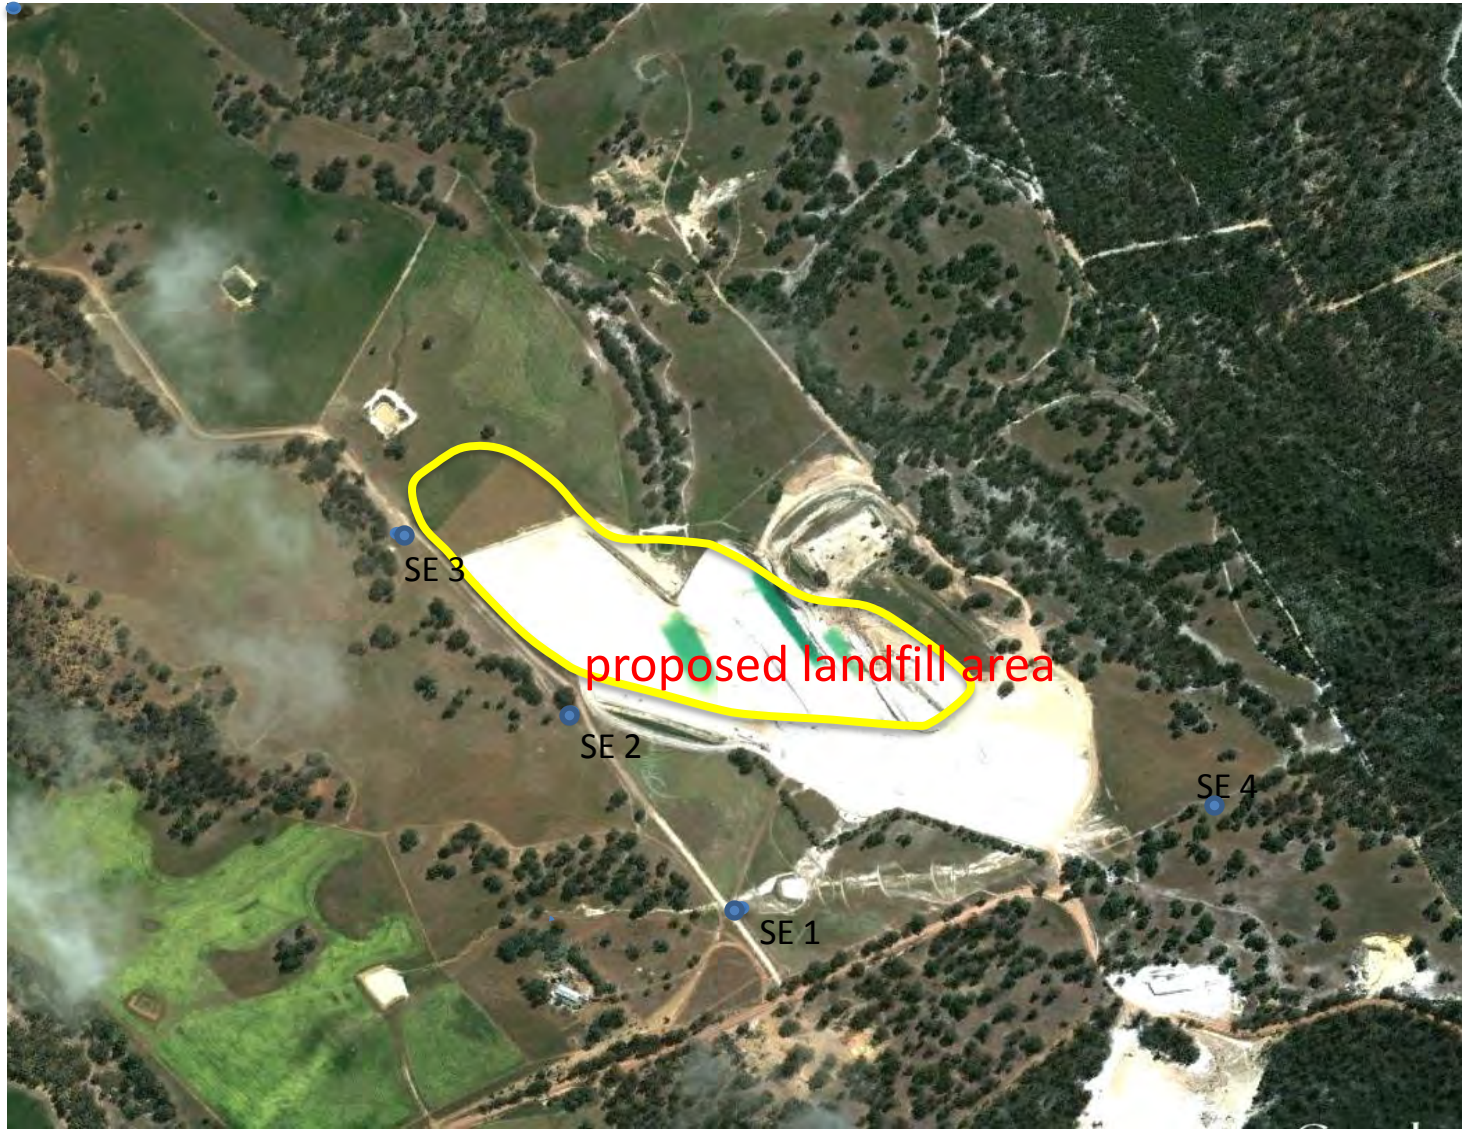
Figure 2 : Site Layout and Monitoring Bore Locations

Monitor wells SE-1 to SE 3 were installed within the south-western (downgradient of the proposed landfill) areas. Monitor well SE 4 targeted the aquifer up-hydraulic gradient boundaries of the site. Prior to the commencement of drilling activities, all services within the site area were identified and located to prevent potential damage. Accurate locations of the four newly installed monitoring bores are shown on Figure 6.

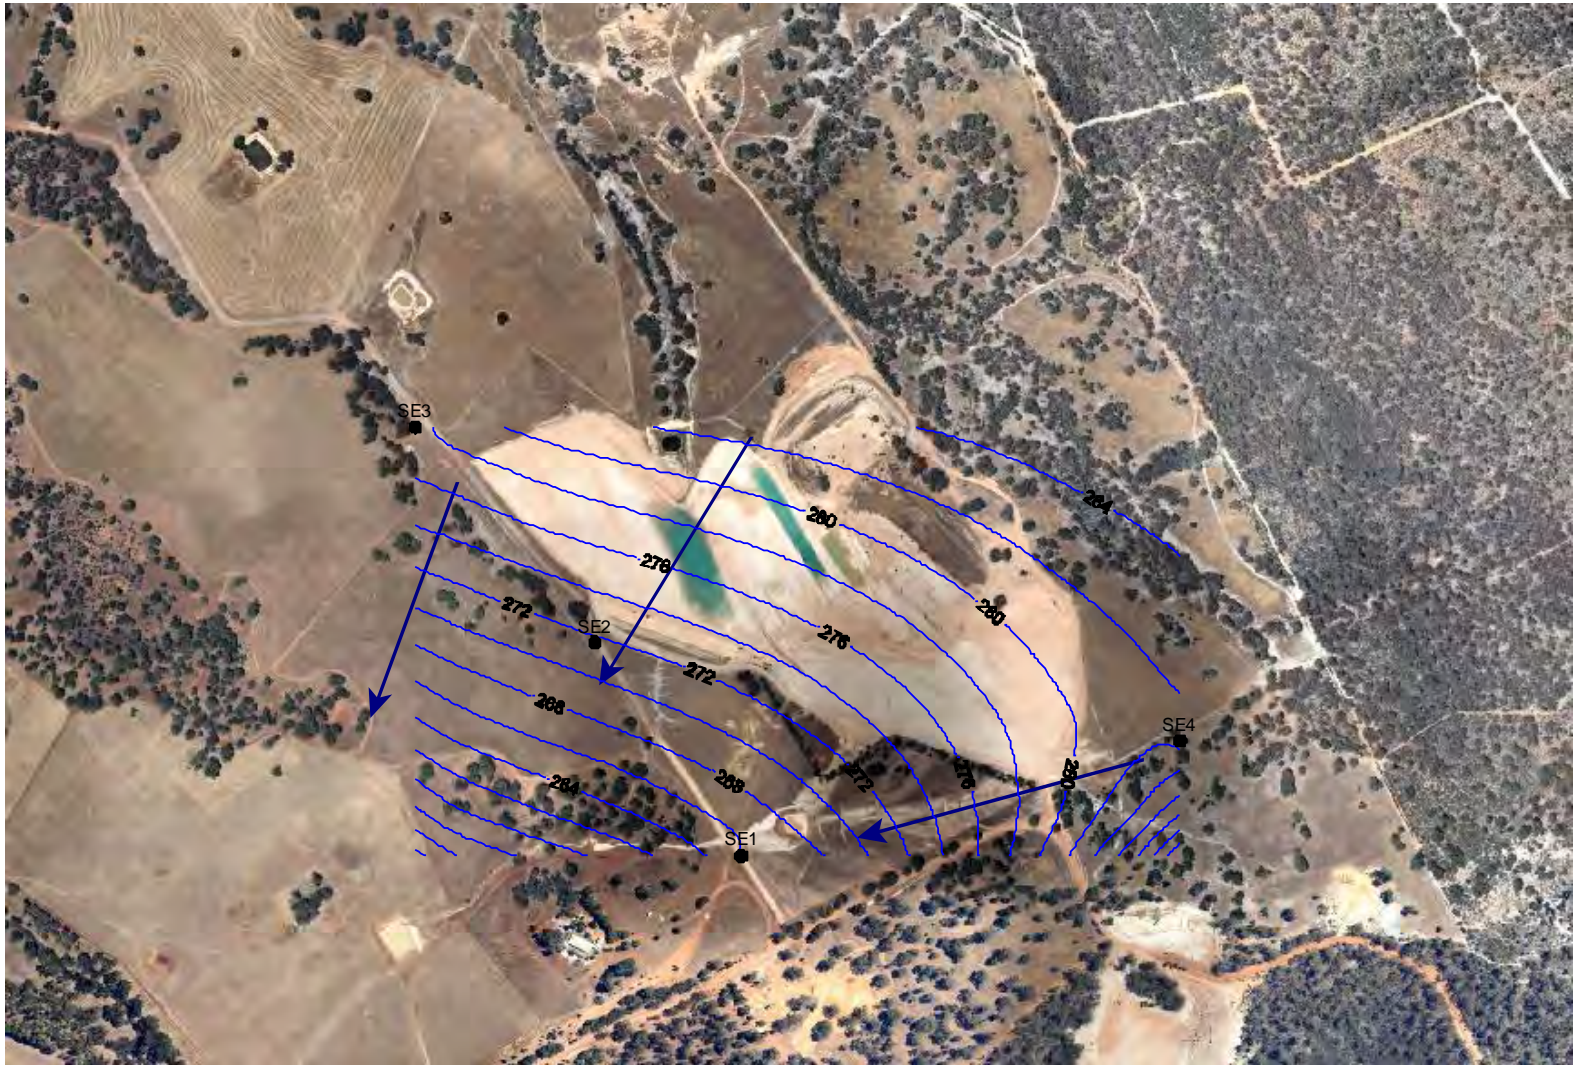
Figure 4 : Static Water Level and Ground Water Flow Direction - June 2011

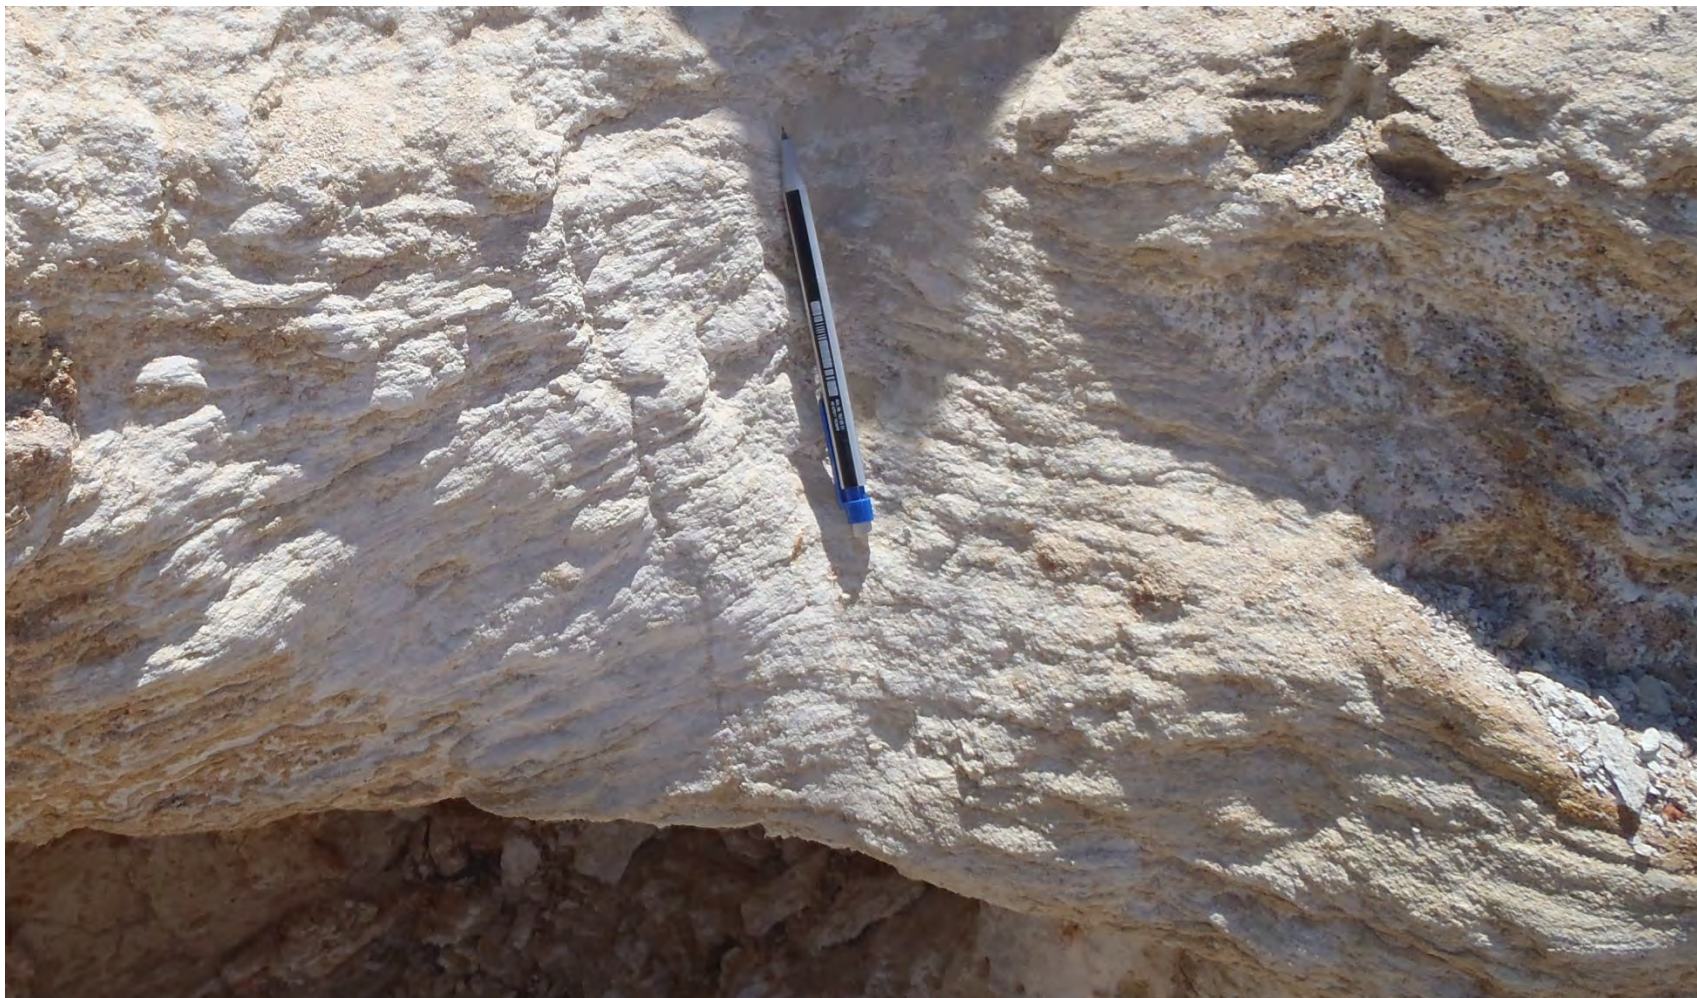
**PLATE 3** – Typical Rock Schistosity

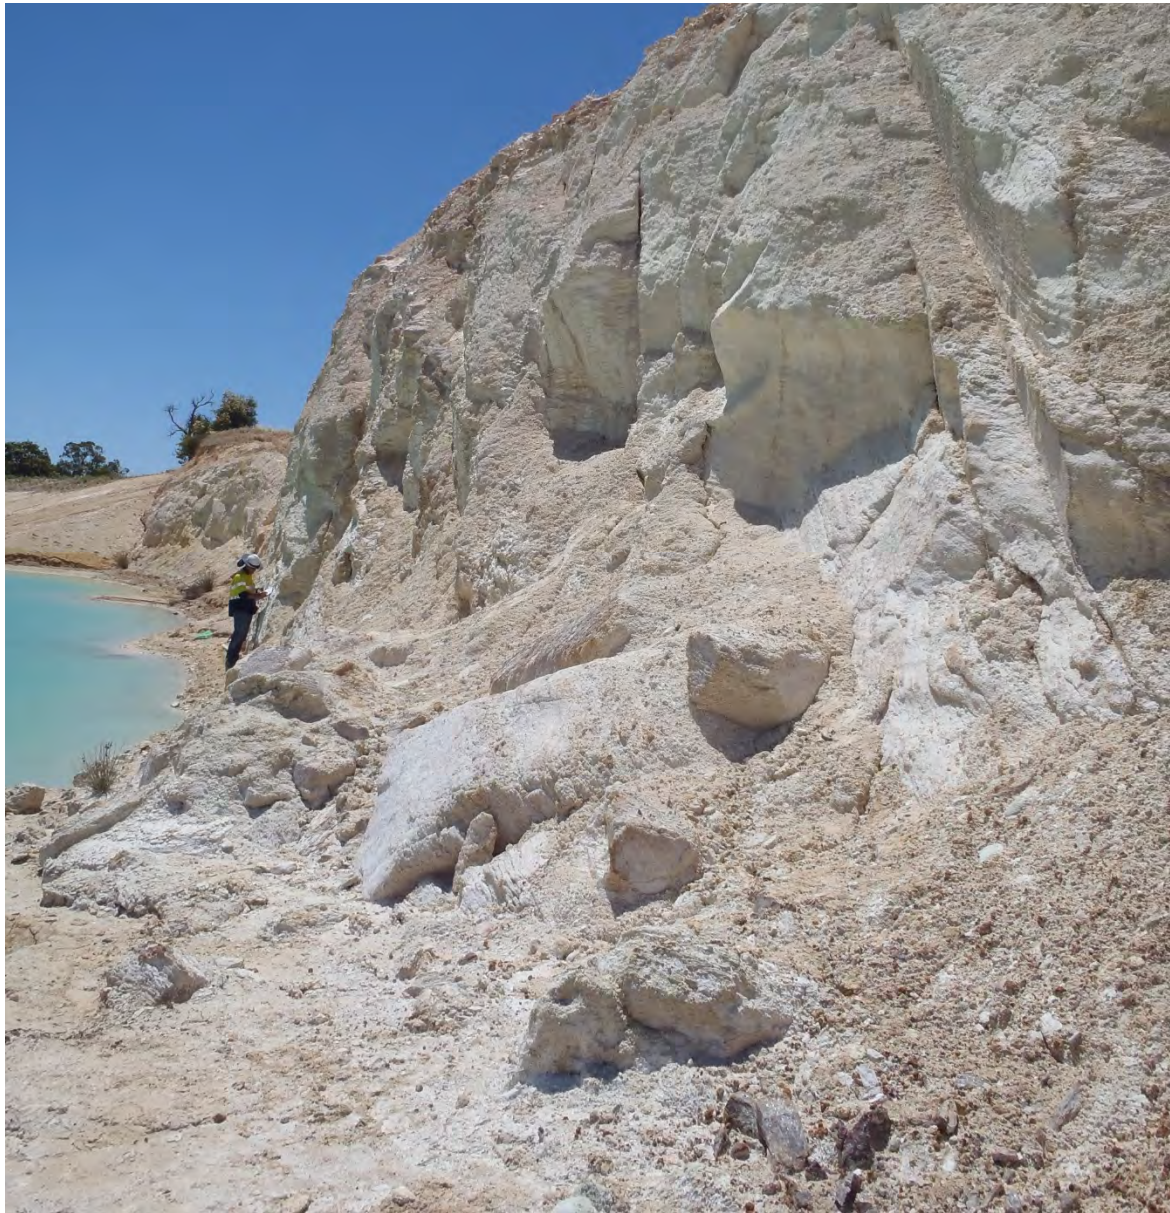
**PLATE 4** – Open Jointing and Slope Debris at Base of Slope Observed in Exposure 2
