Trenchless Construction Techniques Analysis

Water Corporation

Balannup Pressure Main

September 2013

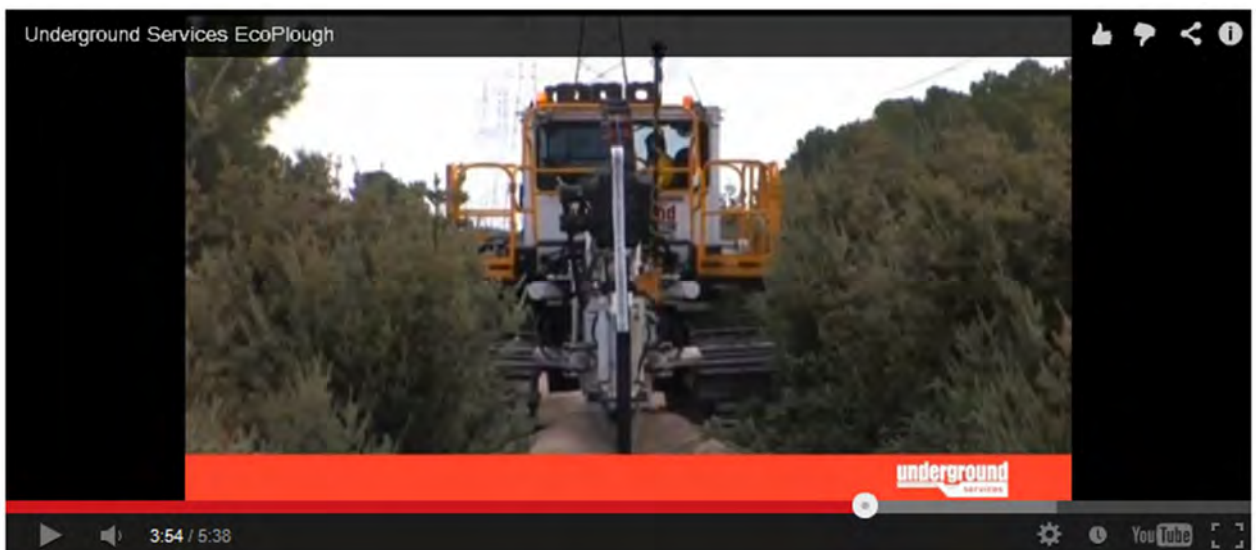
Undercarriage

G. TRACK GAUGE	9.5 ft in	2896 mm
H. STANDARD SHOE SIZE	28 in	710 mm

Screenshot from USA Website

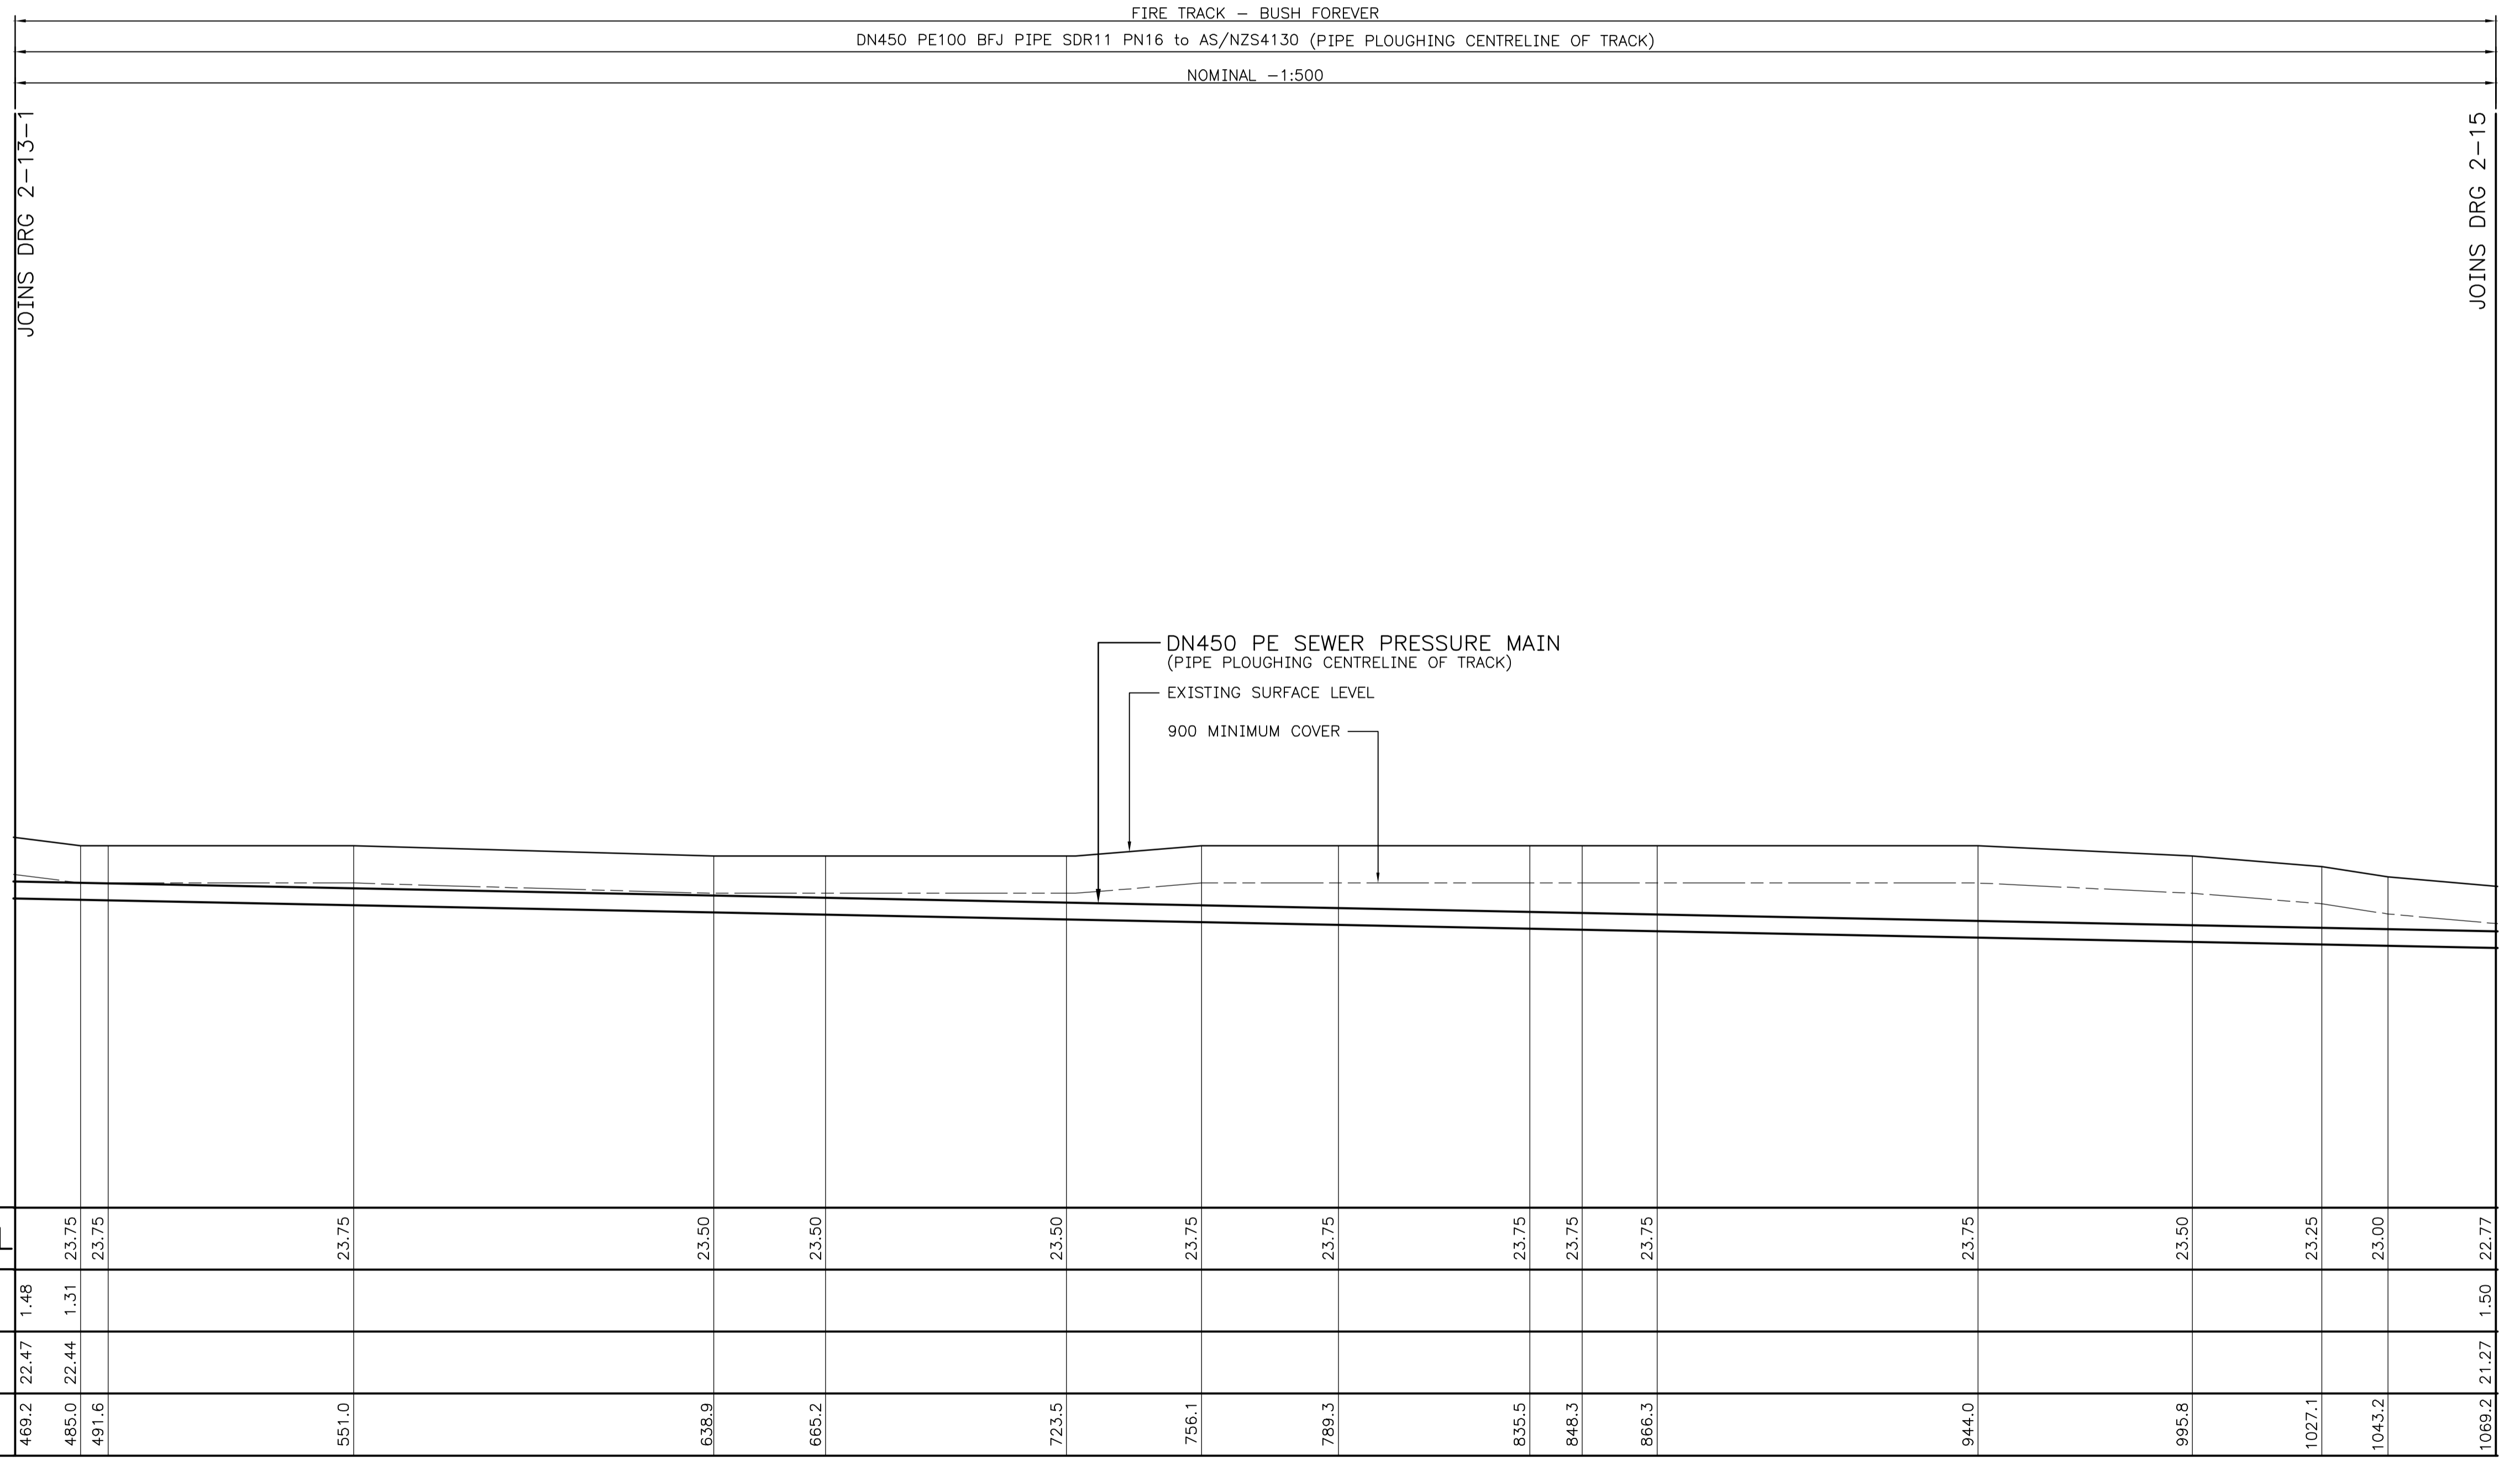
METROPOLITAN WASTEWATER WAPC 127155 BALANNUP PUMPING STATION NO.175-01 - COLLARED ST & PM DN450 PE PRESSURE MAIN - BUSH FOREVER AREA PLAN AND LONGITUDINAL SECTION - SHEET 2 OF 3		ORIGINAL SHEET SIZE A1
FILE JT1 201202141 V01	PLAN HW91-2-14	CAD ISSUE A MF
PROJECT C-S01249

DATUM 15.00m ABOVE AHD																	
EXISTING SURFACE LEVEL		23.75	23.75	23.75	23.50	23.50	23.50	23.75	23.75	23.75	23.75	23.75	23.75	23.50	23.25	23.00	22.77
DEPTH TO INVERT	1.48	1.31															1.50
INVERT LEVEL	22.47	22.44															21.27
HORIZONTAL DISTANCE	489.2	485.0	491.6	551.0	638.9	665.2	723.5	756.1	789.3	835.5	848.3	866.3	944.0	995.8	1027.1	1043.2	1069.2

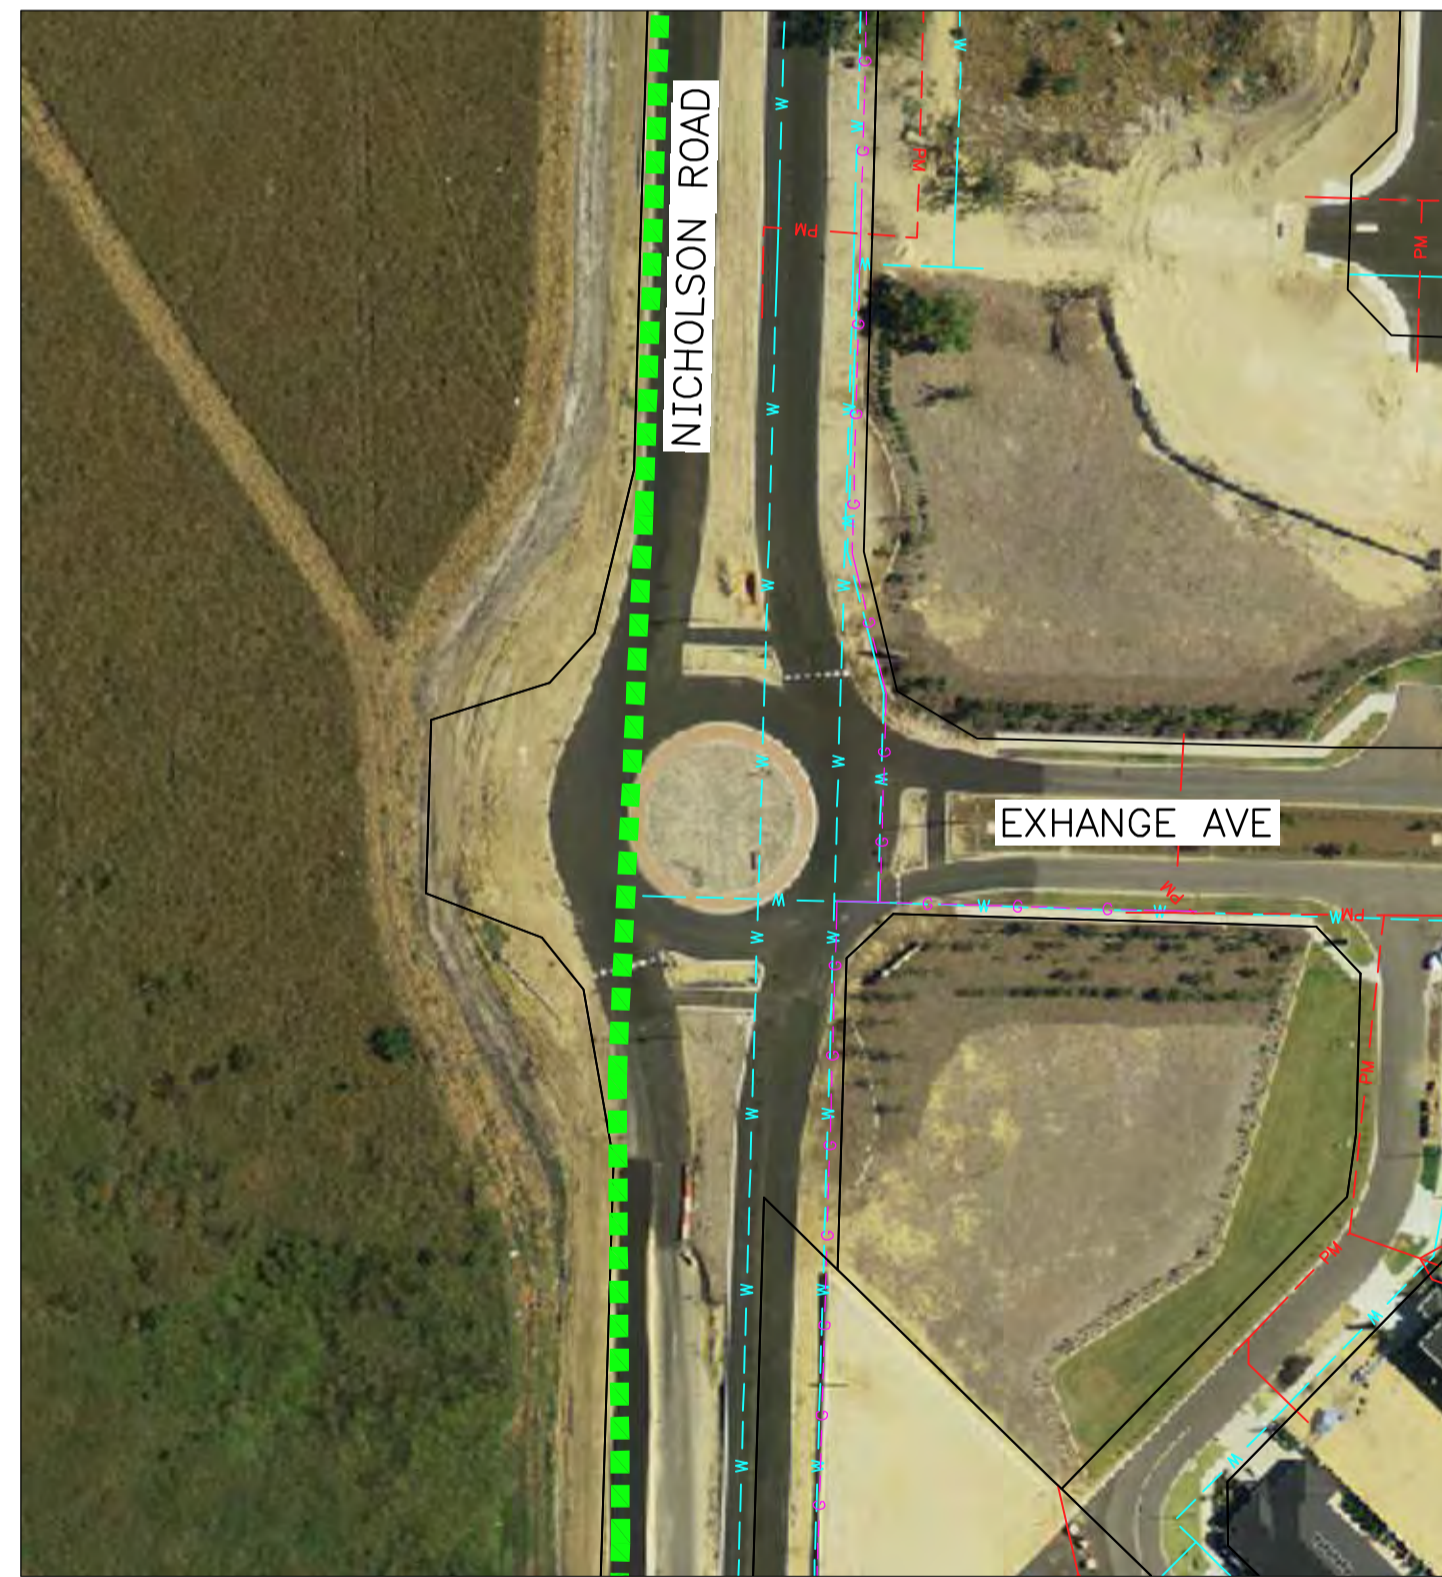
PLAN
ENLARGEMENT 2
SCALE (2)

- PROPOSED ALIGNMENT
- EXISTING WASTEWATER
- EXISTING WATER
- EXISTING GAS
- OVERHEAD POWER LINES

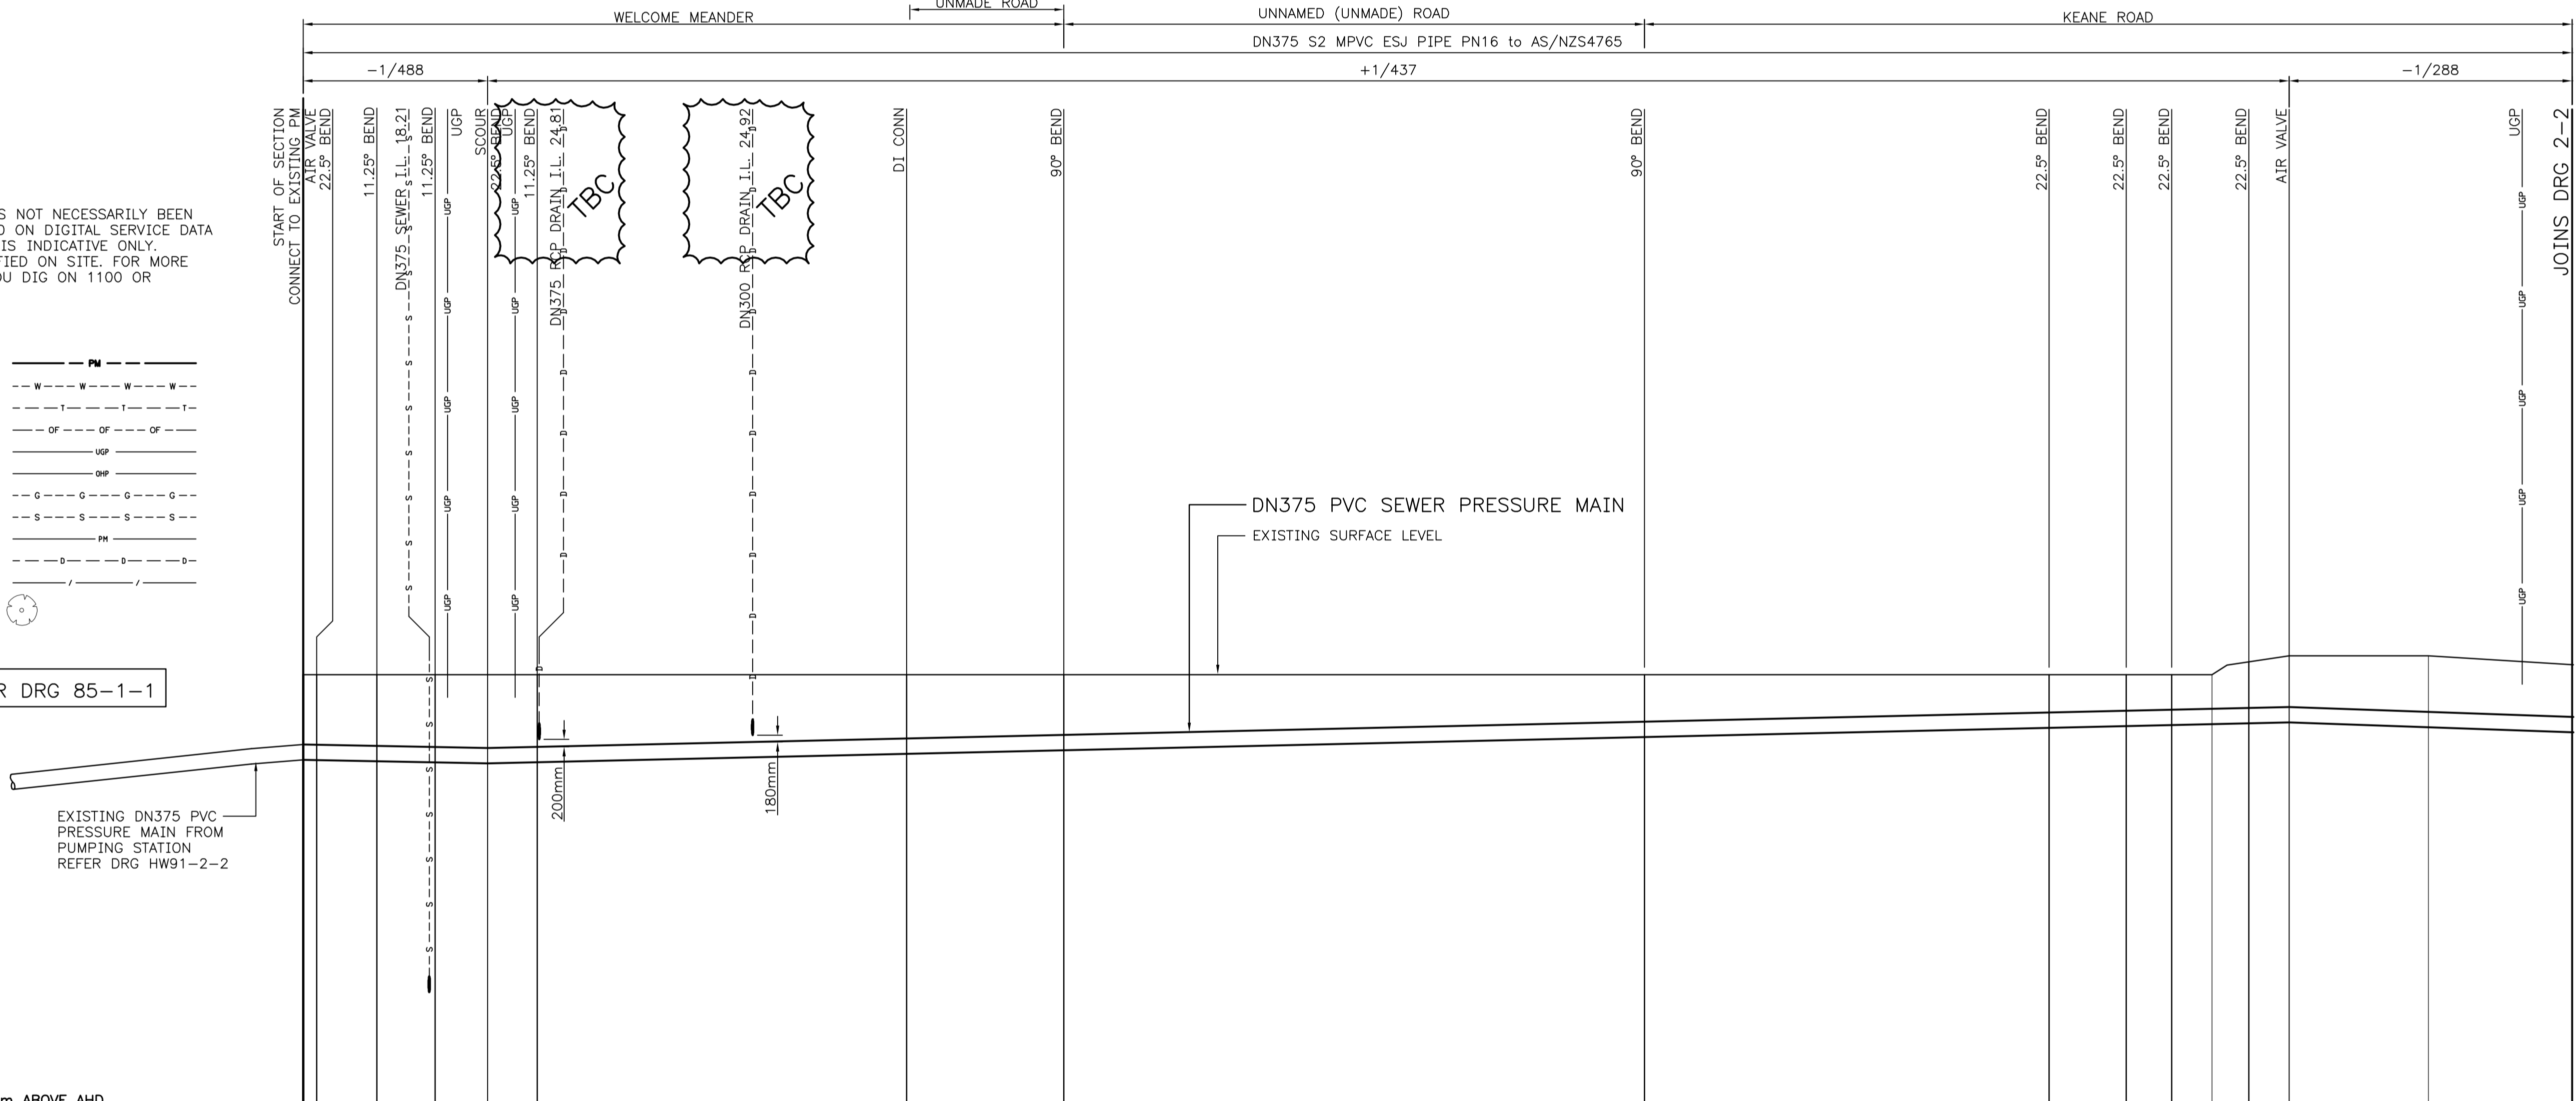
METROPOLITAN WASTEWATER WAPC 127155 BALANNUP PUMPING STATION NO.175-01 - COLLARED ST & PM ENGINEERING DESIGN - DN375 PRESSURE MAIN PLAN AND LONGITUDINAL SECTION - SHEET 2 OF 8	
FILE PROJECT C-S01249	PLAN HW91-85-2-2
CAD A	ISSUE A

DATUM 15.00m ABOVE AHD																				
NATURAL SURFACE LEVEL	26.50				26.50										26.75					
DEPTH TO INVERT	2.25			2.35																
INVERT LEVEL	24.25			24.15																
HORIZONTAL DISTANCE	0.0	3.6	19.5	34.9	48.8	61.9		159.6	201.2		354.7		461.8	482.1	494.1	504.8	514.5	525.2	562.0	600

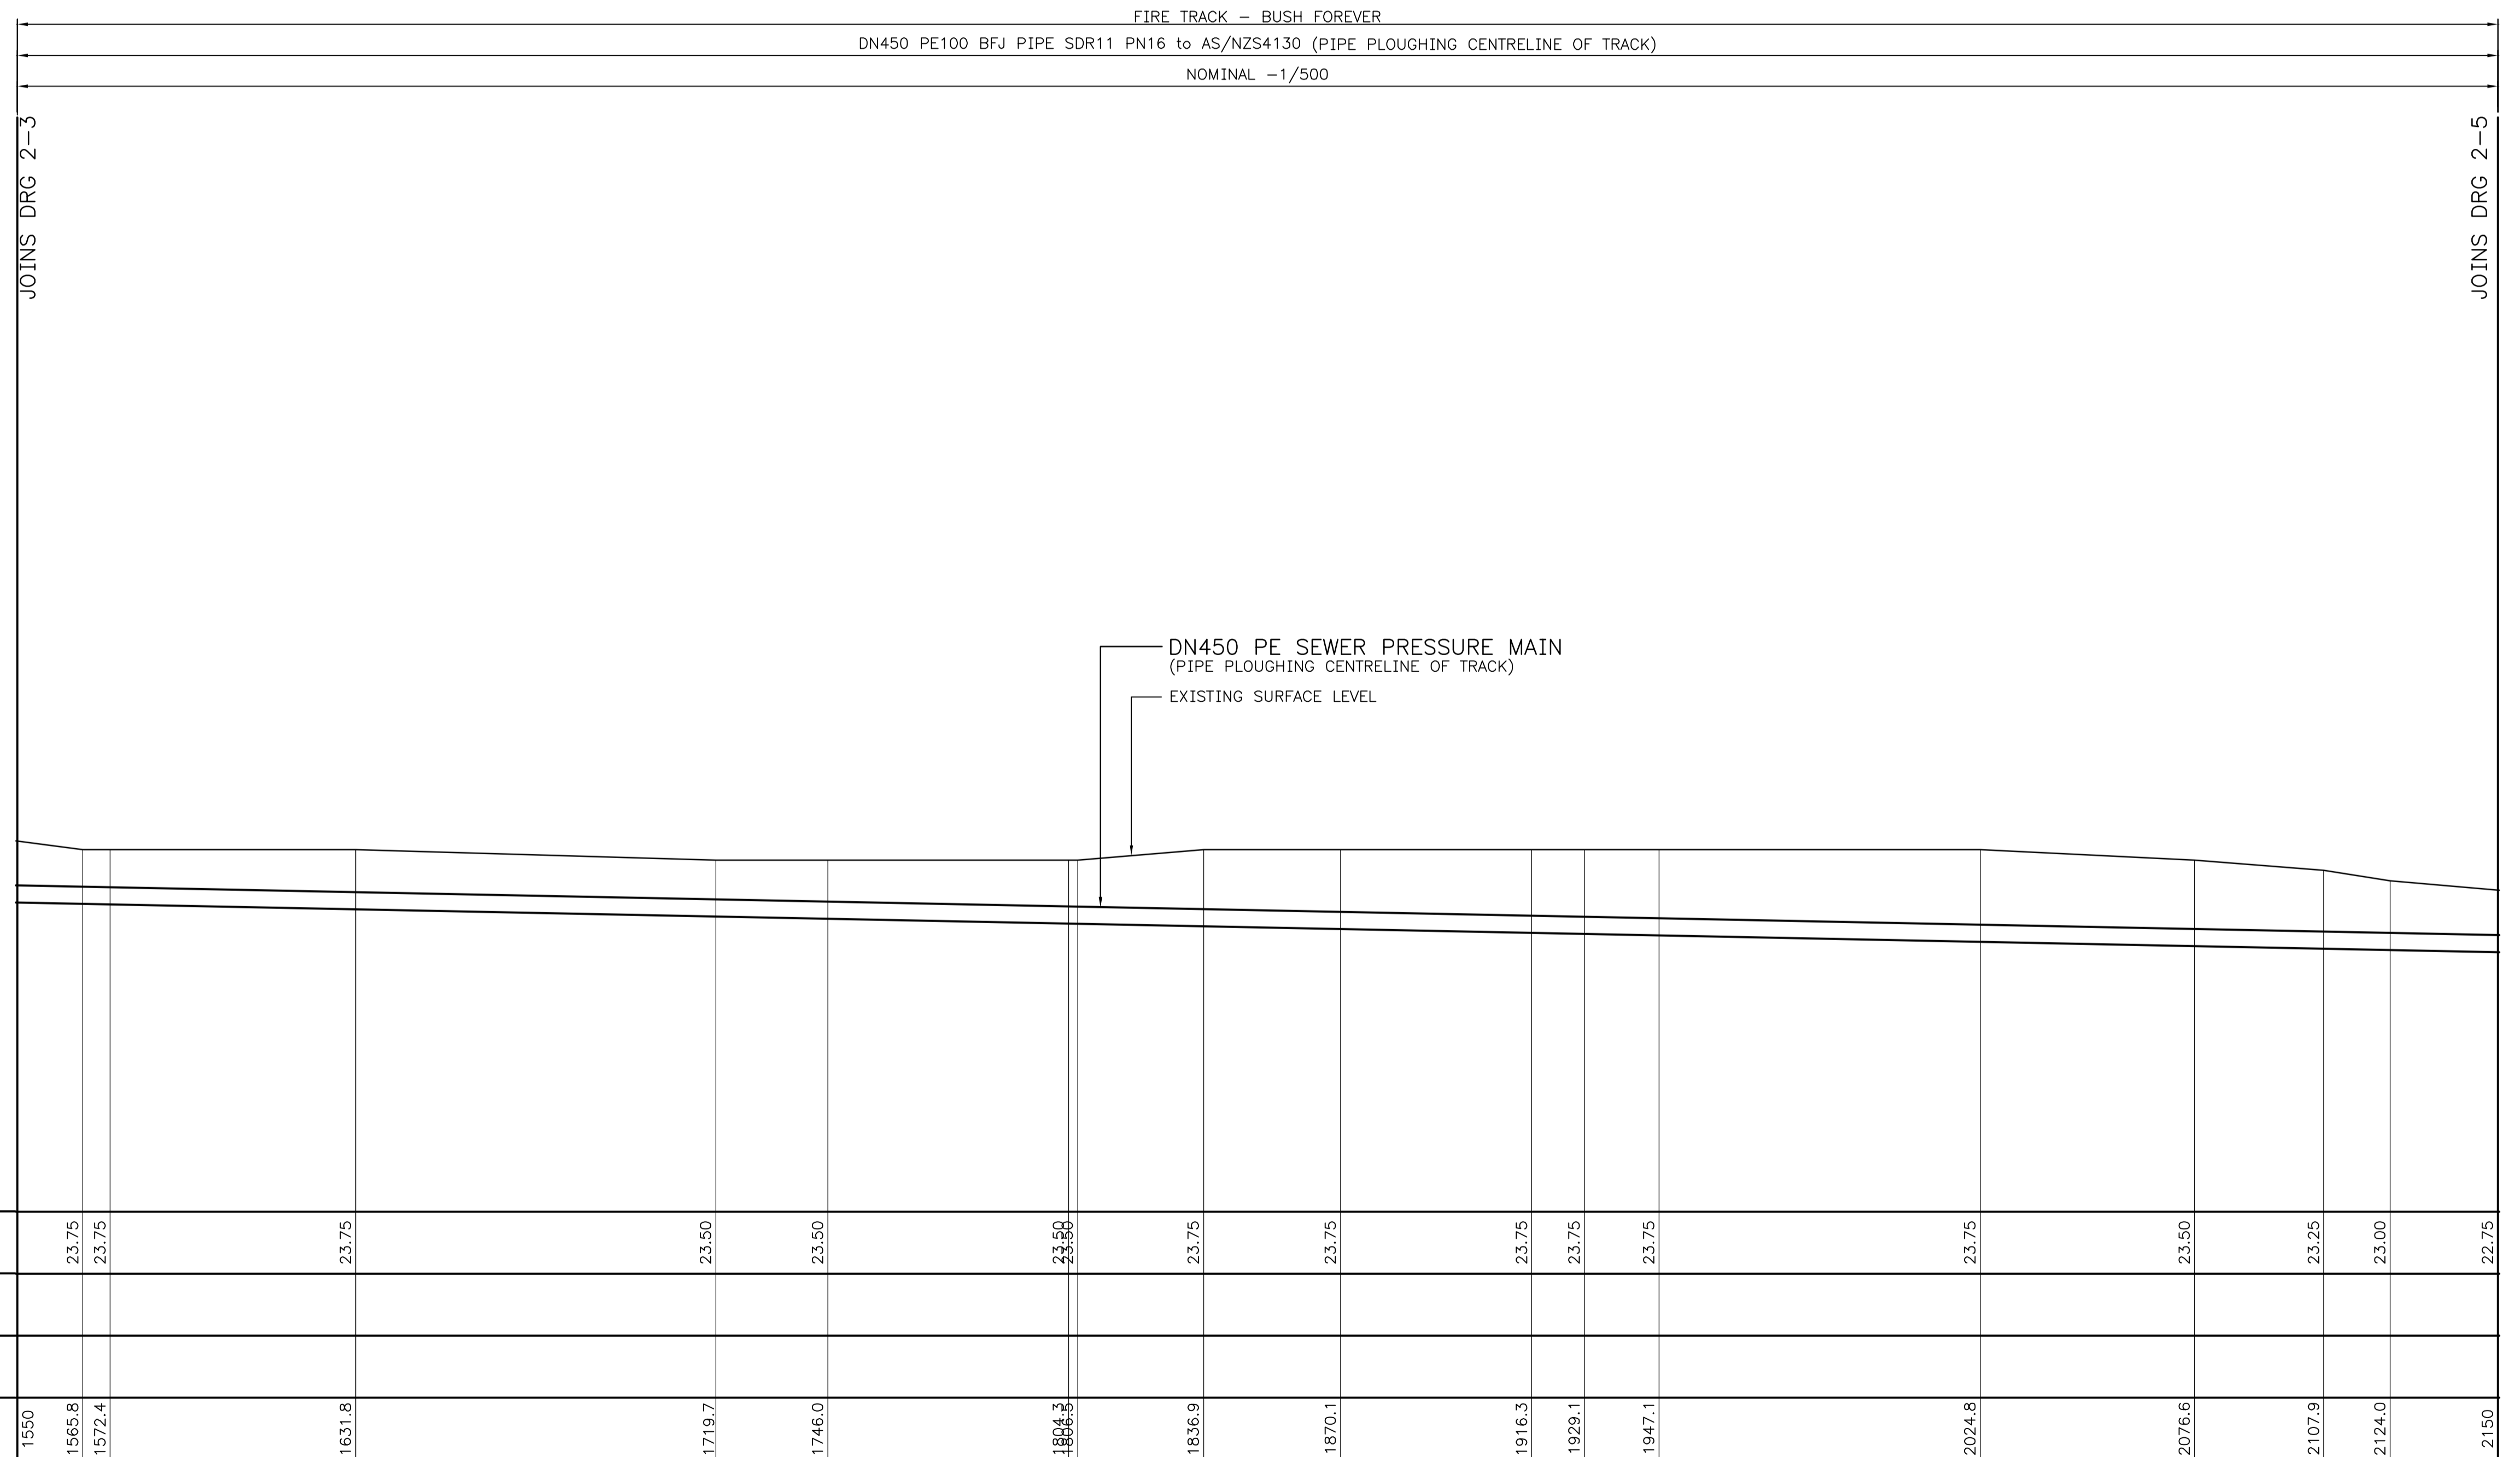
METROPOLITAN WASTEWATER WAPC 127155 BALANNUP PUMPING STATION NO.175-01 - COLLARED ST & PM ENGINEERING DESIGN - DN375 PRESSURE MAIN PLAN AND LONGITUDINAL SECTION - SHEET 4 OF 8		ORIGINAL SHEET SIZE A1
FILE PROJECT C-S01249	PLAN HW91-85-2-4	CAD ISSUE A

DATUM 15.00m ABOVE AHD																		
NATURAL SURFACE LEVEL		23.75	23.75	23.75	23.50	23.50	23.50	23.75	23.75	23.75	23.75	23.75	23.75	23.50	23.25	23.00	22.75	
DEPTH TO INVERT																		
INVERT LEVEL																		
HORIZONTAL DISTANCE		1550	1565.8	1572.4	1631.8	1719.7	1746.0	1804.3	1836.9	1870.1	1916.3	1929.1	1947.1	2024.8	2076.6	2107.9	2124.0	2150

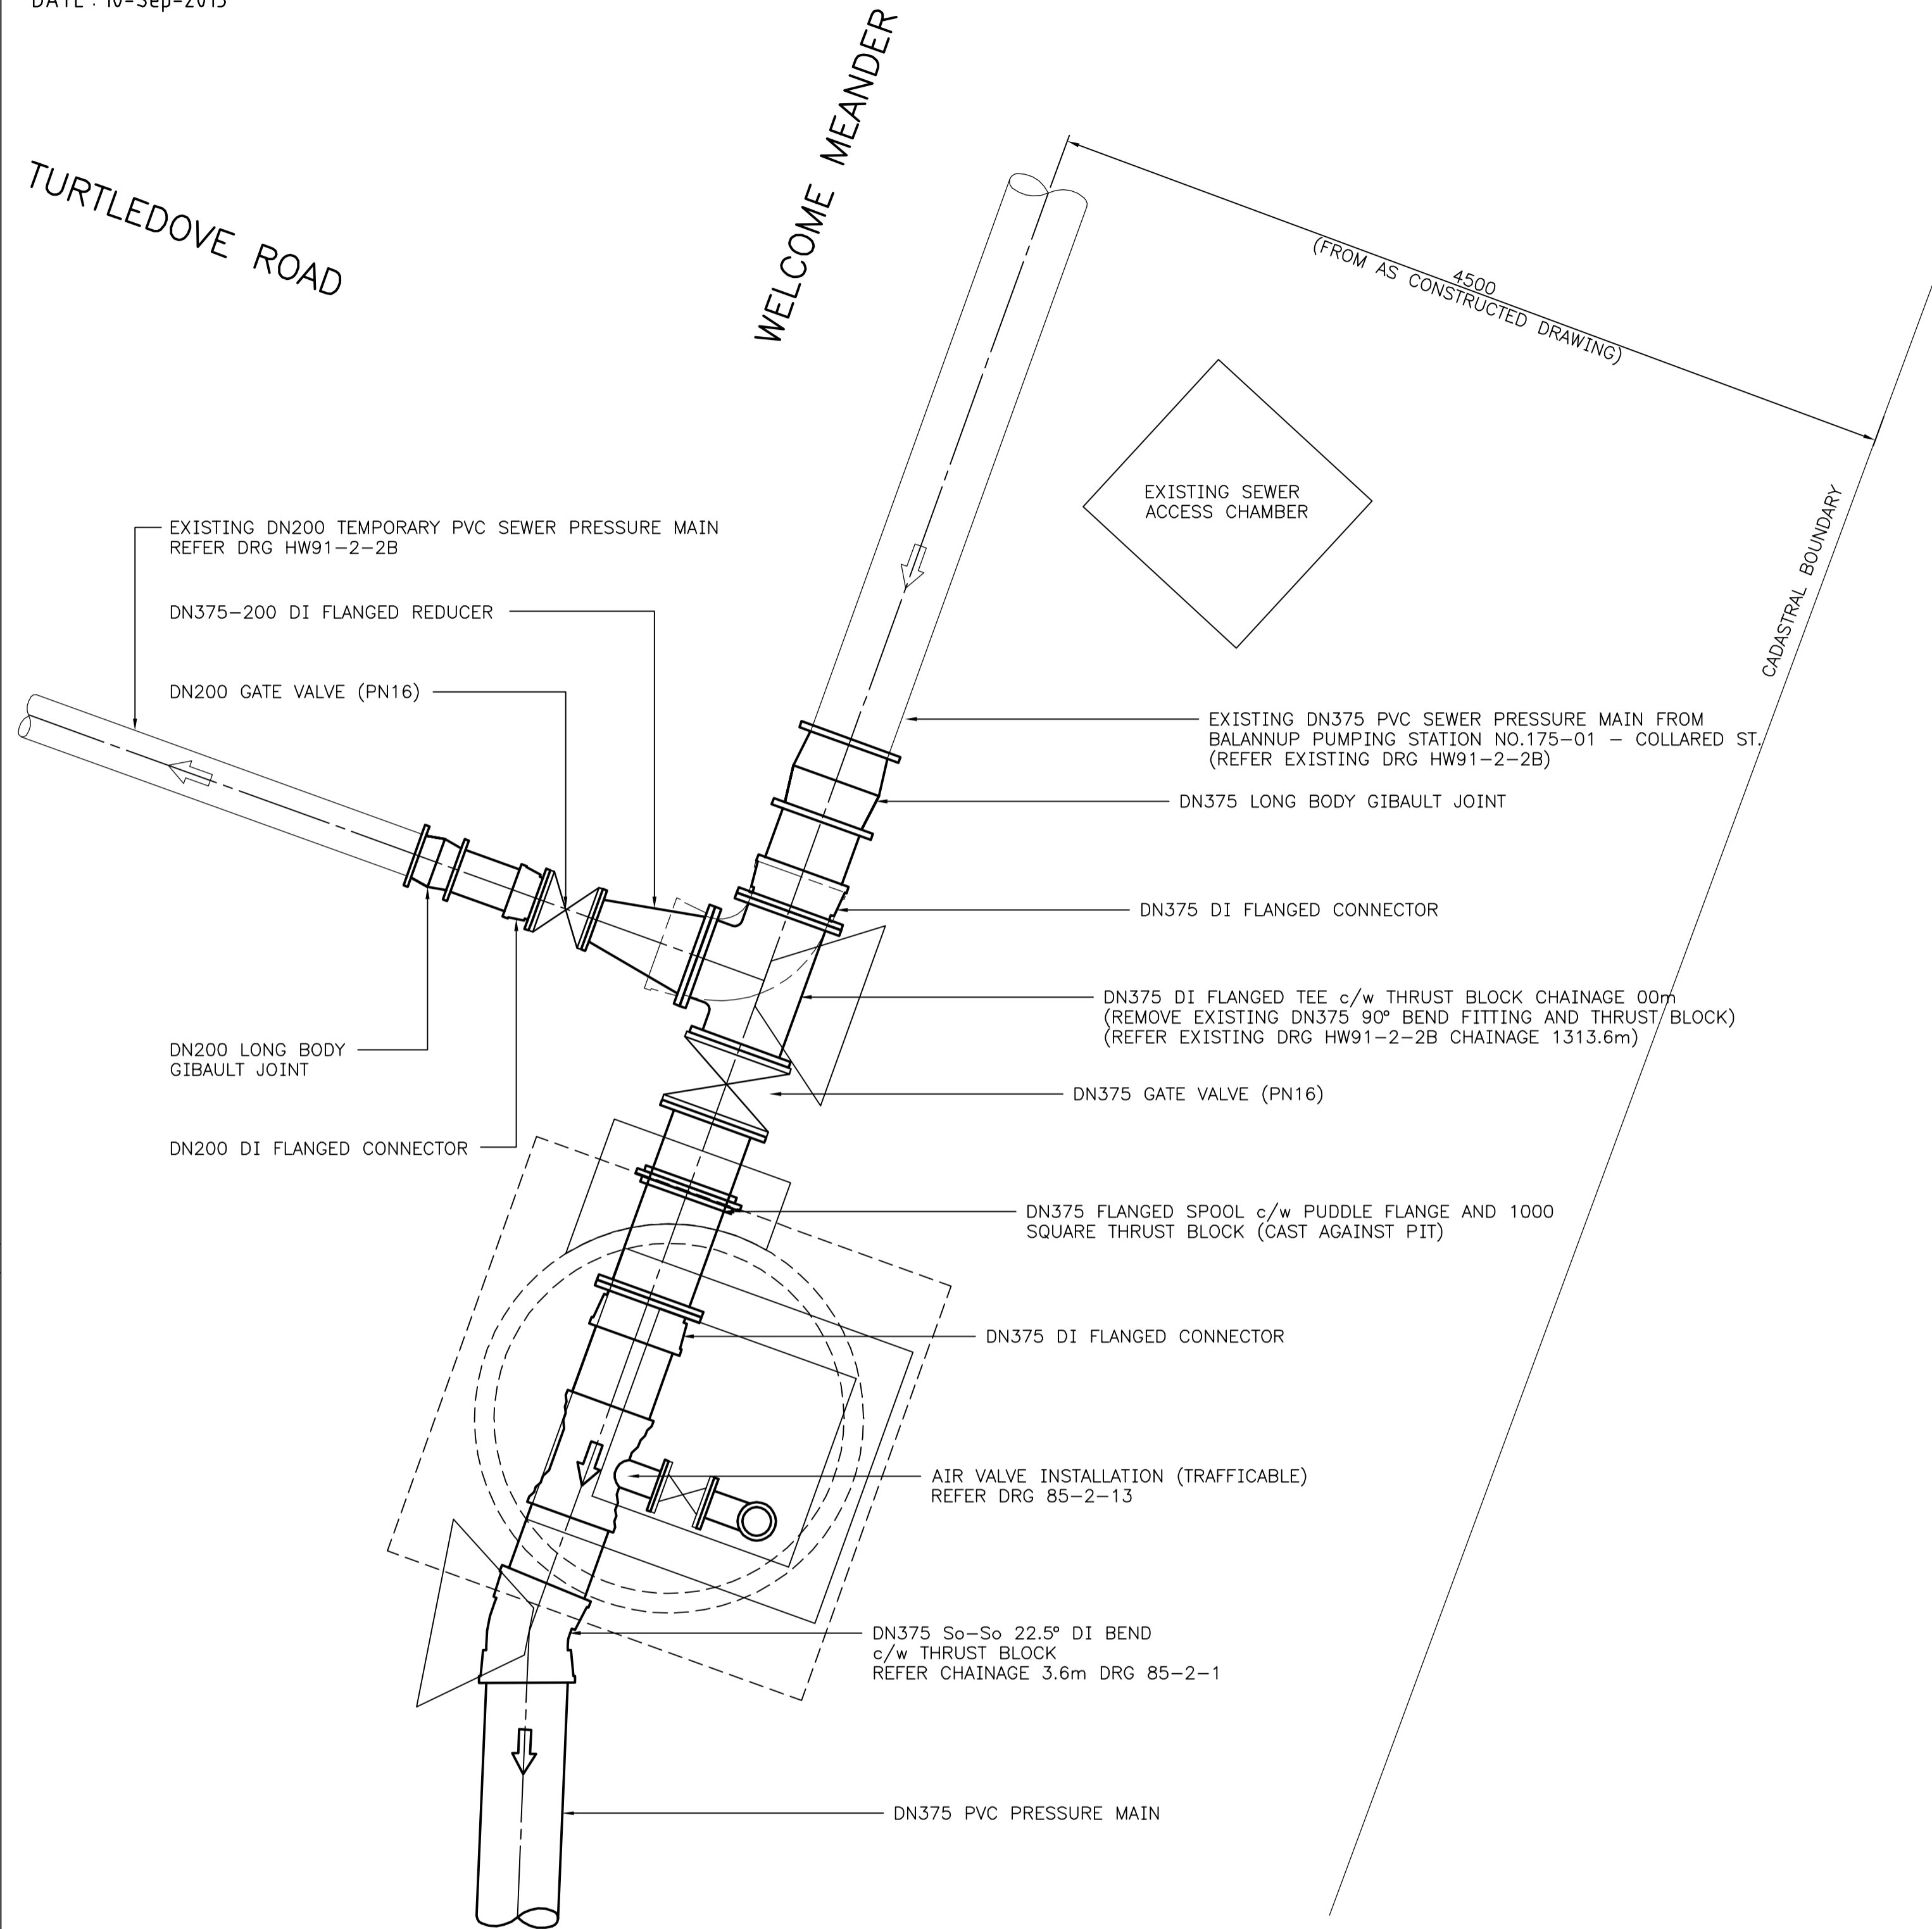
CONNECTION TO EXISTING PRESSURE MAIN
REFER DRG 85-2-1
1:25

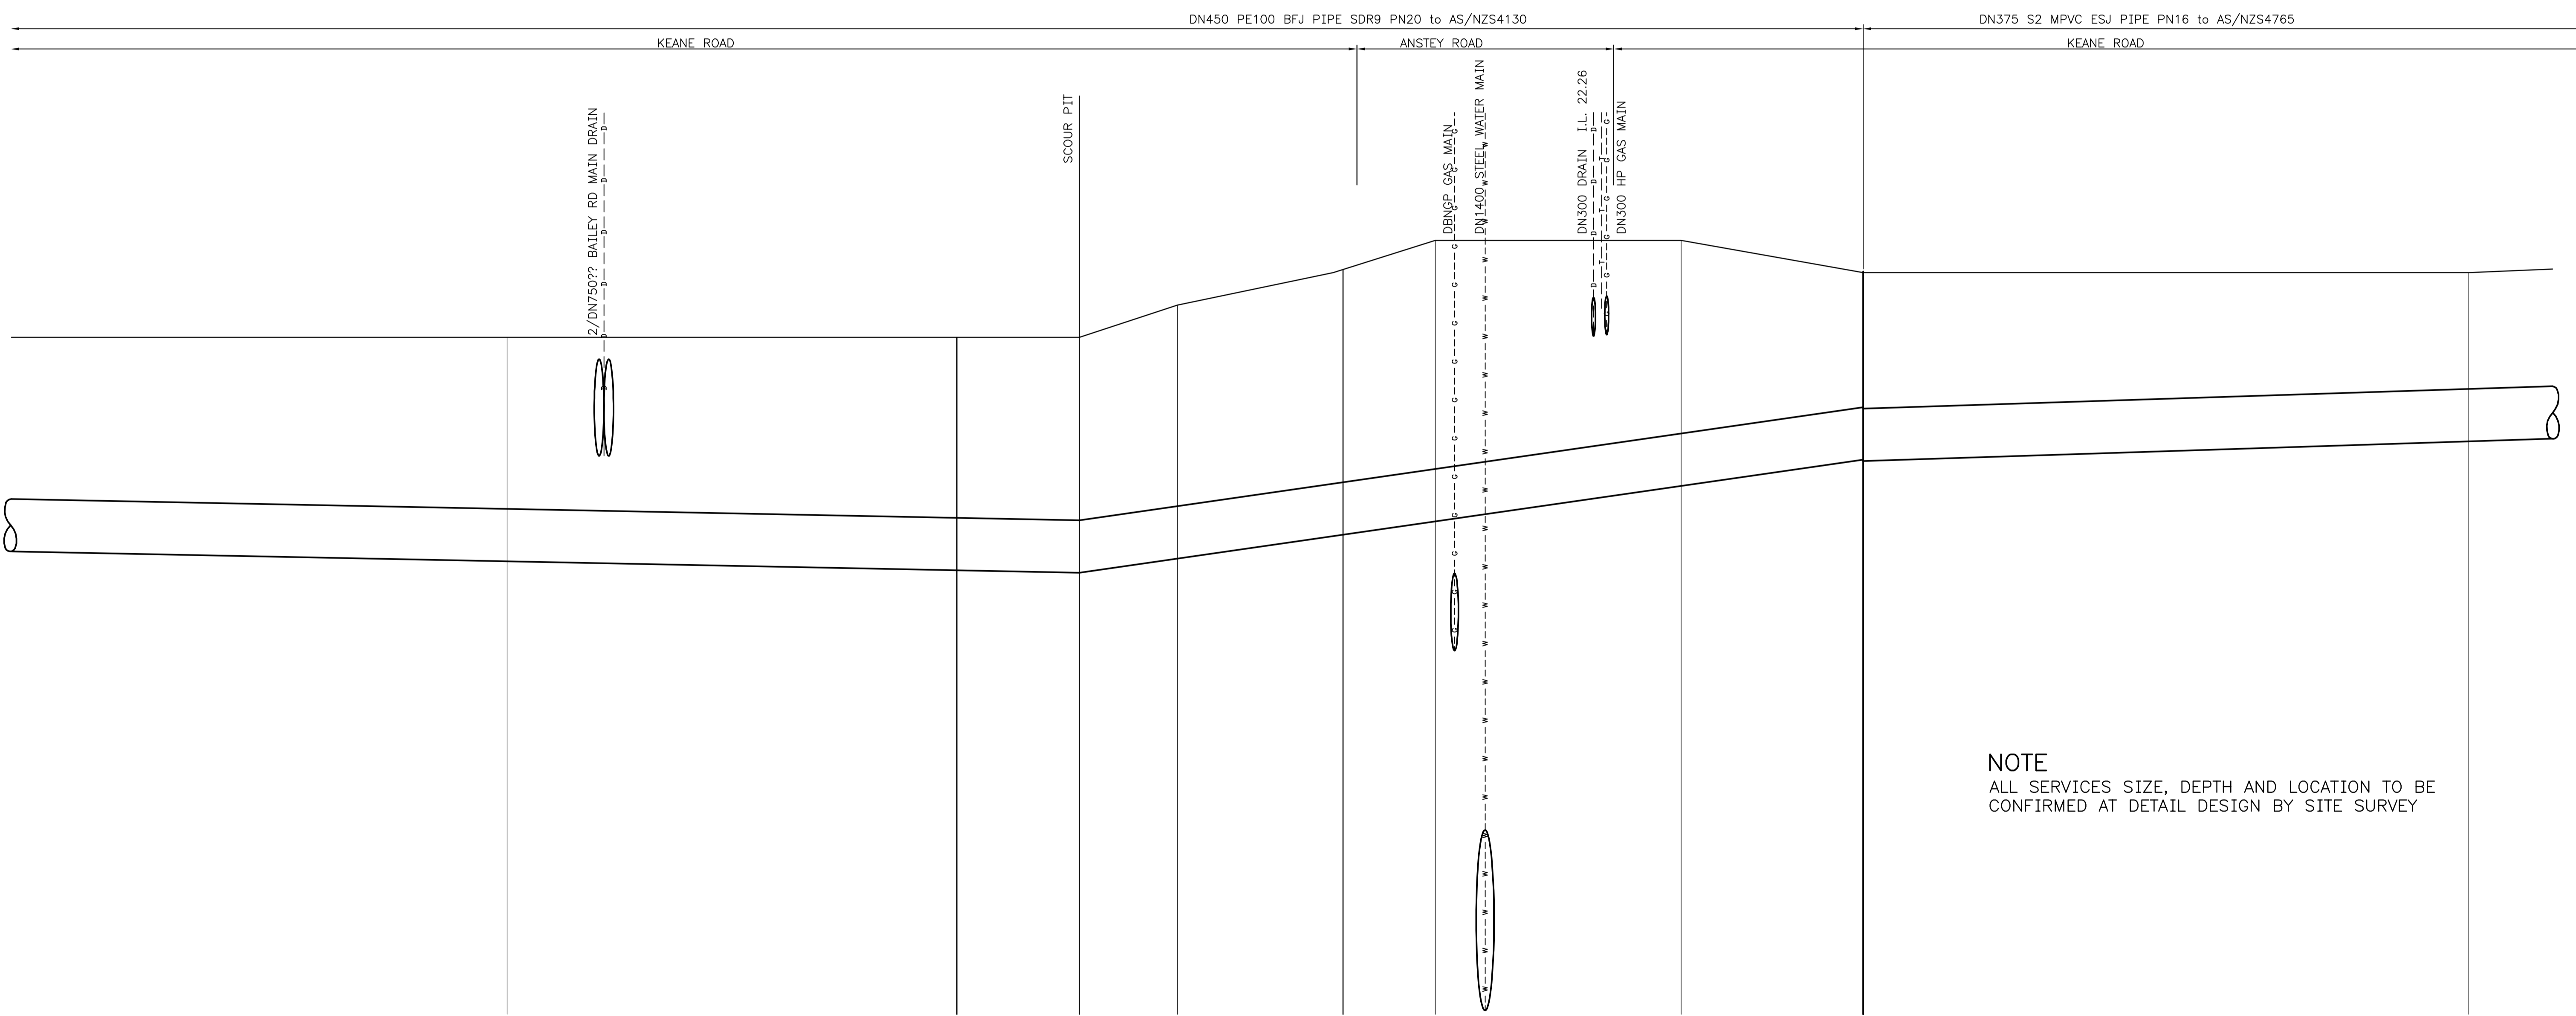
METROPOLITAN WASTEWATER WAPC 127155 BALANNUP PUMPING STATION NO.175-01 - COLLARED ST & PM ENGINEERING DESIGN - DN375 PRESSURE MAIN DBNGP CROSSING			
FILE PROJECT C-S01249	PLAN HW91-85-2-11	CAD A	ISSUE MF

PLAN
1:500

SECTION
HORIZONTAL 1:250
VERTICAL 1:25

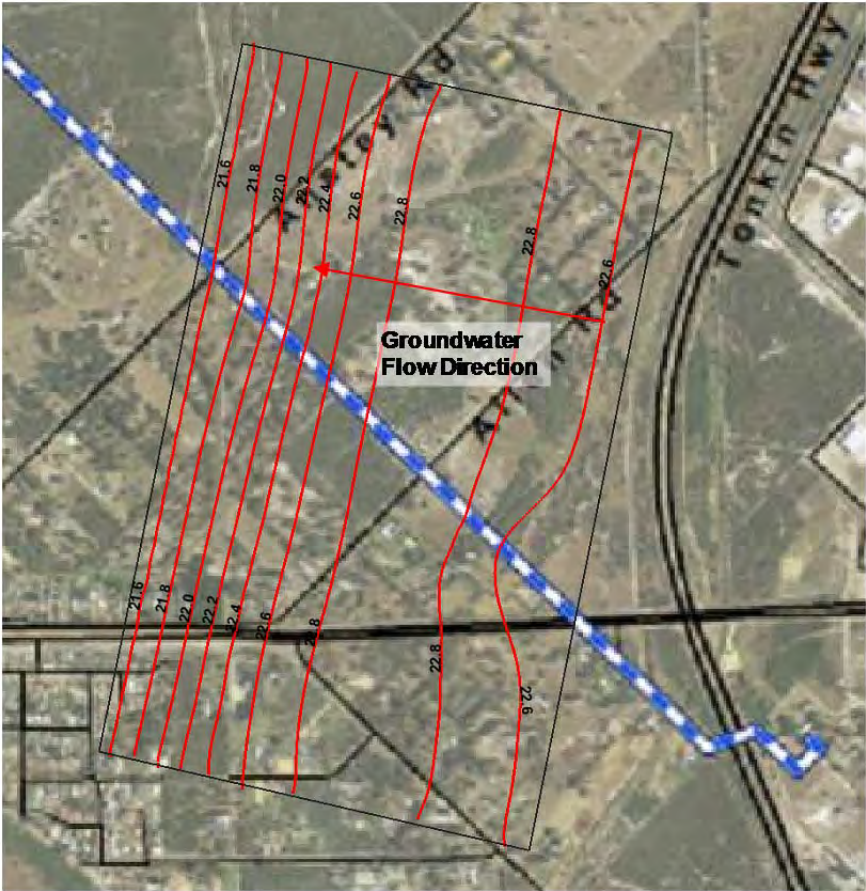
Pre-installation model simulated groundwater contours (Figure A4-4) correspond with the measured flat water table east of the open drain (which is in close proximity to the western

boundary). Graph A4-3 shows a groundwater elevation time series for a point along the proposed main installation, near the centre of the model domain. The model simulated groundwater contours fluctuate approximately 0.8 m which is reasonable for the area.

Figure A4-4: Scenario 2 Pre-Installation Groundwater Contours - August 2013 (Modified from AECOM Basemap)

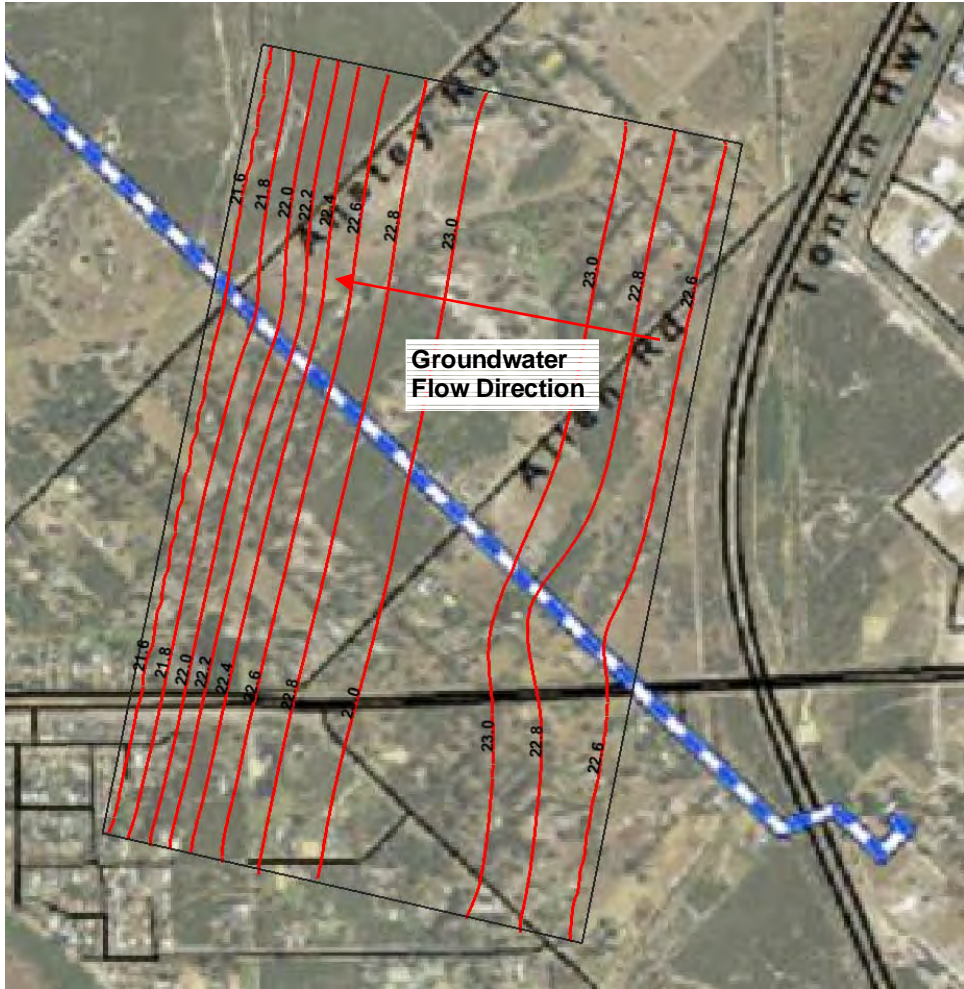
Pre-installation model simulated groundwater contours (Figure A4-5) correspond with the measured flat water table east of the open drain (which is in close proximity to the western boundary). Graph A4-5 shows a groundwater elevation time series for a point along the proposed main installation, near the centre of the model domain. The model simulated groundwater contours fluctuate approximately 1 m which is reasonable for the area.

Figure A4-5: Scenario 3 Pre-Installation Groundwater Contours - August 2013 (Modified from AECOM Basemap)
