BEADON CREEK CAPITAL DREDGING REFERRAL IN ACCORDANCE WITH SECTION 38 OF THE ENVIRONMENTAL PROTECTION ACT

Beadon Creek Capital Dredging

Dredging Environmental Impact Assessment

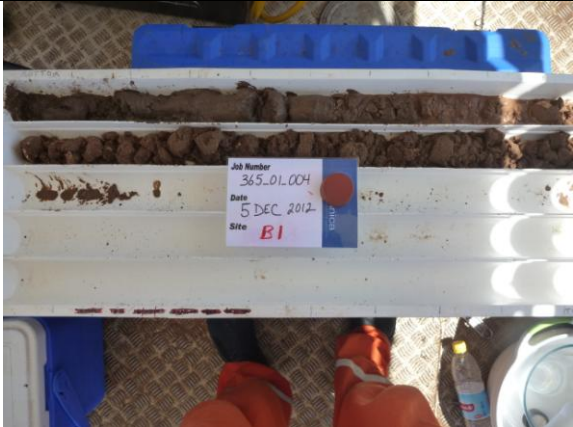
Sample Site	Interval	Sediment interval description	Photo
B1	0-0.5	Red-brown, medium to coarse sands, 5-10% fines

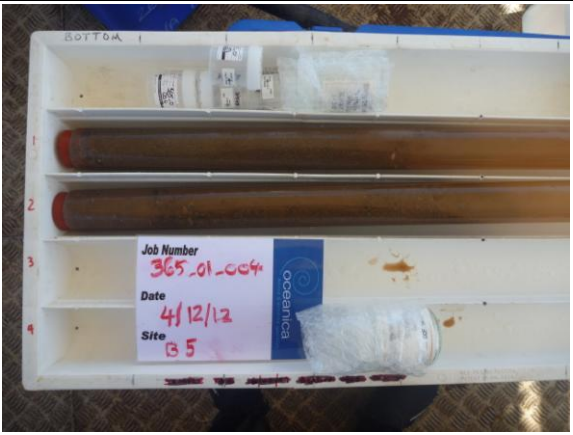
Sample Site	Interval	Sediment interval description	Photo
B5	0-0.5	Brown medium sand, large shell fragments

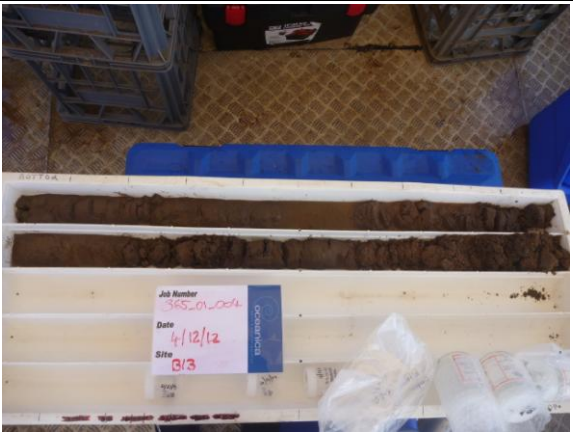
Sample Site	Interval	Sediment interval description	Photo
B13	0-0.5	Brown fine to coarse homogenous sand, 20% fines

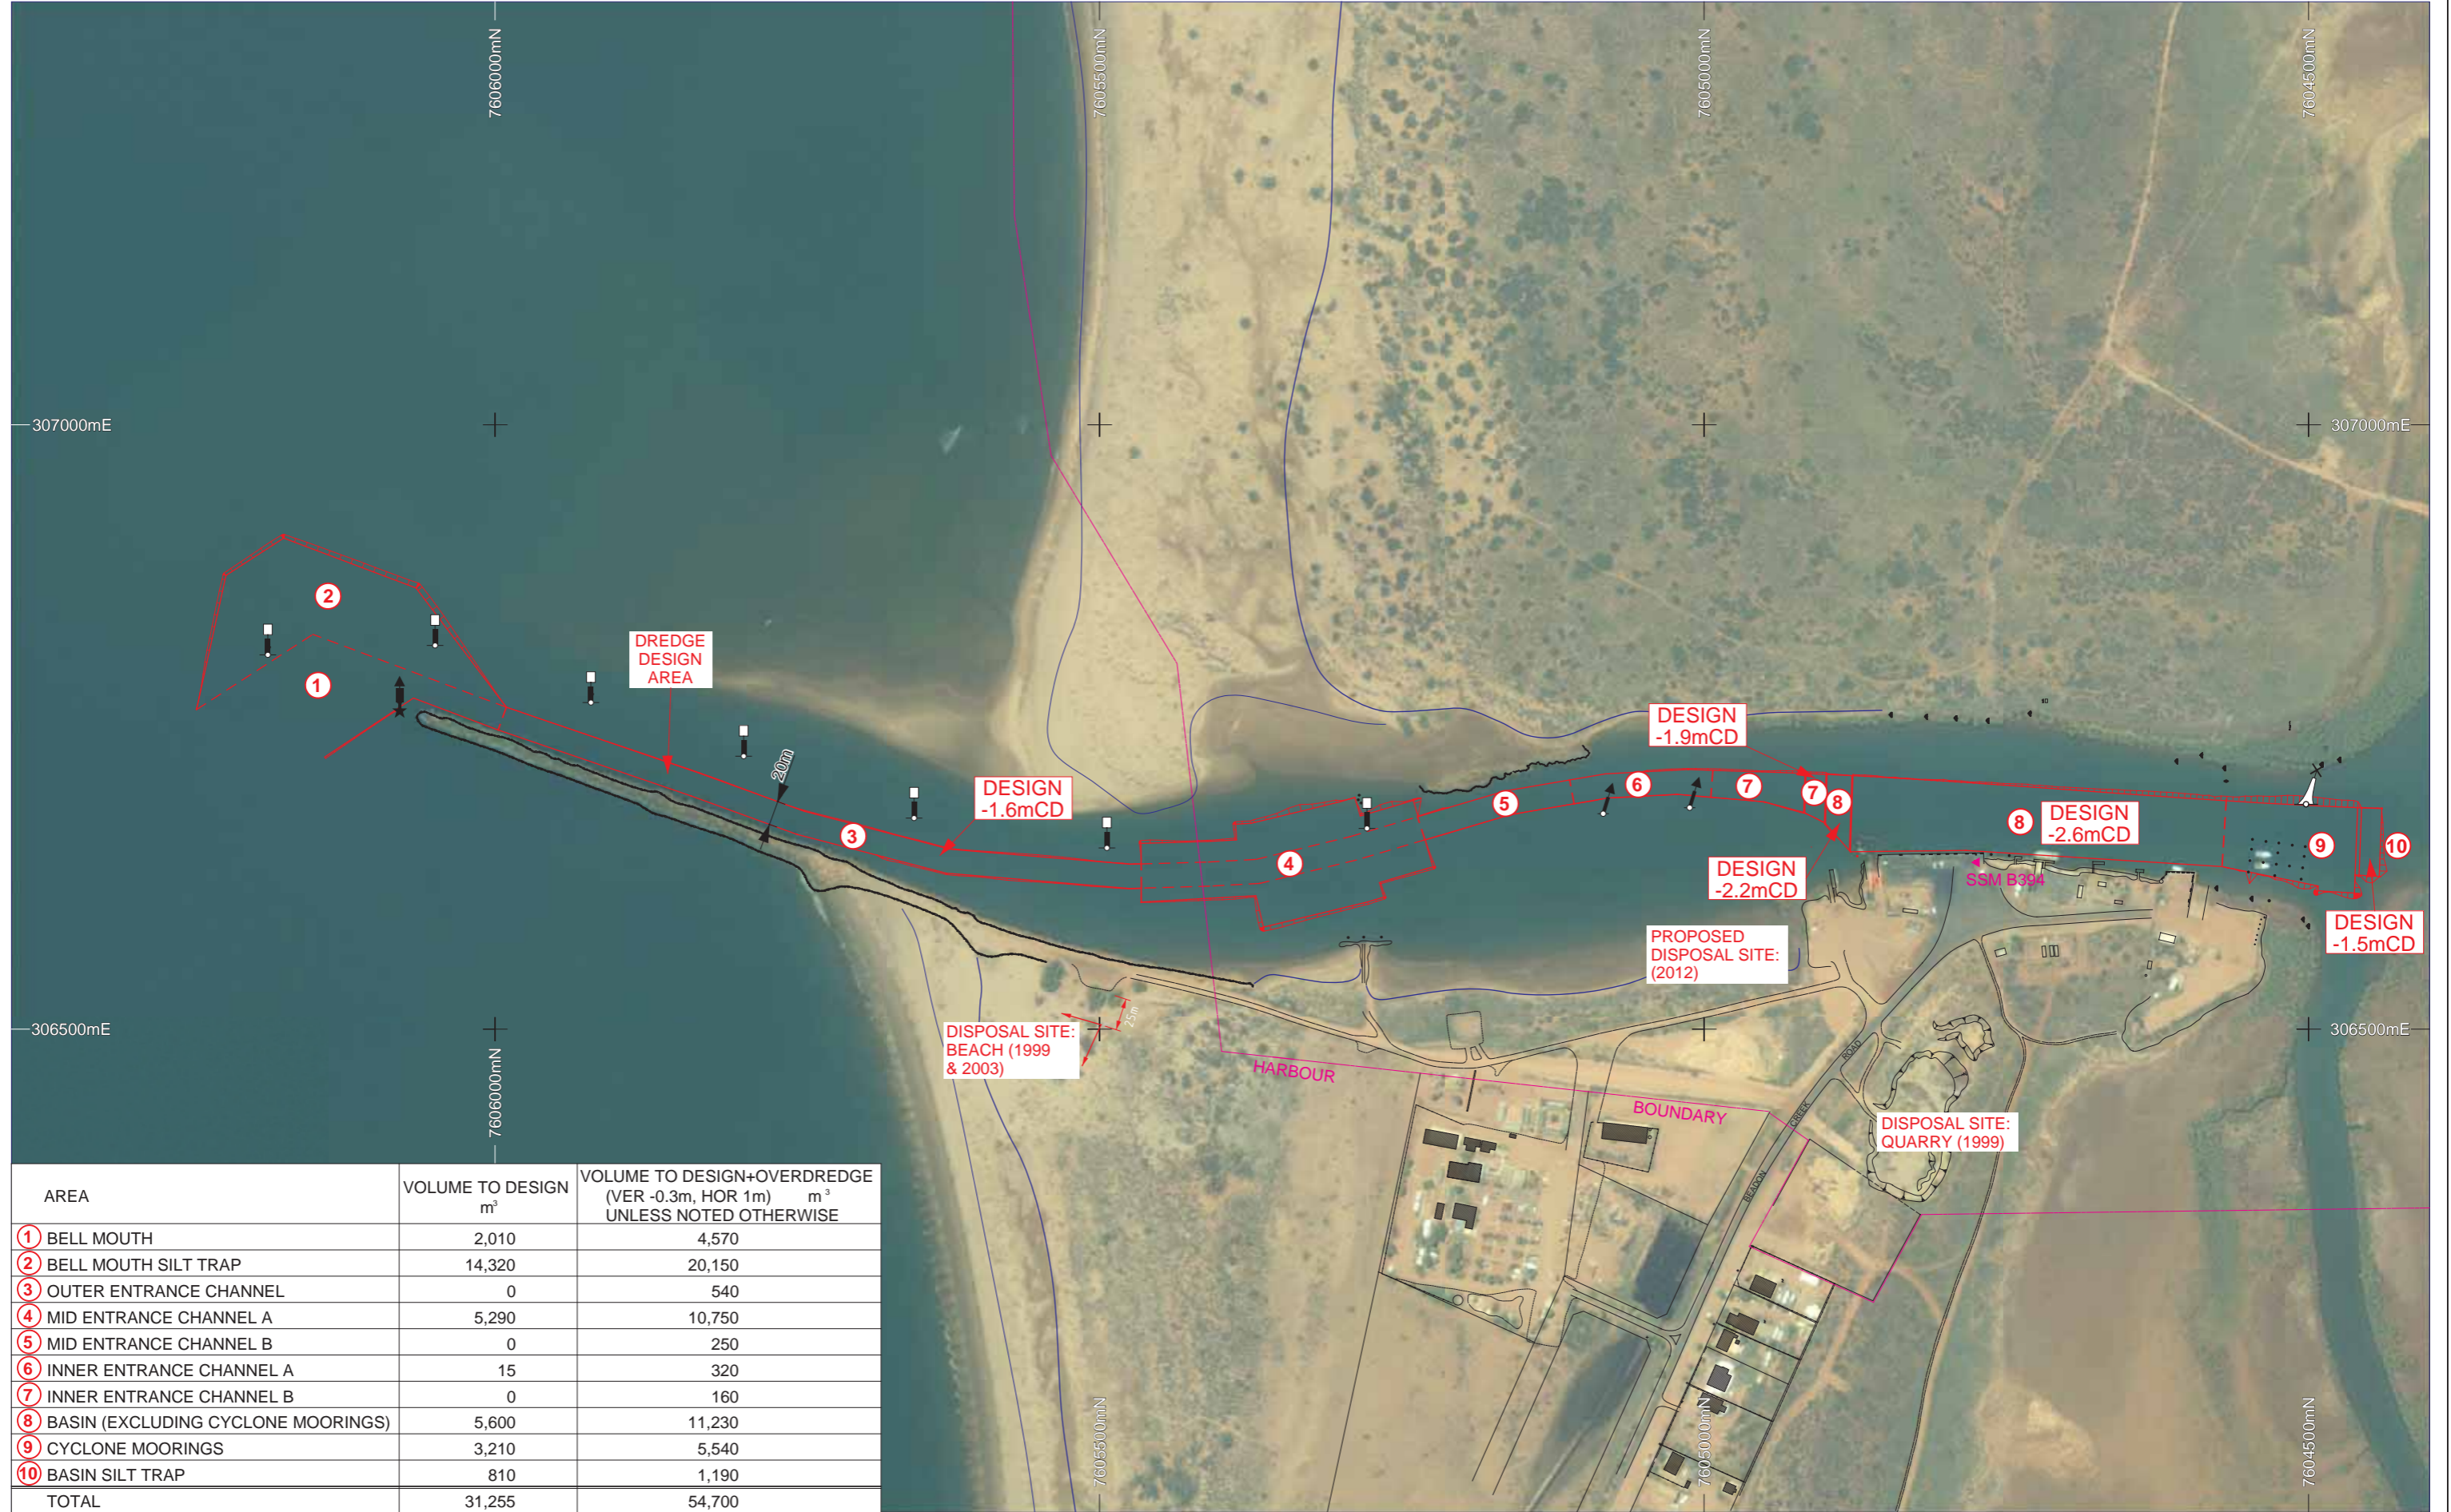
2012 Maintenance Dredging Design Drawing

AREA	VOLUME TO DESIGN m ³	VOLUME TO DESIGN+OVERDREDGE (VER -0.3m, HOR 1m) UNLESS NOTED OTHERWISE m ³
① BELL MOUTH	2,010	4,570
② BELL MOUTH SILT TRAP	14,320	20,150
③ OUTER ENTRANCE CHANNEL	0	540
④ MID ENTRANCE CHANNEL A	5,290	10,750
⑤ MID ENTRANCE CHANNEL B	0	250
⑥ INNER ENTRANCE CHANNEL A	15	320
⑦ INNER ENTRANCE CHANNEL B	0	160
⑧ BASIN (EXCLUDING CYCLONE MOORINGS)	5,600	11,230
⑨ CYCLONE MOORINGS	3,210	5,540
⑩ BASIN SILT TRAP	810	1,190
TOTAL	31,255	54,700

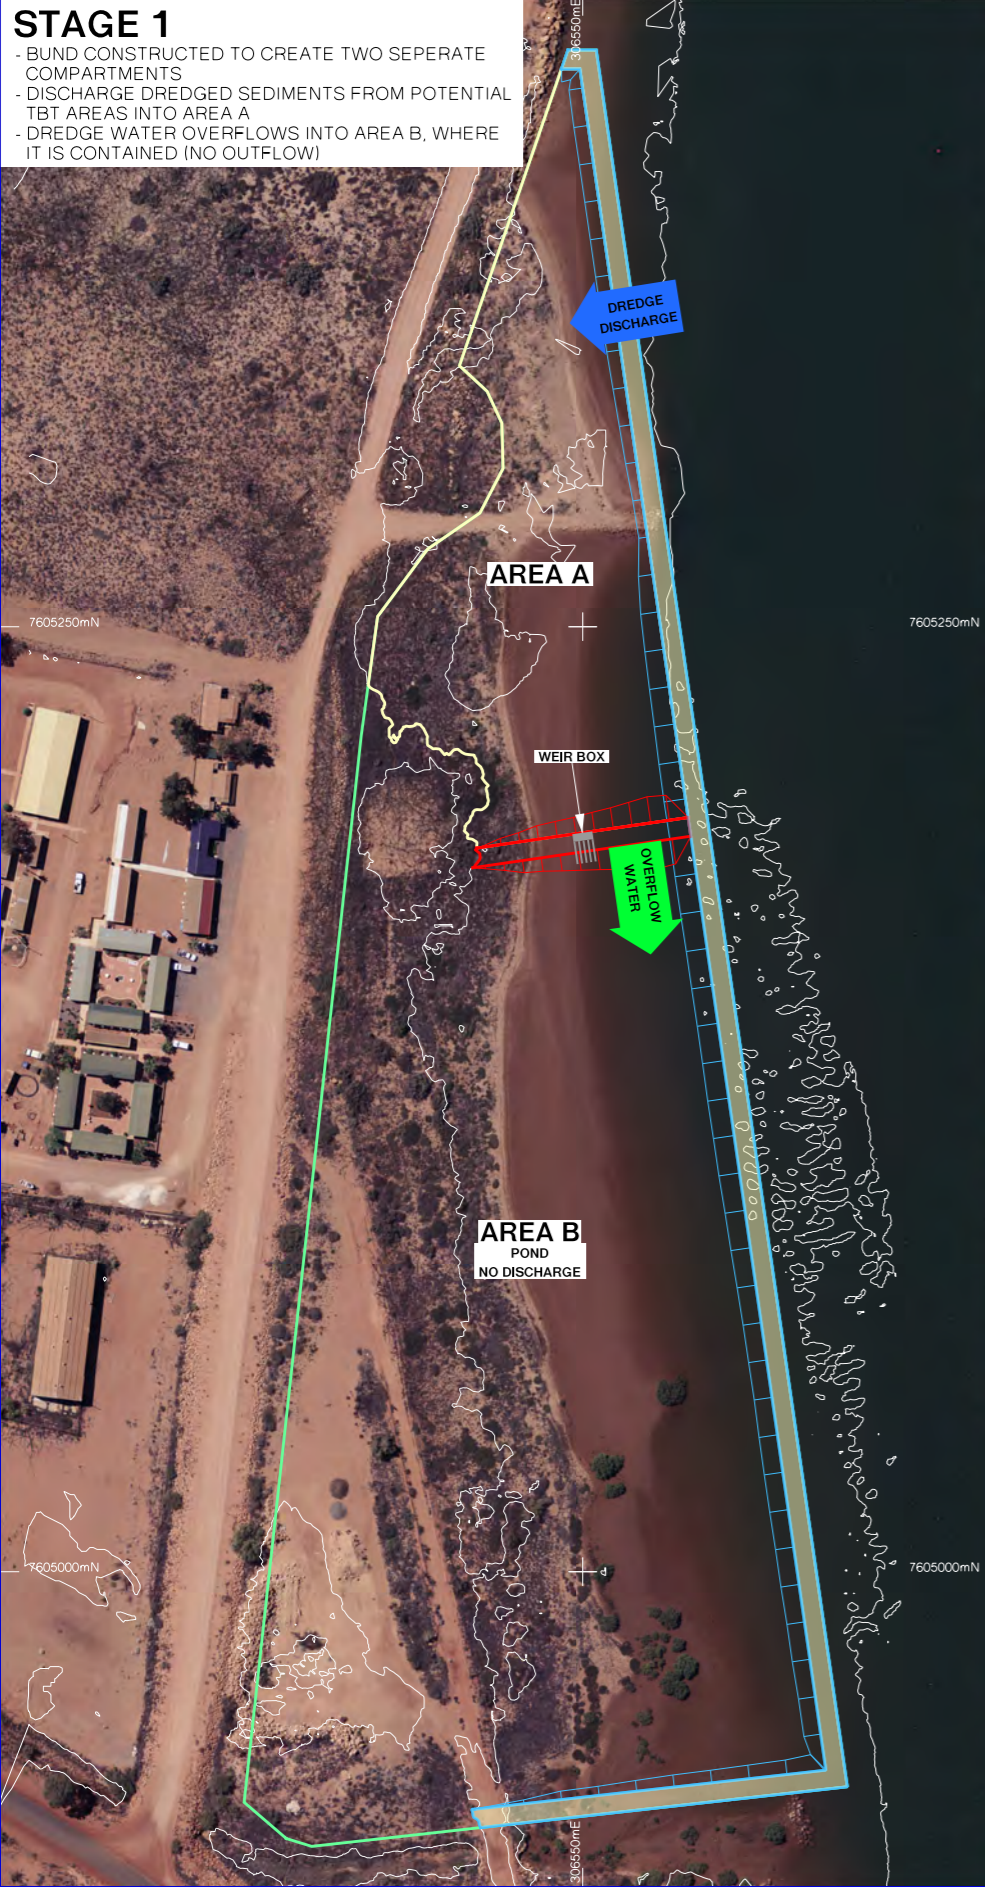
STAGE 1

- BUND CONSTRUCTED TO CREATE TWO SEPERATE COMPARTMENTS
- DISCHARGE DREDGED SEDIMENTS FROM POTENTIAL TBT AREAS INTO AREA A
- DREDGE WATER OVERFLOWS INTO AREA B, WHERE IT IS CONTAINED (NO OUTFLOW)

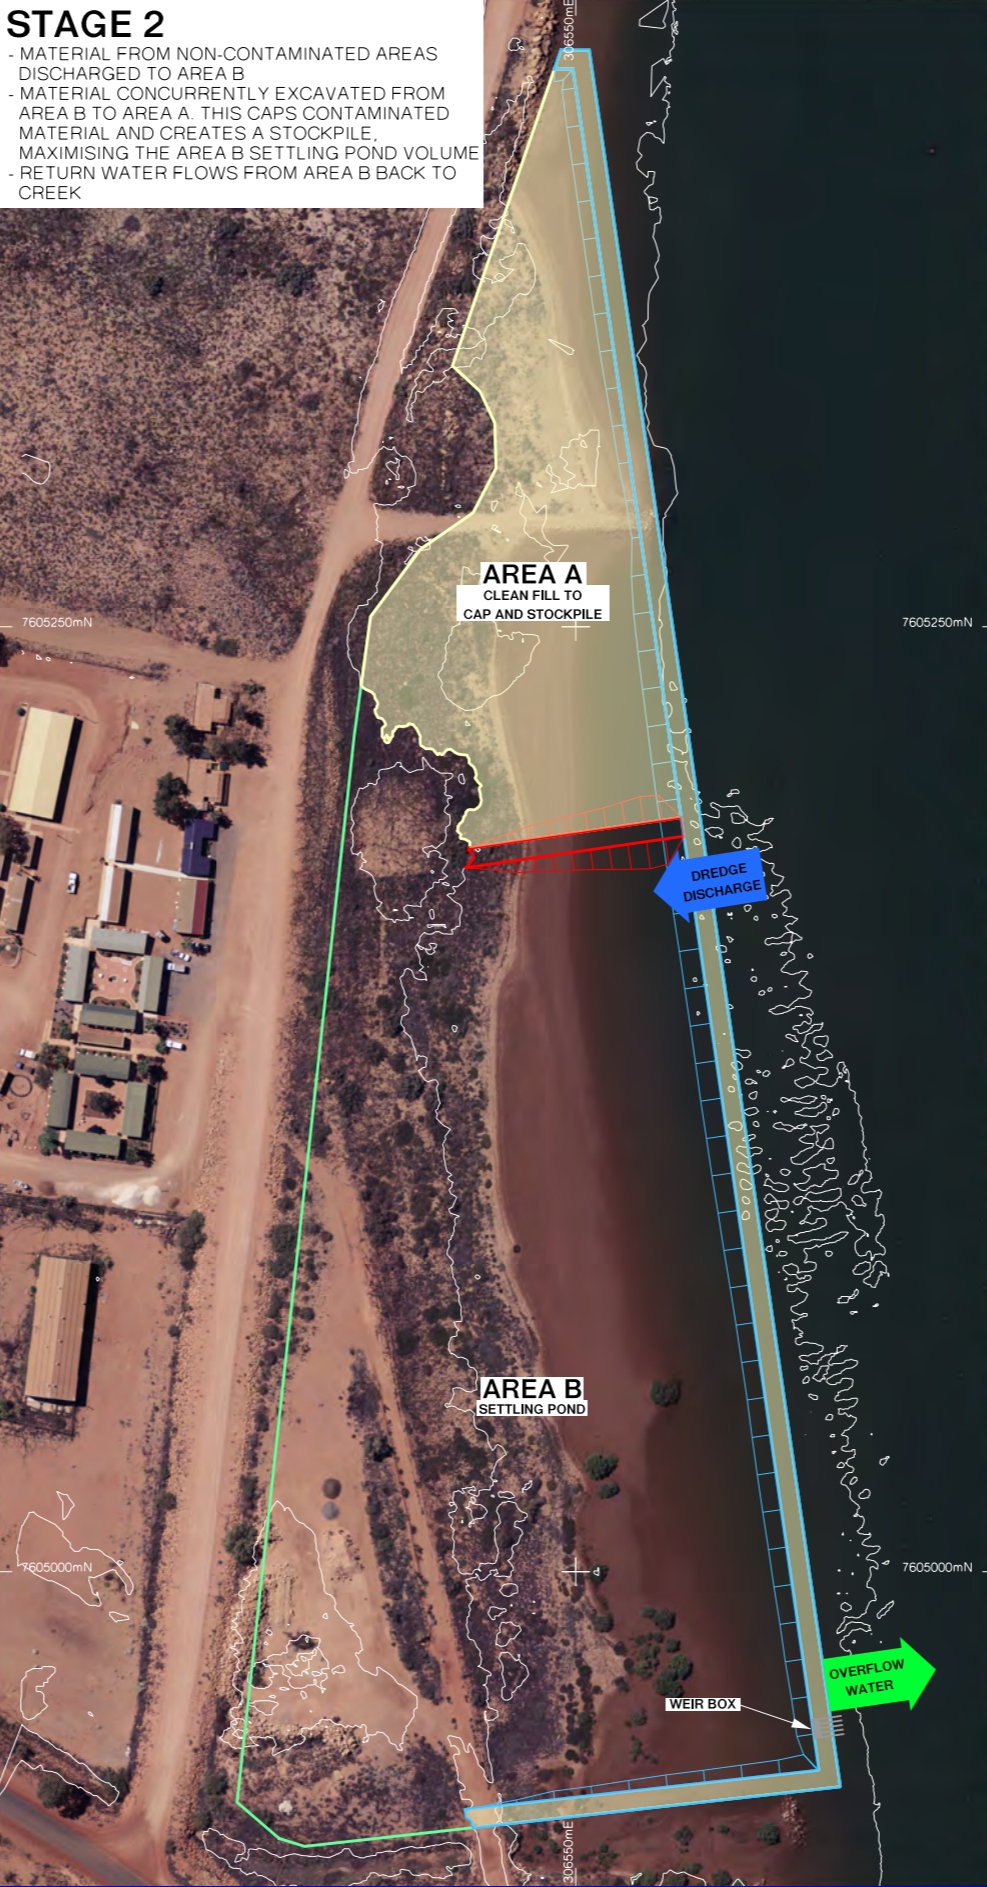
STAGE 2

- MATERIAL FROM NON-CONTAMINATED AREAS DISCHARGED TO AREA B
- MATERIAL CONCURRENTLY EXCAVATED FROM AREA B TO AREA A. THIS CAPS CONTAMINATED MATERIAL AND CREATES A STOCKPILE, MAXIMISING THE AREA B SETTLING POND VOLUME
- RETURN WATER FLOWS FROM AREA B BACK TO CREEK

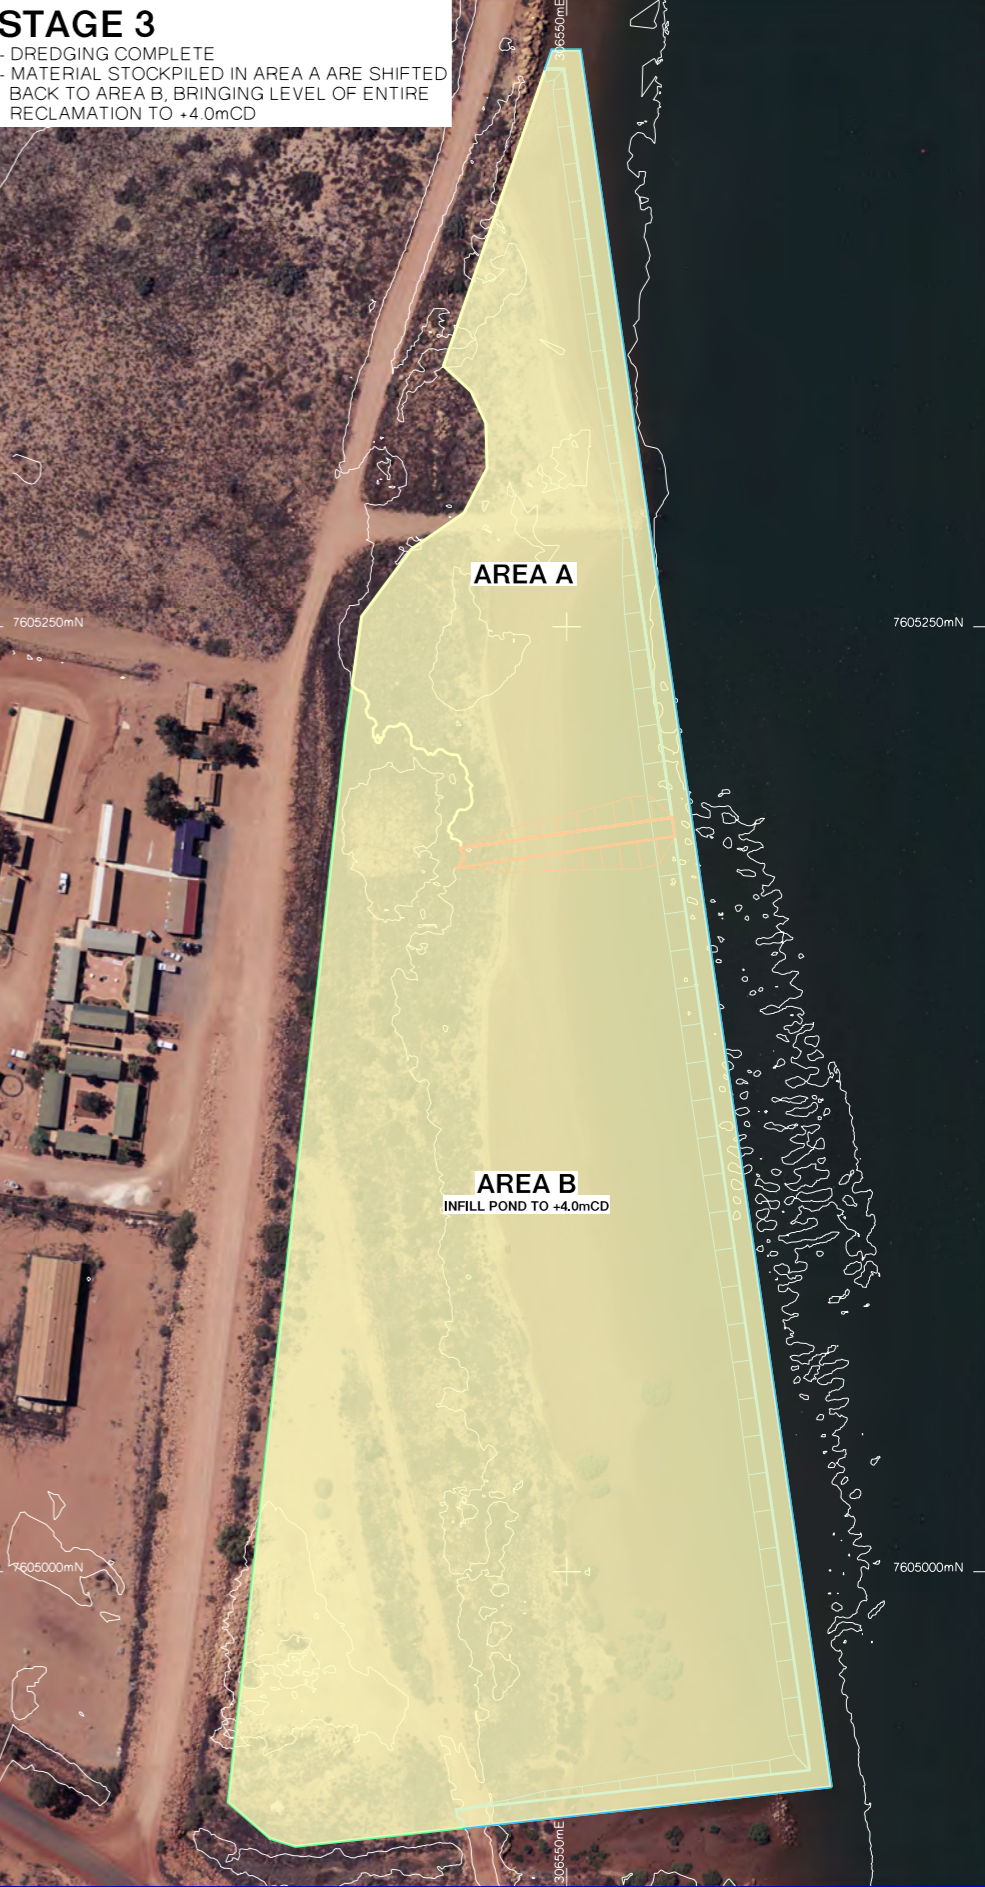
STAGE 3

- DREDGING COMPLETE
- MATERIAL STOCKPILED IN AREA A ARE SHIFTED BACK TO AREA B, BRINGING LEVEL OF ENTIRE RECLAMATION TO +4.0mCD
