**Lots 19 - 21 Old Coast Rd, Lake Clifton - Park Home
Redevelopment**

Environmental Impact Assessment Document

Beck Advisory

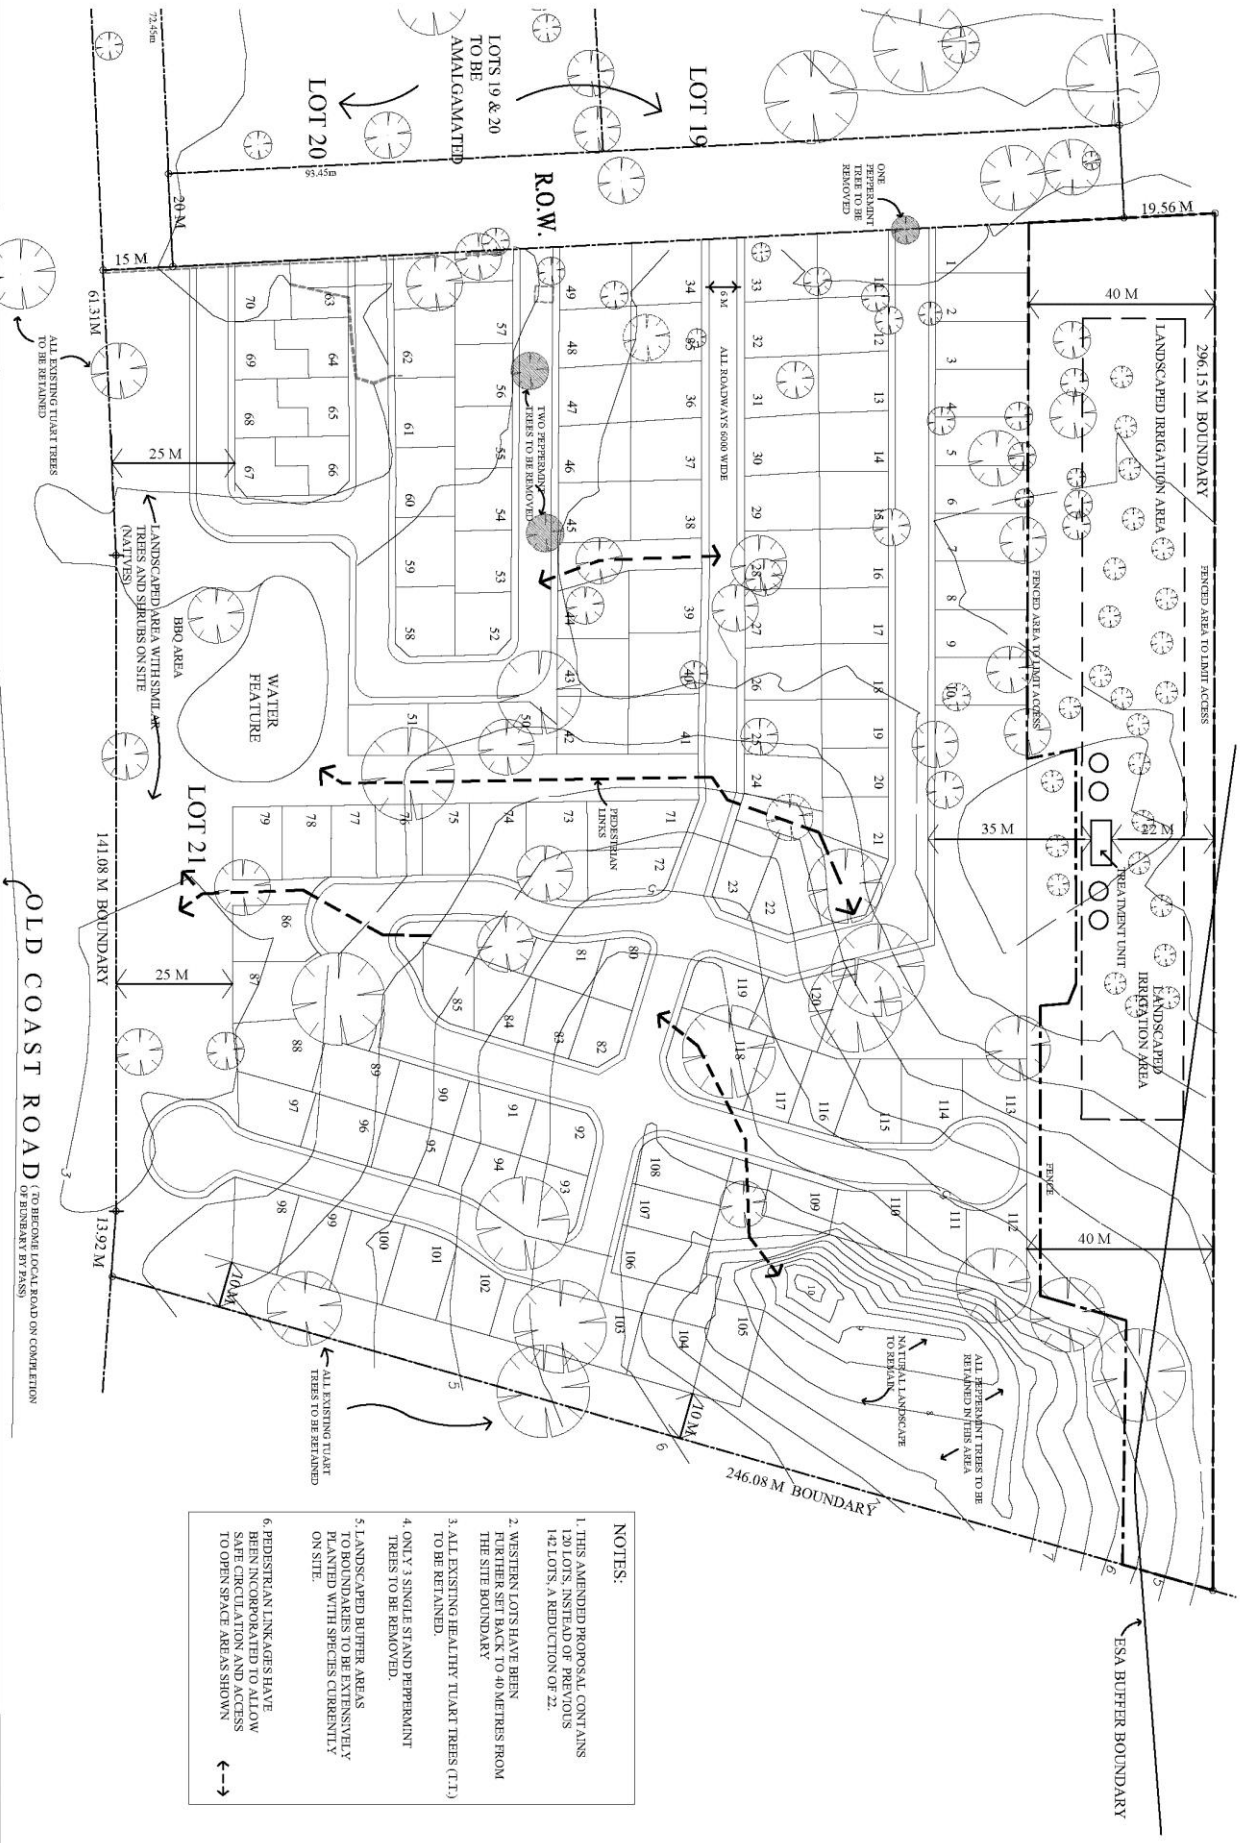
- NOTES:**
1. THIS AMENDED PROPOSAL CONTAINS 120 LOTS, INSTEAD OF PREVIOUS 142 LOTS, A REDUCTION OF 22.
 2. WESTERN LOTS HAVE BEEN FURTHER SET BACK TO 40 METRES FROM THE SITE BOUNDARY
 3. ALL EXISTING HEALTHY TUART TREES (T.T.) TO BE RETAINED.
 4. ONLY 3 SINGLE STAND PEPPERMINT TREES TO BE REMOVED.
 5. LANDSCAPED BUFFER AREAS TO BOUNDARIES TO BE EXTENSIVELY PLANTED WITH SPEECHES CURRENTLY ON SITE.
 6. PEDESTRIAN LINKAGES HAVE BEEN REORIENTED TO ALLOW SAFE CIRCULATION AND ACCESS TO OPEN SPACE AREAS SHOWN

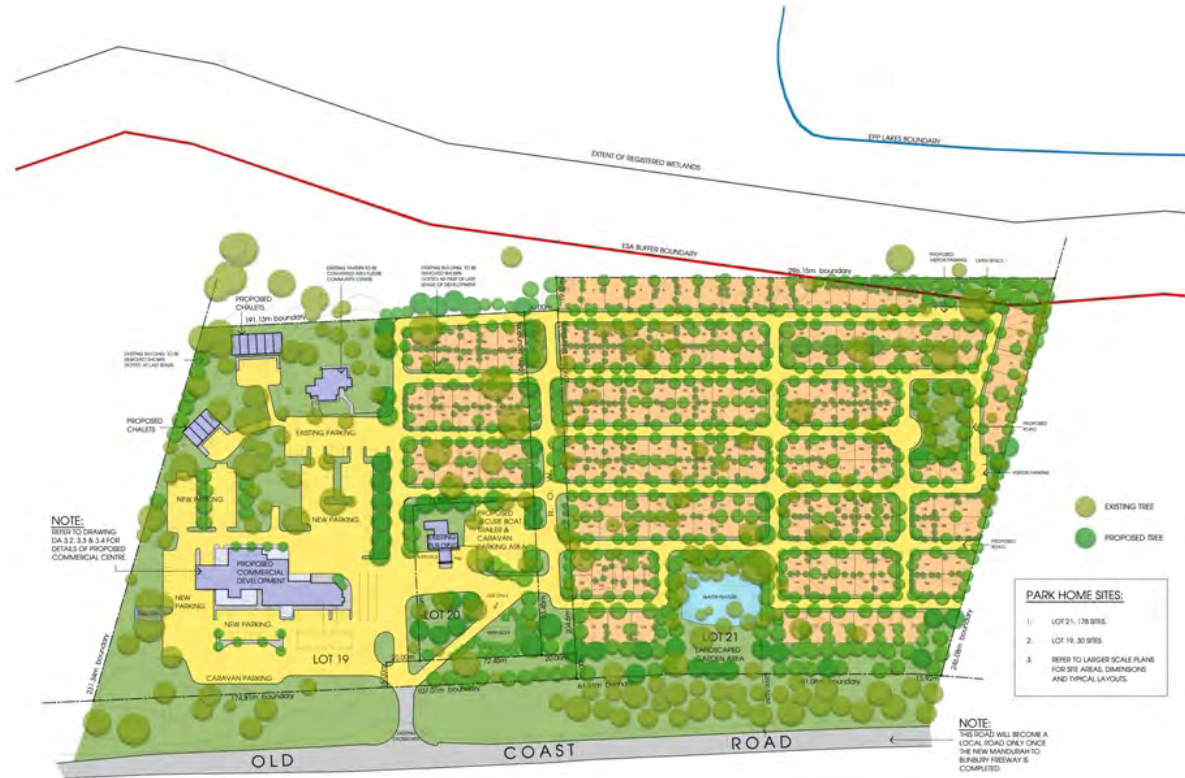
Development Approval 4

<p>DOEPEL MARSH</p> <p>architects</p>	<p>OVERALL SITE PLAN</p> <p>scale 1:1000</p>	<p>LAKE CLIFTON DEVELOPMENT</p> <p>LOT 19, 20 & 21 OLD COAST RD,</p> <p>LAKE CLIFTON</p>	<p>JOB NO. 28.31</p> <p>DATE: MAR 2009</p> <p>DA-3.1A</p>
--	---	---	---

The site plans for the proposed development are shown below.

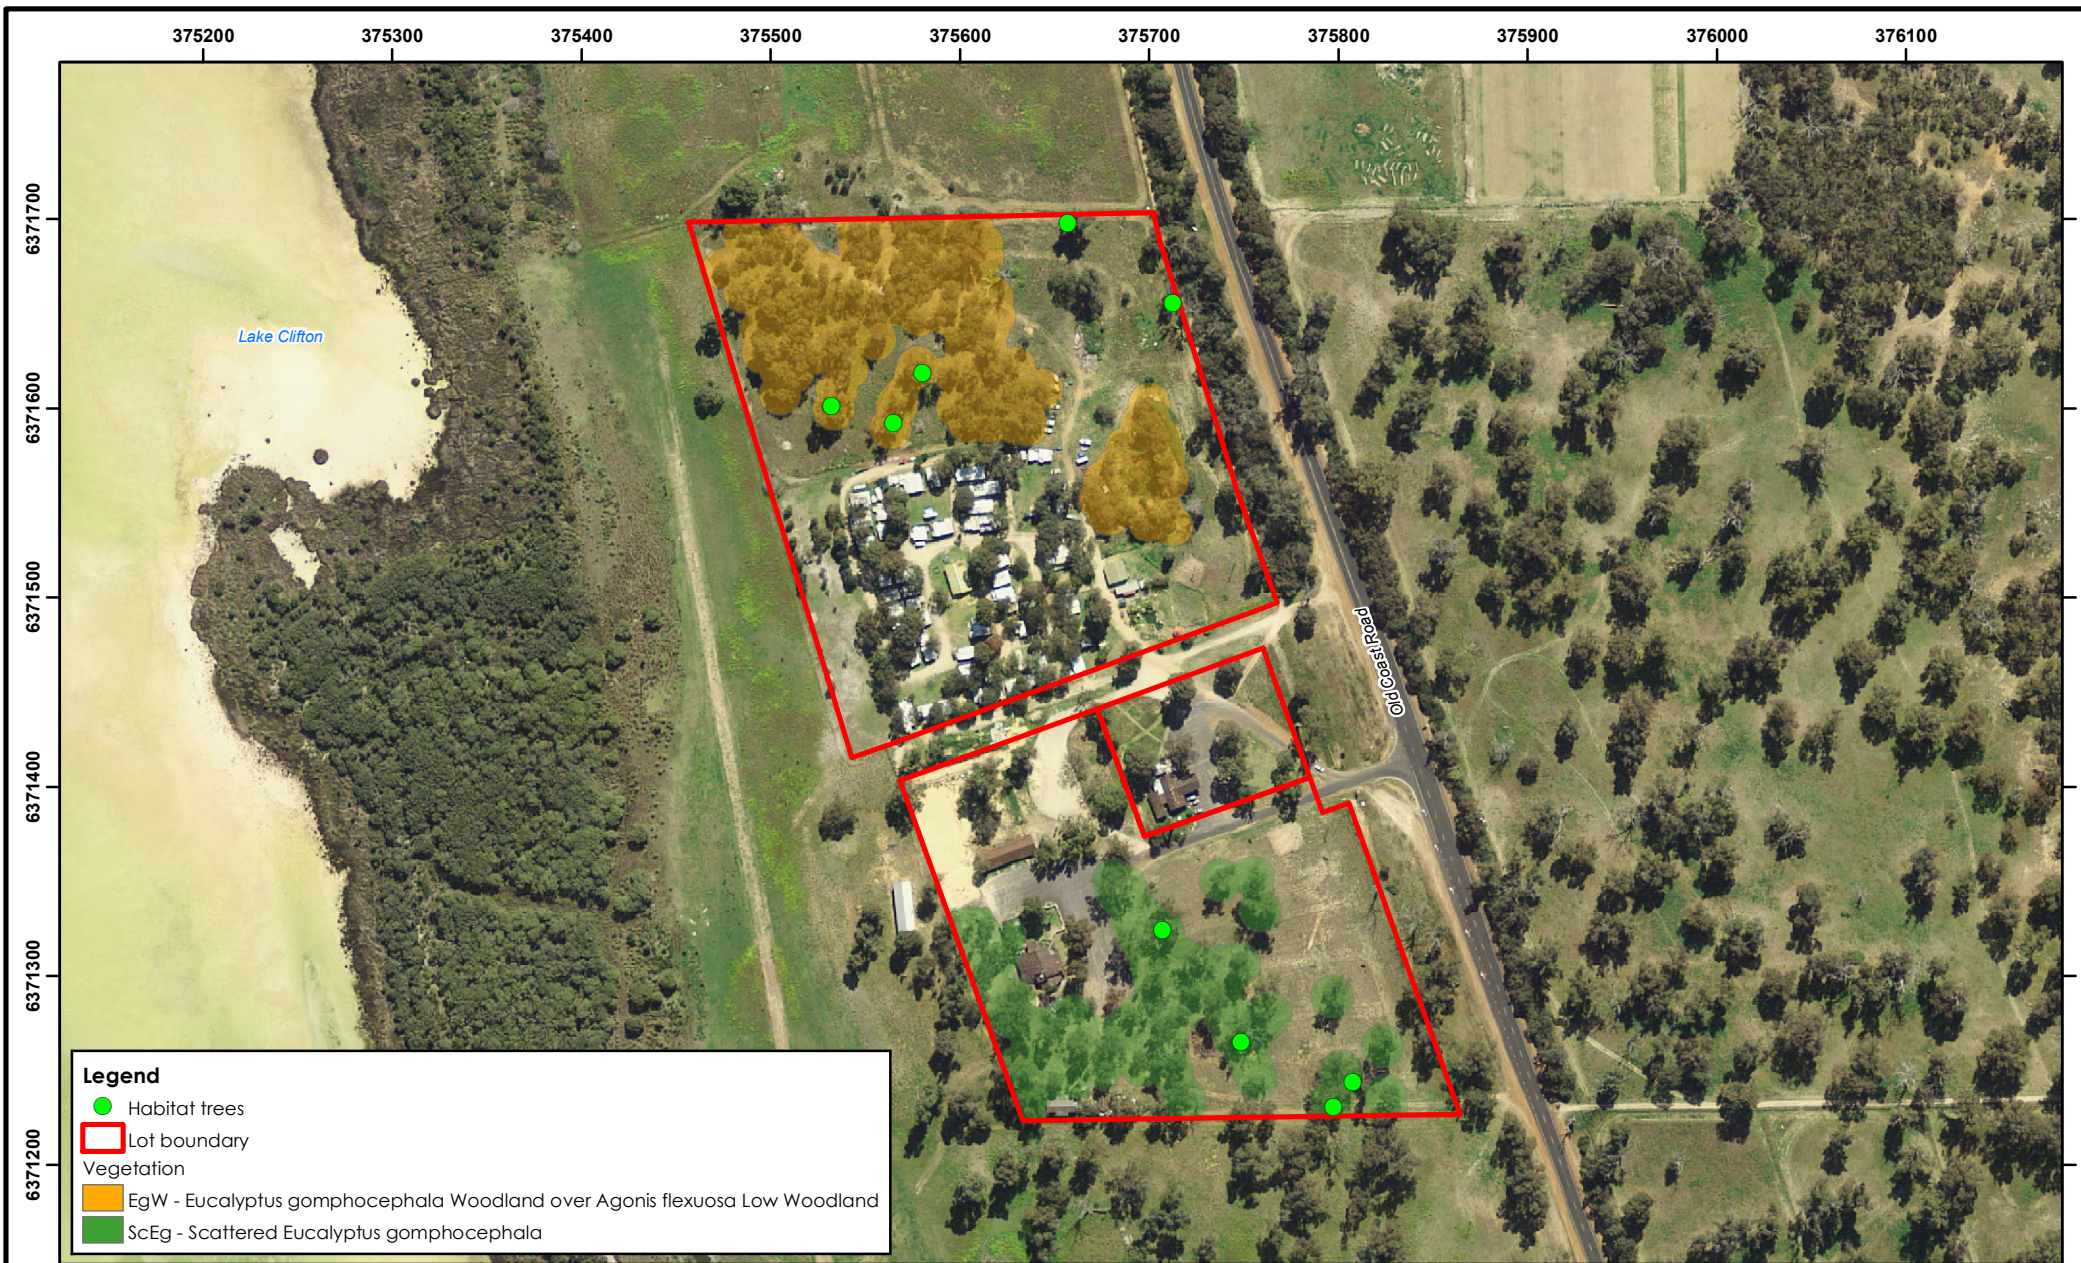
Figure 8 Vegetation and fauna plan

Vegetation and flora studies on the site were undertaken by Ecoscape in 2009. The vegetation was described as *Eucalyptus gomphocephala* (Tuart) Woodland, over *Agonis flexuosa* (Peppermint) Low Open Woodland over an understory of introduced grasses and weed species in the north and scattered *A. flexuosa* in the south of the site (Figure 8, Ecoscape 2009). This understory reflected that the site has previously been parkland cleared. Greater than 90% of study area was considered to be completely degraded with little or no native understory remaining (Ecoscape 2009).

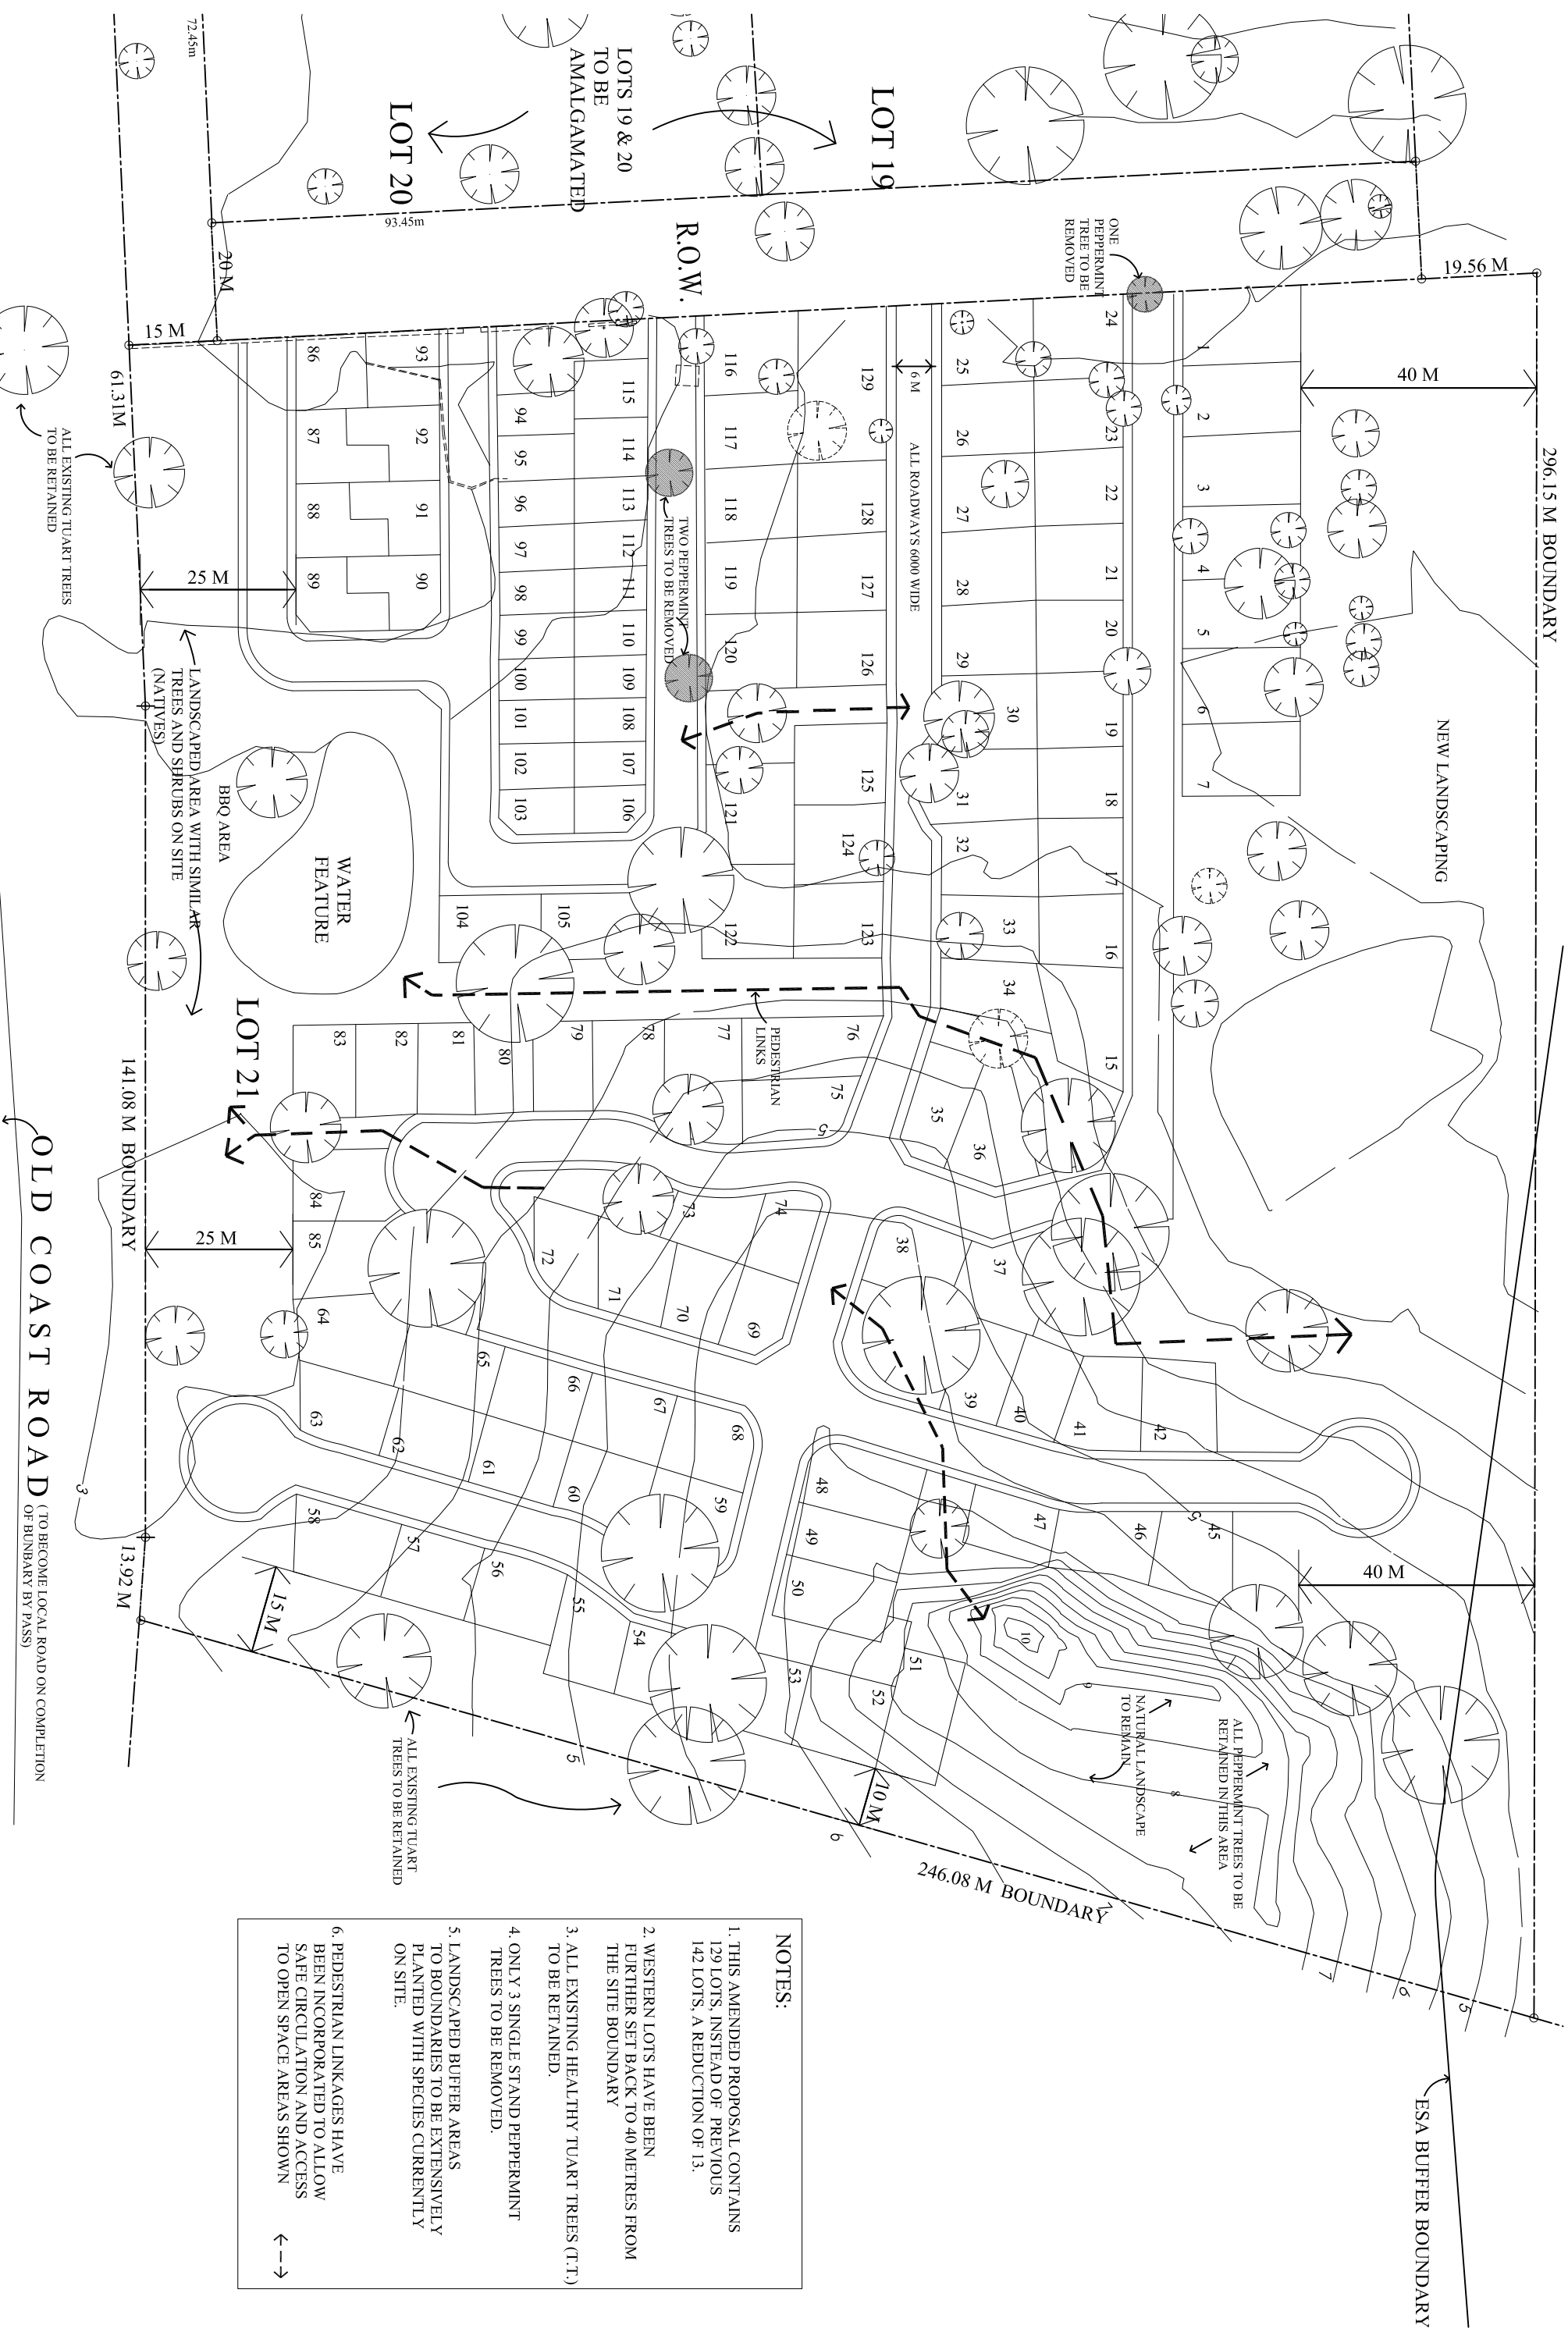
APPENDIX A

1. THIS AMENDED PROPOSAL CONTAINS 129 LOTS, INSTEAD OF PREVIOUS 142 LOTS, A REDUCTION OF 13.
2. WESTERN LOTS HAVE BEEN FURTHER SET BACK TO 40 METRES FROM THE SITE BOUNDARY
3. ALL EXISTING HEALTHY TUART TREES (T.T.) TO BE RETAINED.
4. ONLY 3 SINGLE STAND PEPPERMINT TREES TO BE REMOVED.
5. LANDSCAPED BUFFER AREAS TO BOUNDARIES TO BE EXTENSIVELY PLANTED WITH SPECIES CURRENTLY ON SITE.
6. PEDESTRIAN LINKAGES HAVE BEEN INCORPORATED TO ALLOW SAFE CIRCULATION AND ACCESS TO OPEN SPACE AREAS SHOWN

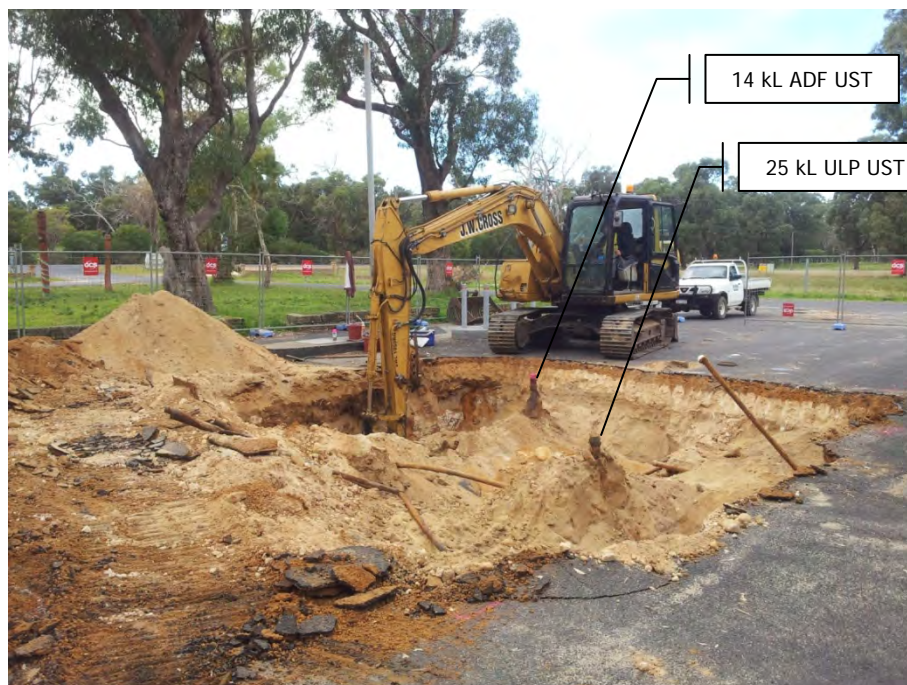
Exposing the 14 kL ADF and 25 kL LRP USTs – view to the south-east

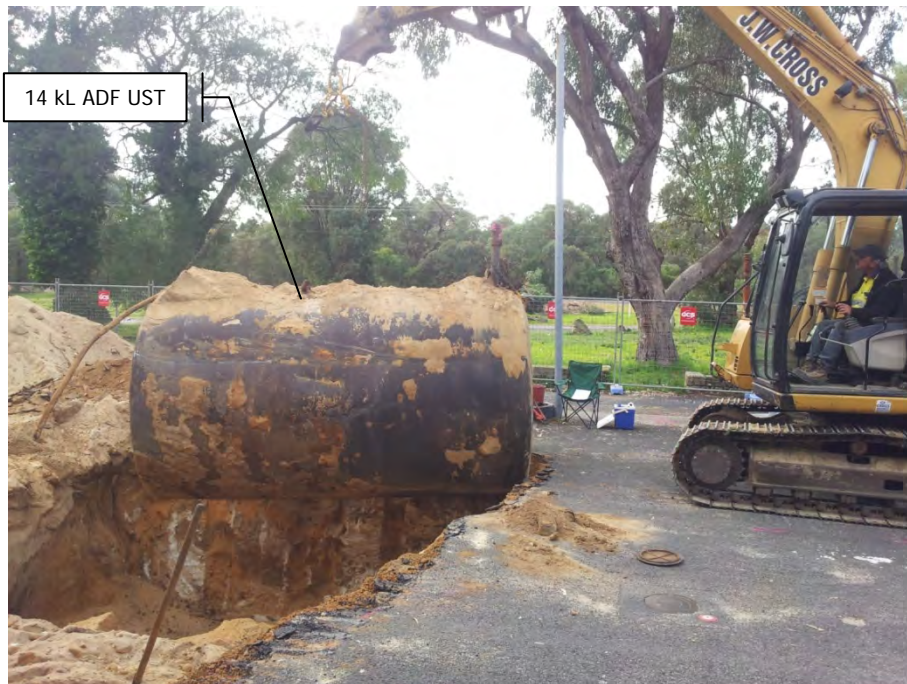
Removing 14 kL ADF UST from ground – view to the east, north-east

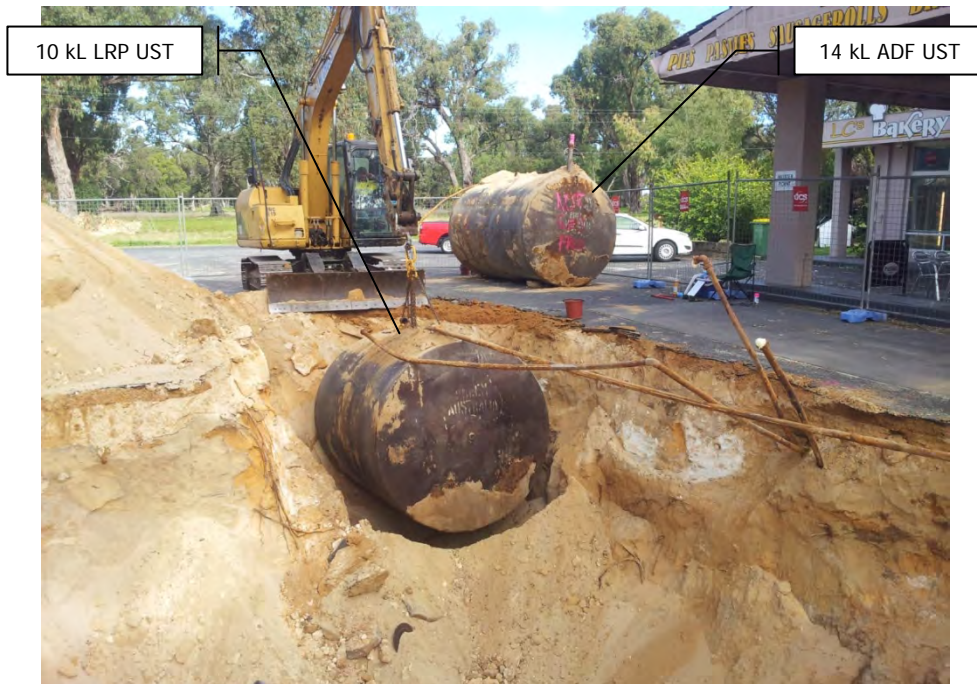
Removing 10 kL LRP UST– view to the south south-west

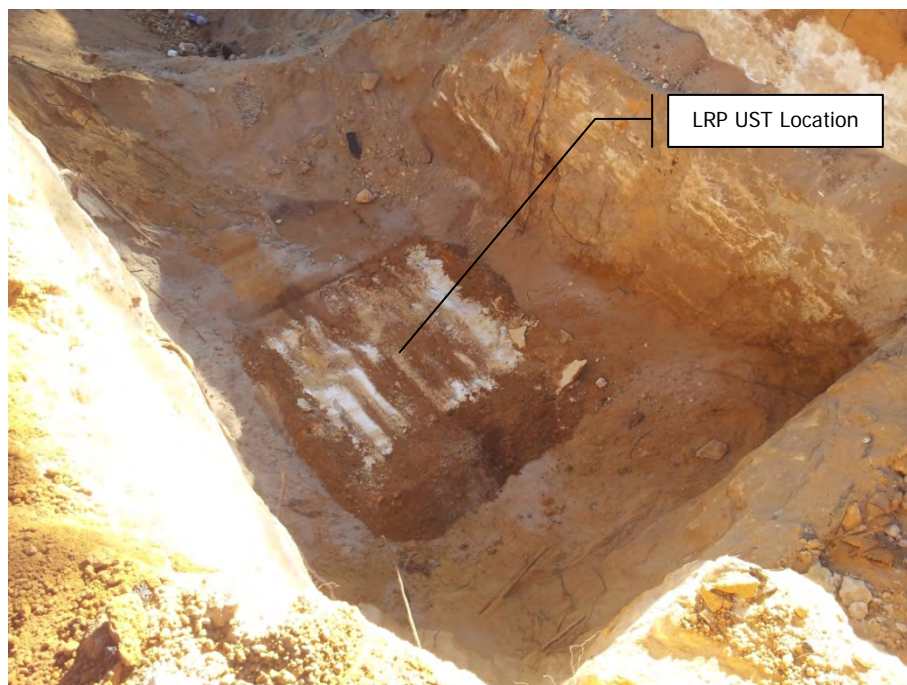
Limestone base below 10 kL LRP UST location – view to the north-east

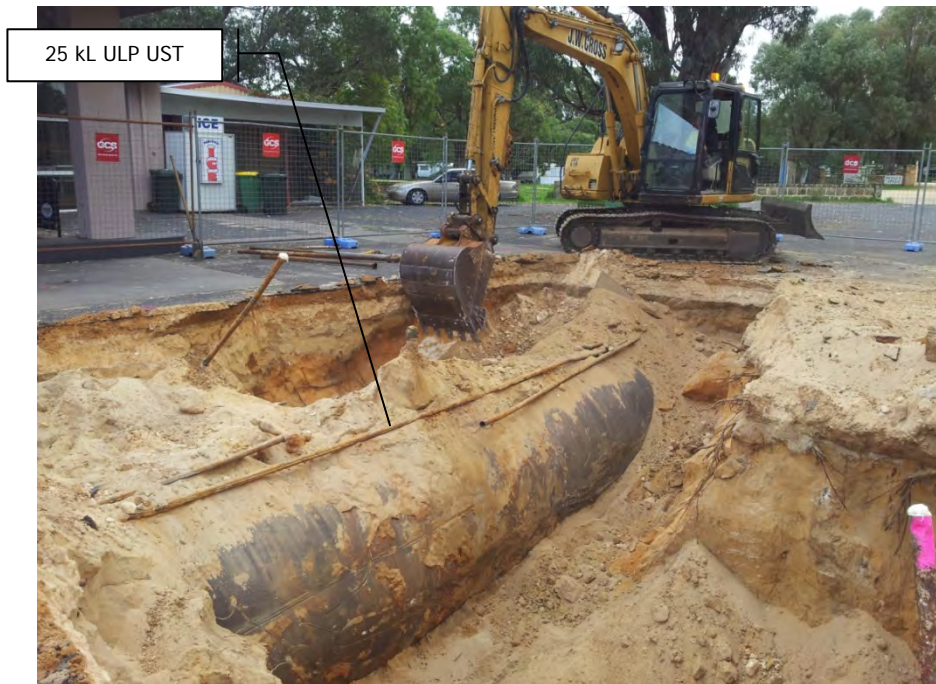
Exposing 25 kL ULP UST – view to the north north-west

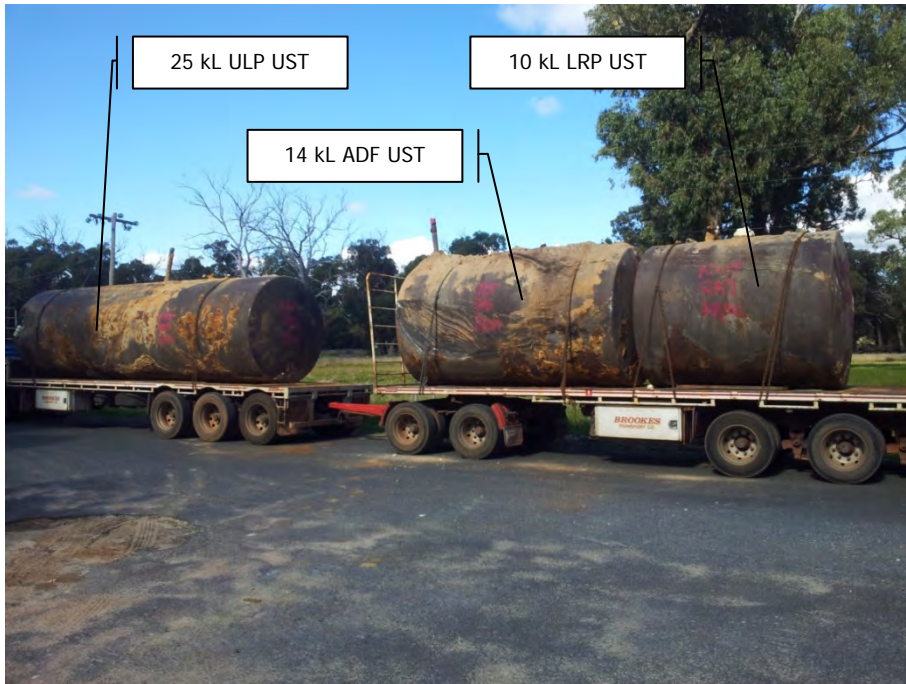
All three USTs secured for transport

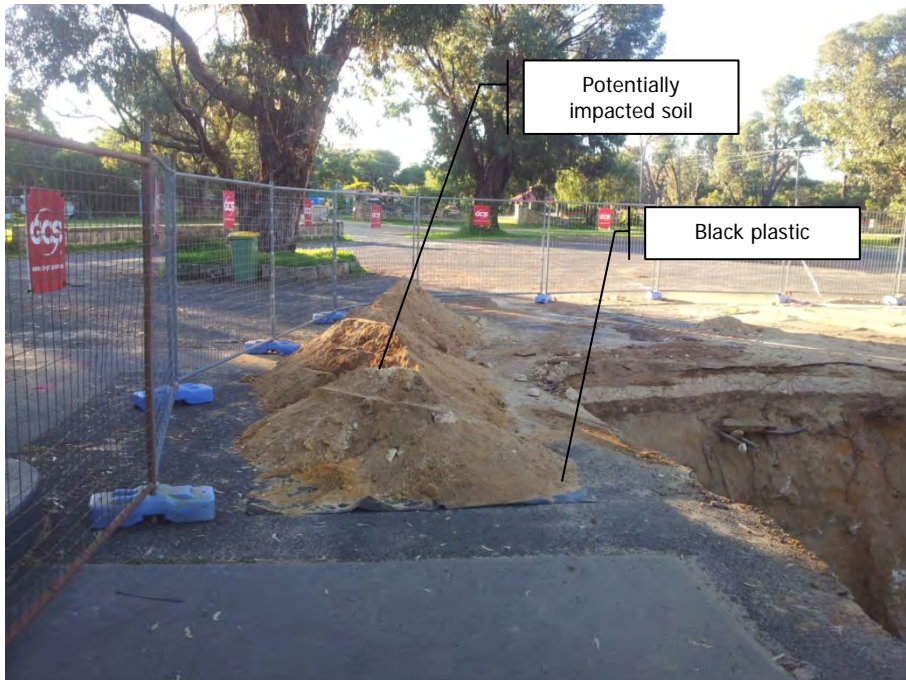
Minor quantity of temporarily stockpiled potentially impacted soil – view to the north

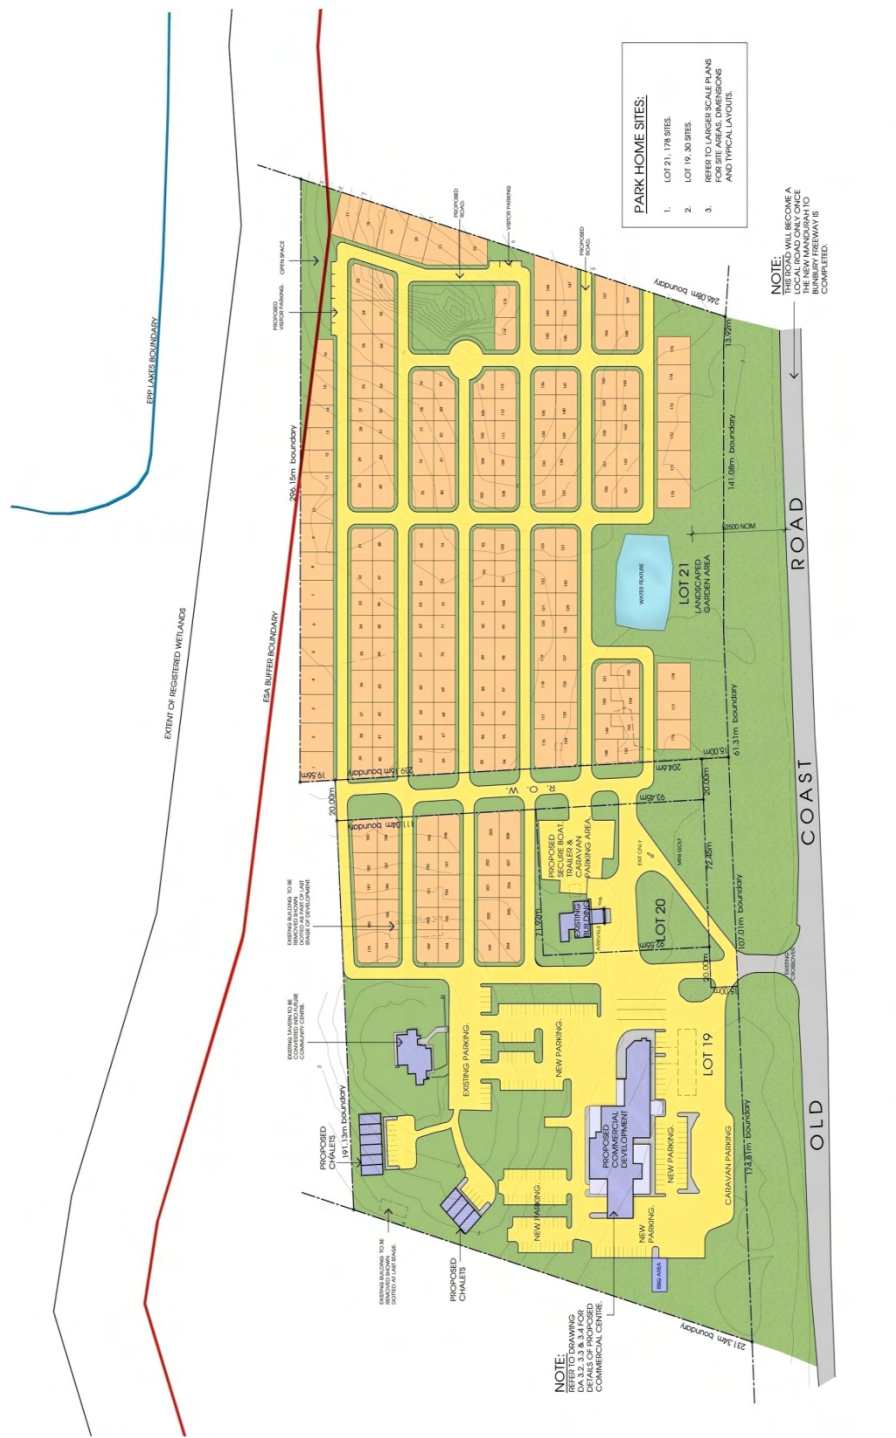
JOB NO. 2831
DATE: MAR 2009
DA-3.1A

The proposal considered in this EIA is the redevelopment of an existing tavern, caravan and former service station located on Lots 19 – 21 Old Coast Road, Lake Clifton into a commercial development and Park Home Estate, as detailed in the current development plan prepared by Doepel Marsh (**Figure 2**).

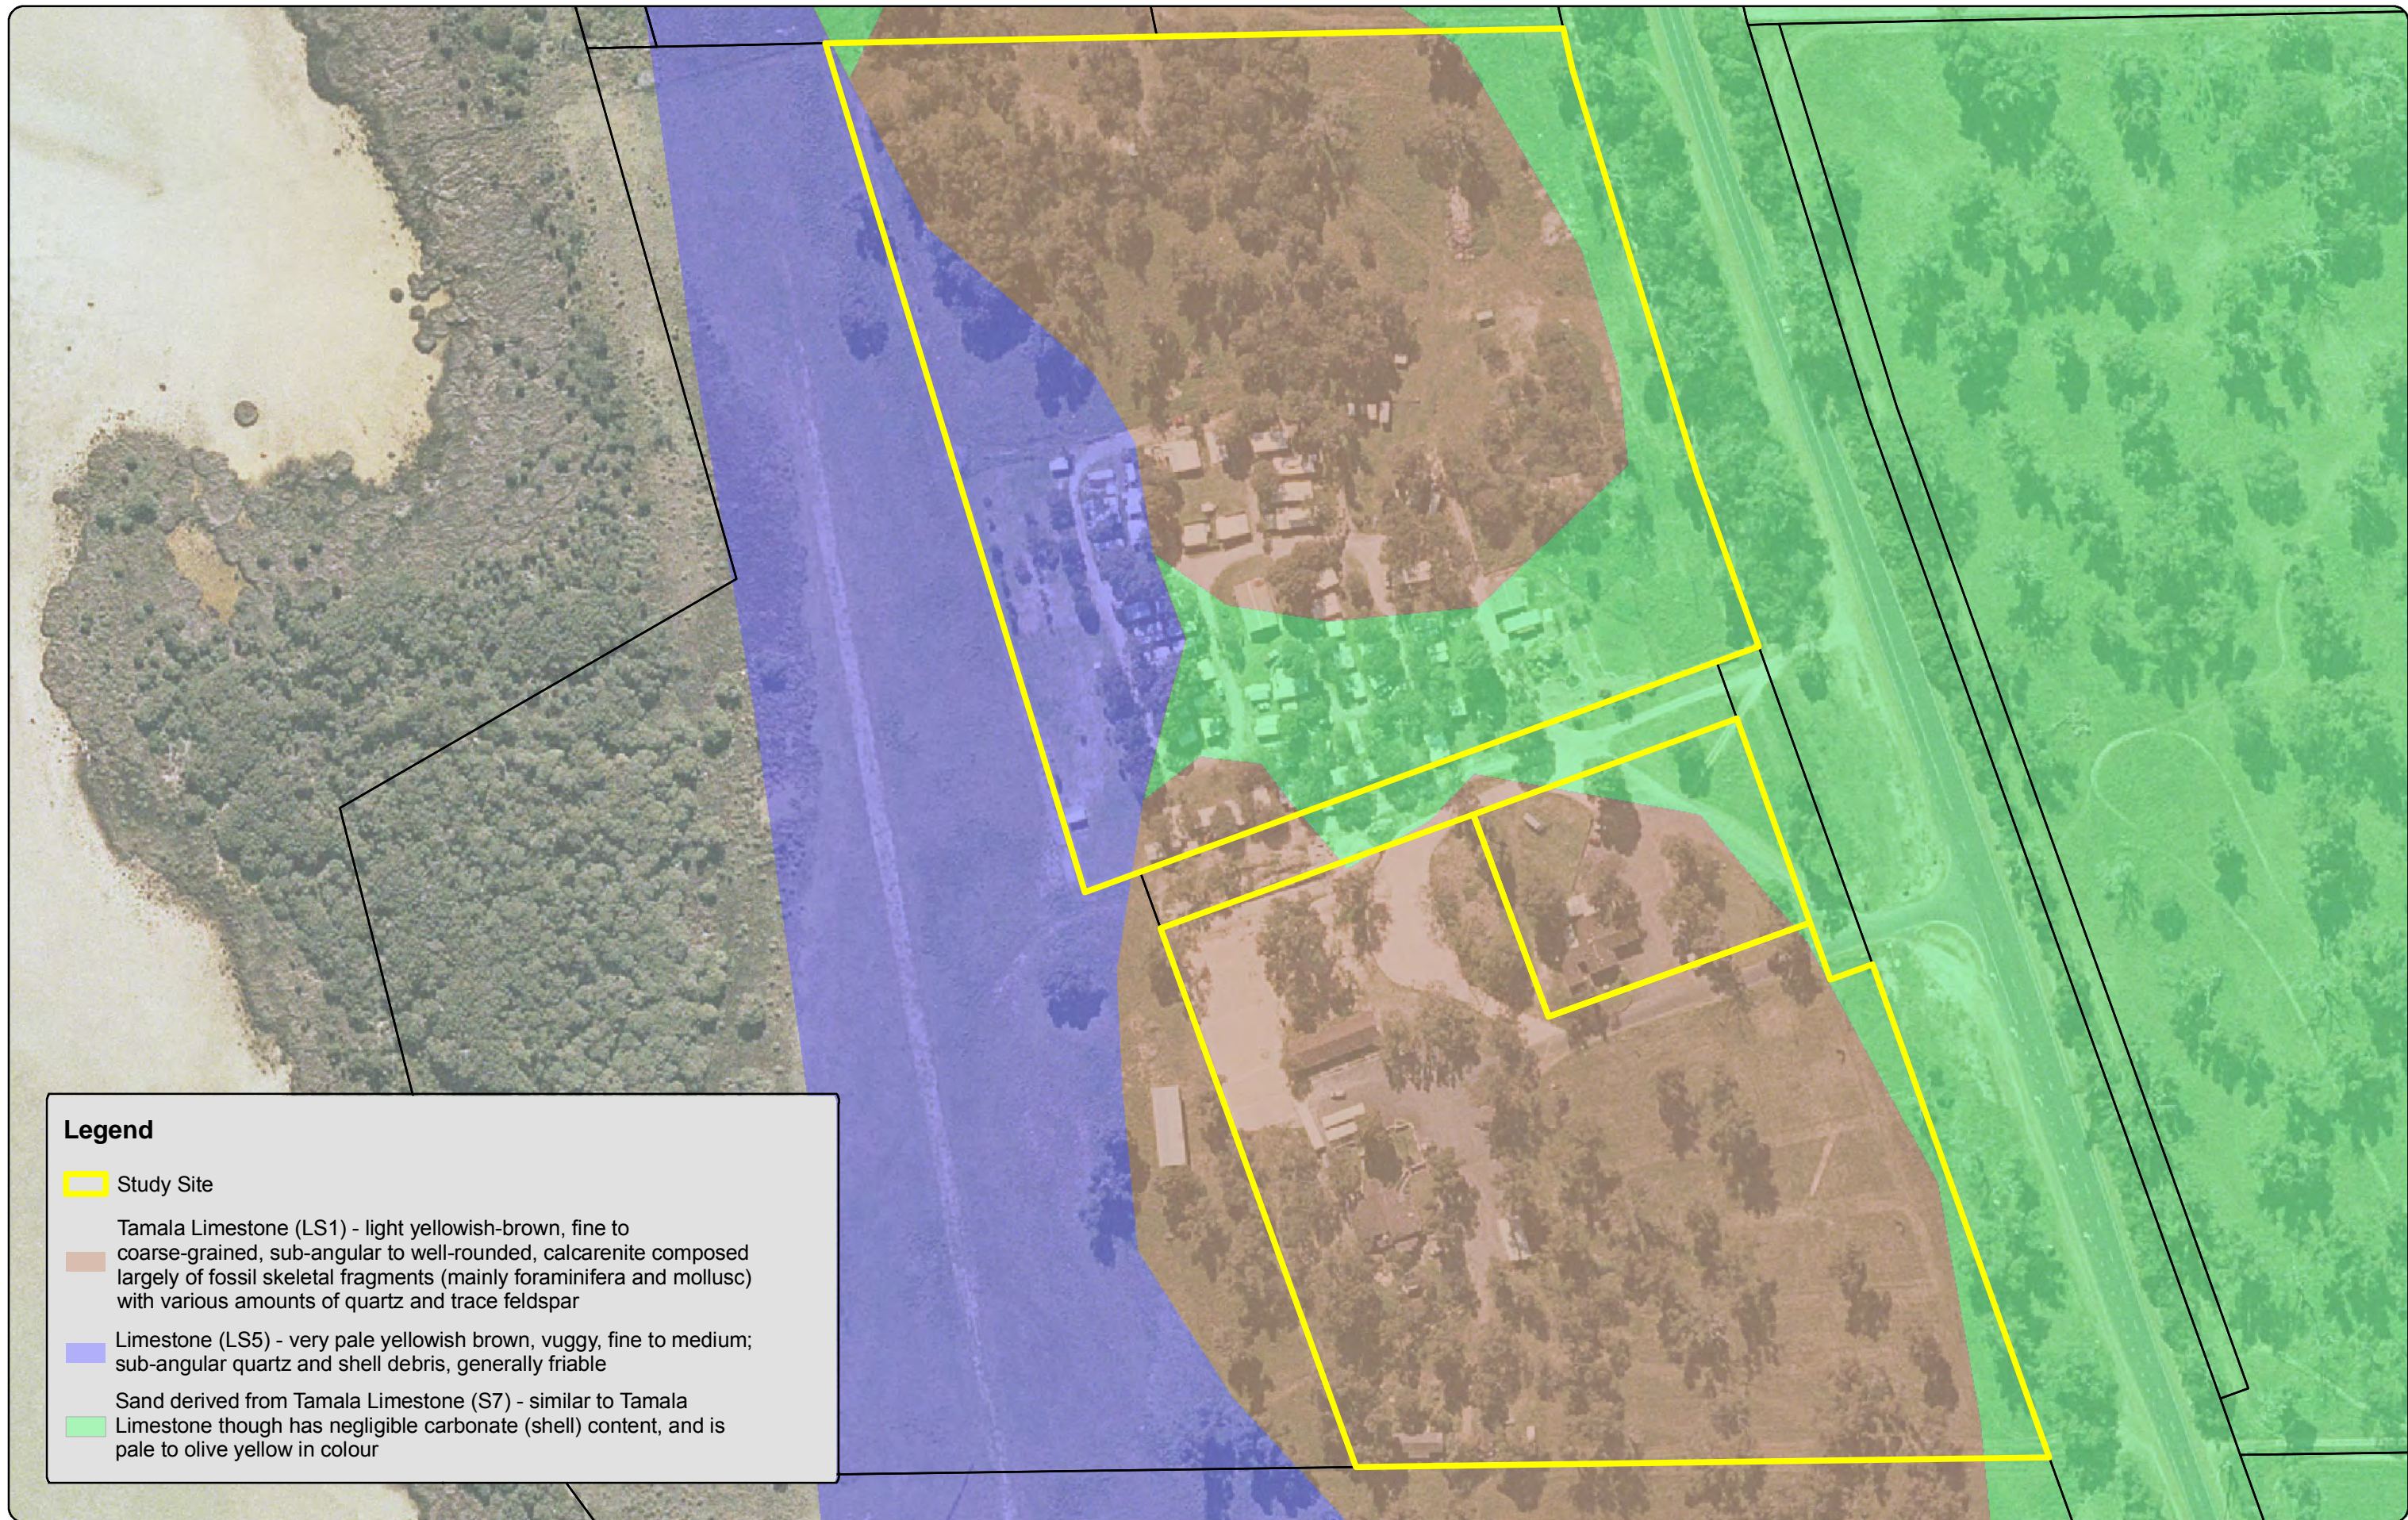
- Study Site
- Tamala Limestone (LS1) - light yellowish-brown, fine to coarse-grained, sub-angular to well-rounded, calcarenite composed largely of fossil skeletal fragments (mainly foraminifera and mollusc) with various amounts of quartz and trace feldspar
- Limestone (LS5) - very pale yellowish brown, vuggy, fine to medium; sub-angular quartz and shell debris, generally friable
- Sand derived from Tamala Limestone (S7) - similar to Tamala
- Limestone though has negligible carbonate (shell) content, and is pale to olive yellow in colour

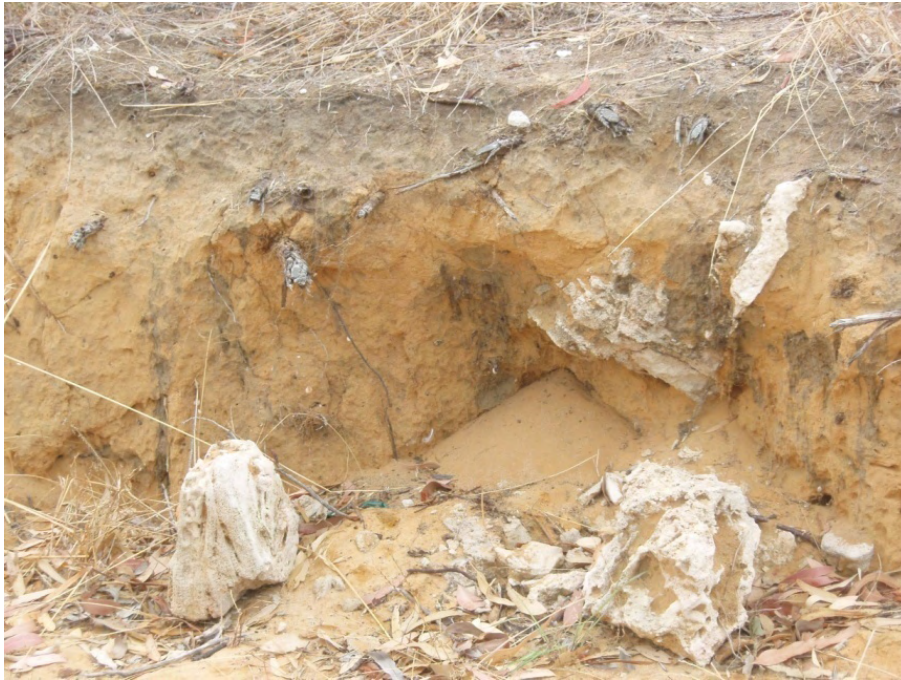
Plate 1: Existing Vertical Exposure Illustrating Typical Soil Profile

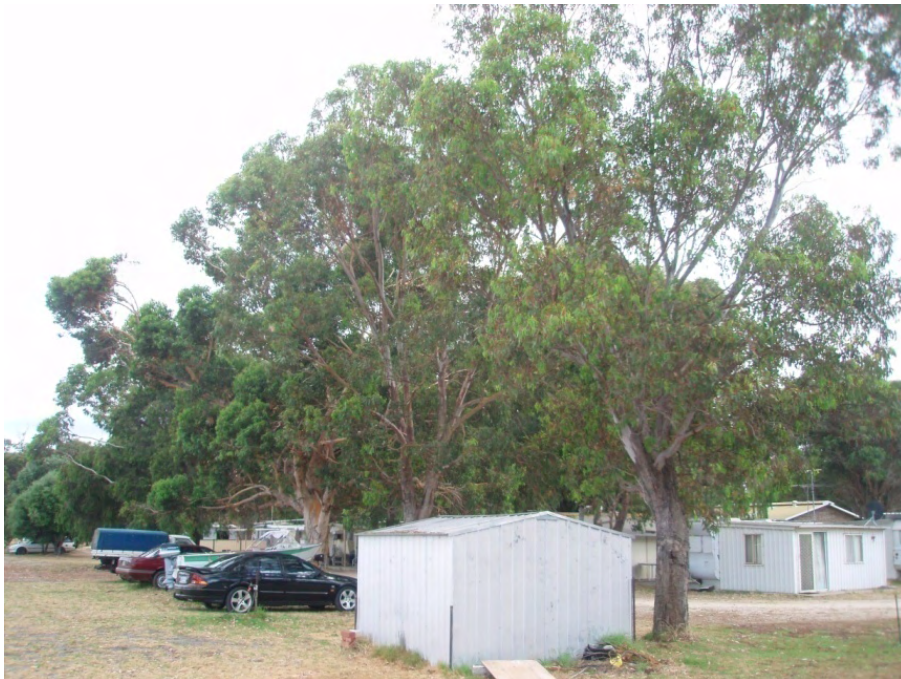
Plate 6: Planted Eucalyptus spp. running along western extent of Caravan Park

Planted, non-endemic *Eucalyptus* spp. were located within and along the boundary of the Caravan Park (**Plate 6 in Appendix Four**).
