APPENDIX A
Fieldwork Report

IRON VALLEY

Fieldwork undertaken for the Below Water Table
Mining Groundwater Study

January 2016

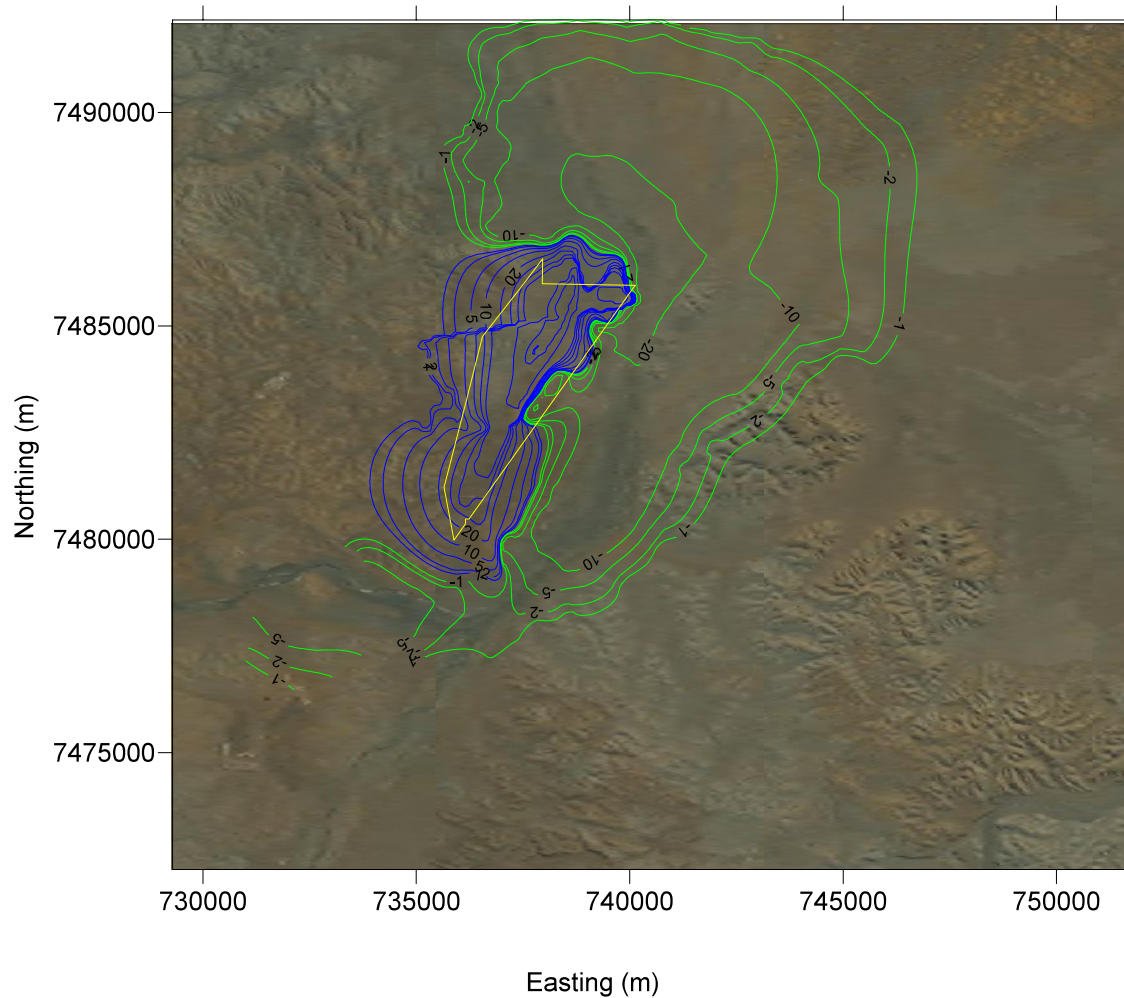
**FIGURE 4.43
 CONTOURS OF
 PREDICTED DRAWDOWN
 END OF 2025 RTIO
 SURPLUS DISPOSAL
 CASE**

Positive drawdown represents a water level decrease while a negative drawdown represents a water level increase.
 Contours shown at -20m, -10m, -5m, -2m, -1m, 1m, 2m, 5m, 10m, 20m, 30m, 40m, 50m, 100m, 150m and 200m.
