**Maintenance Dredging at Stirling
Naval base Garden Island WA**

Review of the effects of shading on
seagrass

HMAS Stirling Dredging

ADCP tidal currents and dredge disposal
summary

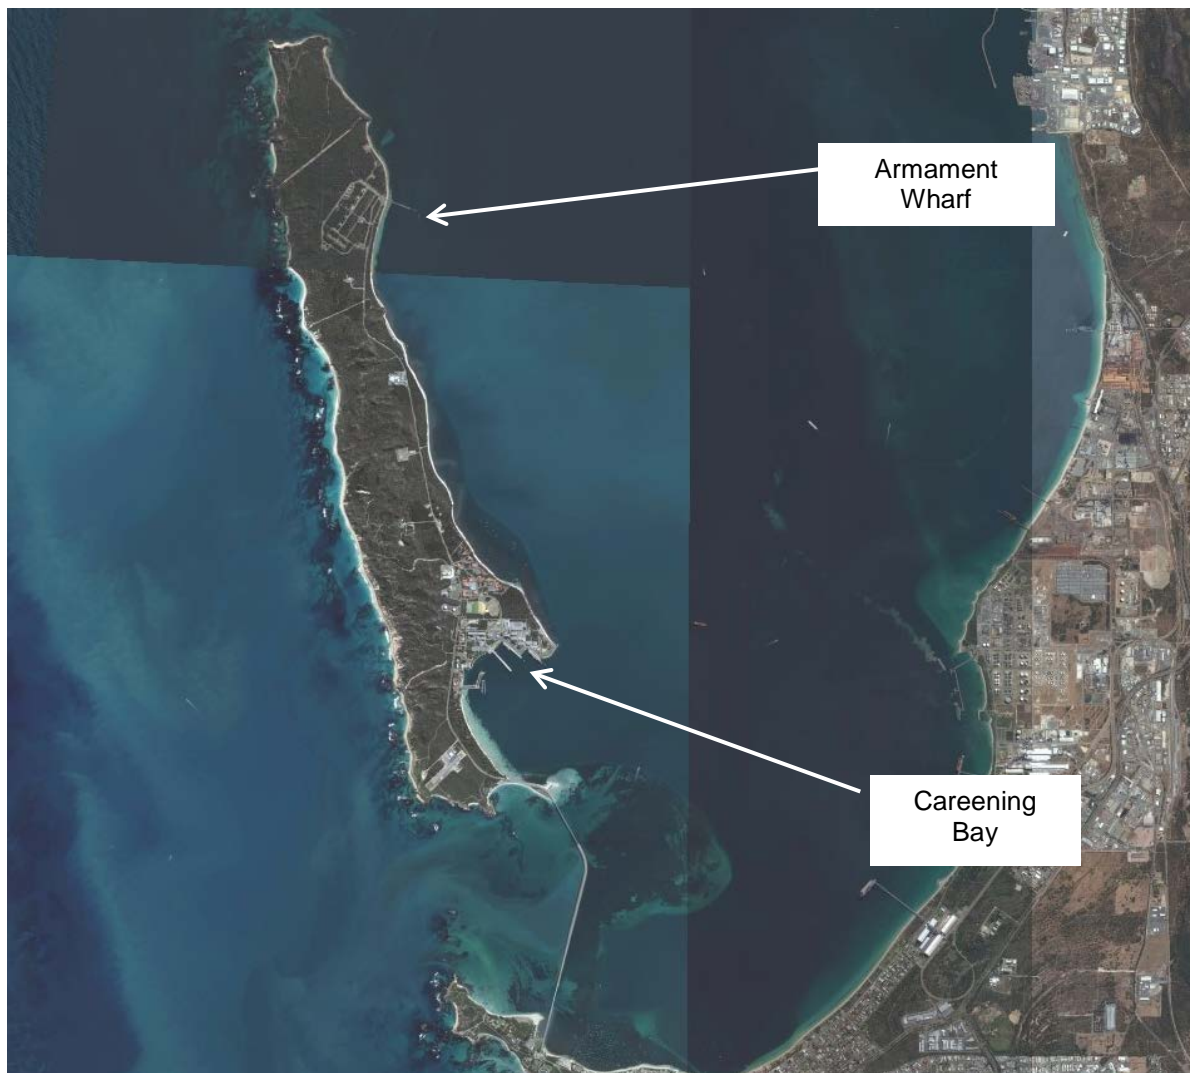
Figure 1 Garden Island layout and dredging sites

The Garden Island dredging sites are shown below, and are detailed further in Section 2.2 of this memo.

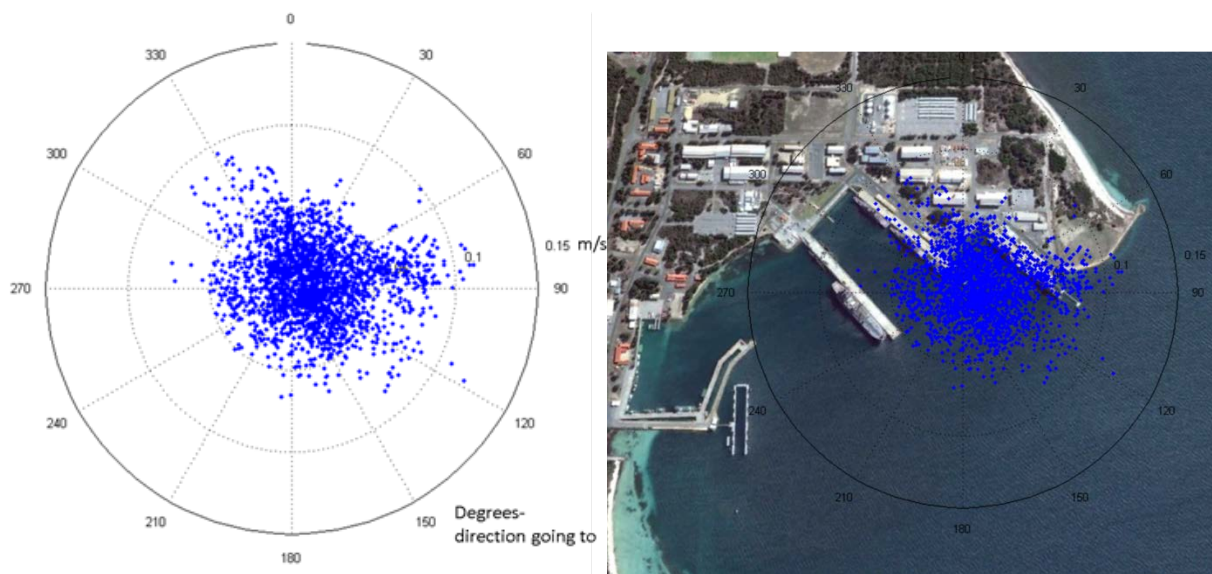
Figure 4 Measured tidal currents rose at ADCP 1 – Careening Bay – depth-averaged velocities

The measured tidal currents at the ADCP1 location within Careening Bay are spread over a large range of directions but are of small velocity, with velocities typically less than 0.1m/s. Tidal currents in the upper part of the water column in particular appear highly variable, and current can be stronger in magnitude than at mid-water.

A summary of the measured depth-averaged tidal currents is shown below, on a tidal current rose. The direction shown is degrees True North, with direction current going to.

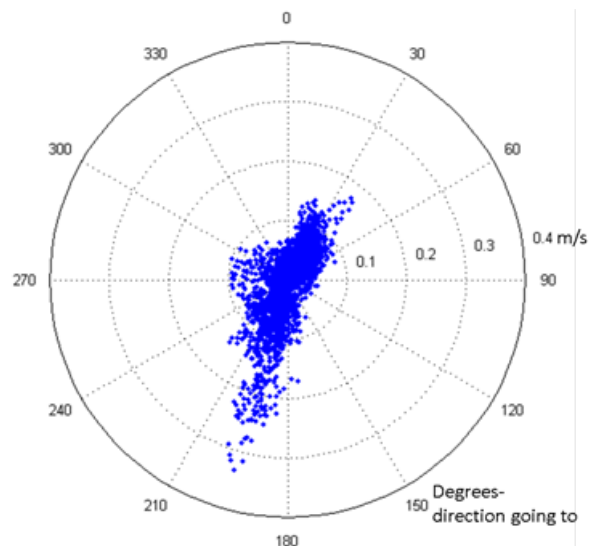
Figure 6 Measured tidal currents rose at ADCP 2 – Armament Wharf – depth averaged velocities

The measured tidal currents at the ADCP 2 location are relatively uniform, and relatively omni-directional along the NNE-SSW direction. The dominant tidal currents are parallel to the shoreline and seabed bathymetry, with up to 0.2m/s current to the NNE during the ebb tide and up to approximately 0.3m/s to the SSW during the flood tide. Tidal currents of up to 0.1m/s can occur in other directions.

A summary of the depth-averaged tidal currents is shown below, shown on the tidal current rose. The direction shown is degrees True North, with direction current going to.

Overall the tidal currents at the Armament Wharf dredging site are of small velocity, typically less than 0.2-0.3m/s and parallel to shore. The small tidal currents are due largely to the small tidal range at the site.

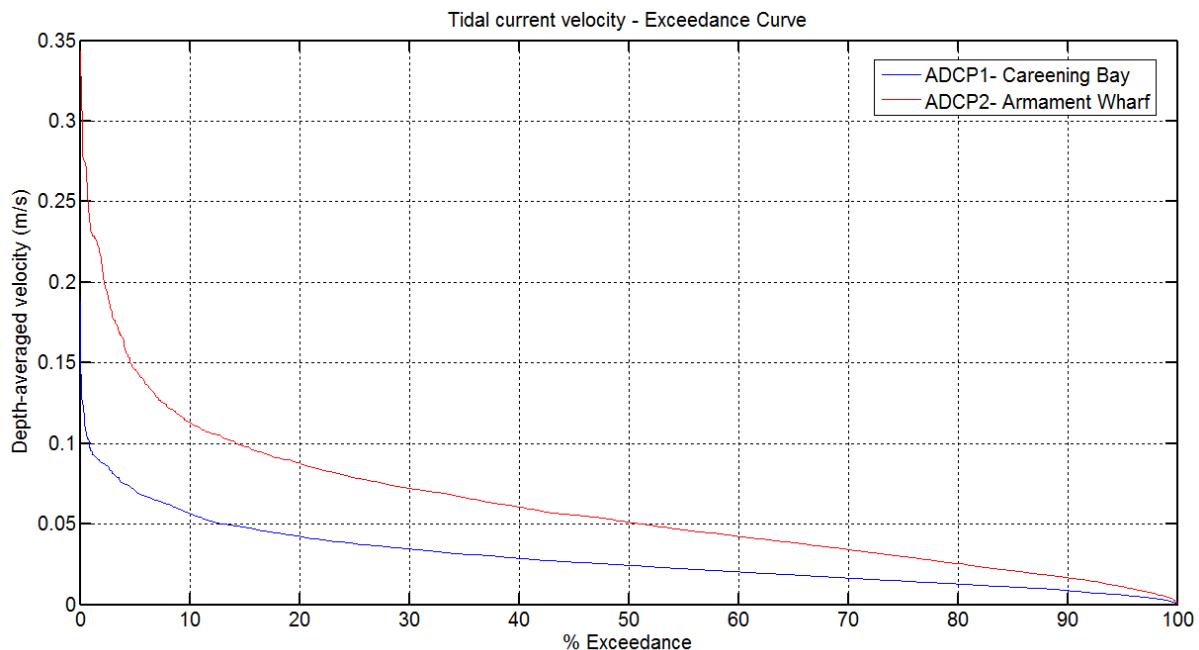
Figure 9 ADCP measured tidal currents – velocity exceedance curve

The bed shear stresses generated by the tidal currents are directly dependent upon bed velocities. An exceedance analysis of the measured tidal currents at each of the two ADCP sites has been undertaken, showing the occurrence and spread of velocities. The exceedance curves are shown below.

The upper recorded velocities (1% exceedance) of the measured ADCP data are:

- 0.1m/s – ADCP 1 – Careening Bay
- 0.23m/s – ADCP 2 – Armament Wharf

The ADCP2 data is located very close to the Armament Wharf dredge disposal location, and is in similar water depths and on the same exposed coastline. The ADCP2 tidal currents therefore apply to the dredge disposal site. The ADCP1 location is in a more sheltered location within Careening Bay than the more offshore Careening Bay disposal location. Tidal currents at the Careening Bay disposal site may be higher than the ADCP1 measurements, but are likely to be less than ADCP2. The tidal currents at the Careening Bay disposal site are assumed to be similar to the Armament Wharf site for the bed shear stress assessment, which is conservative.

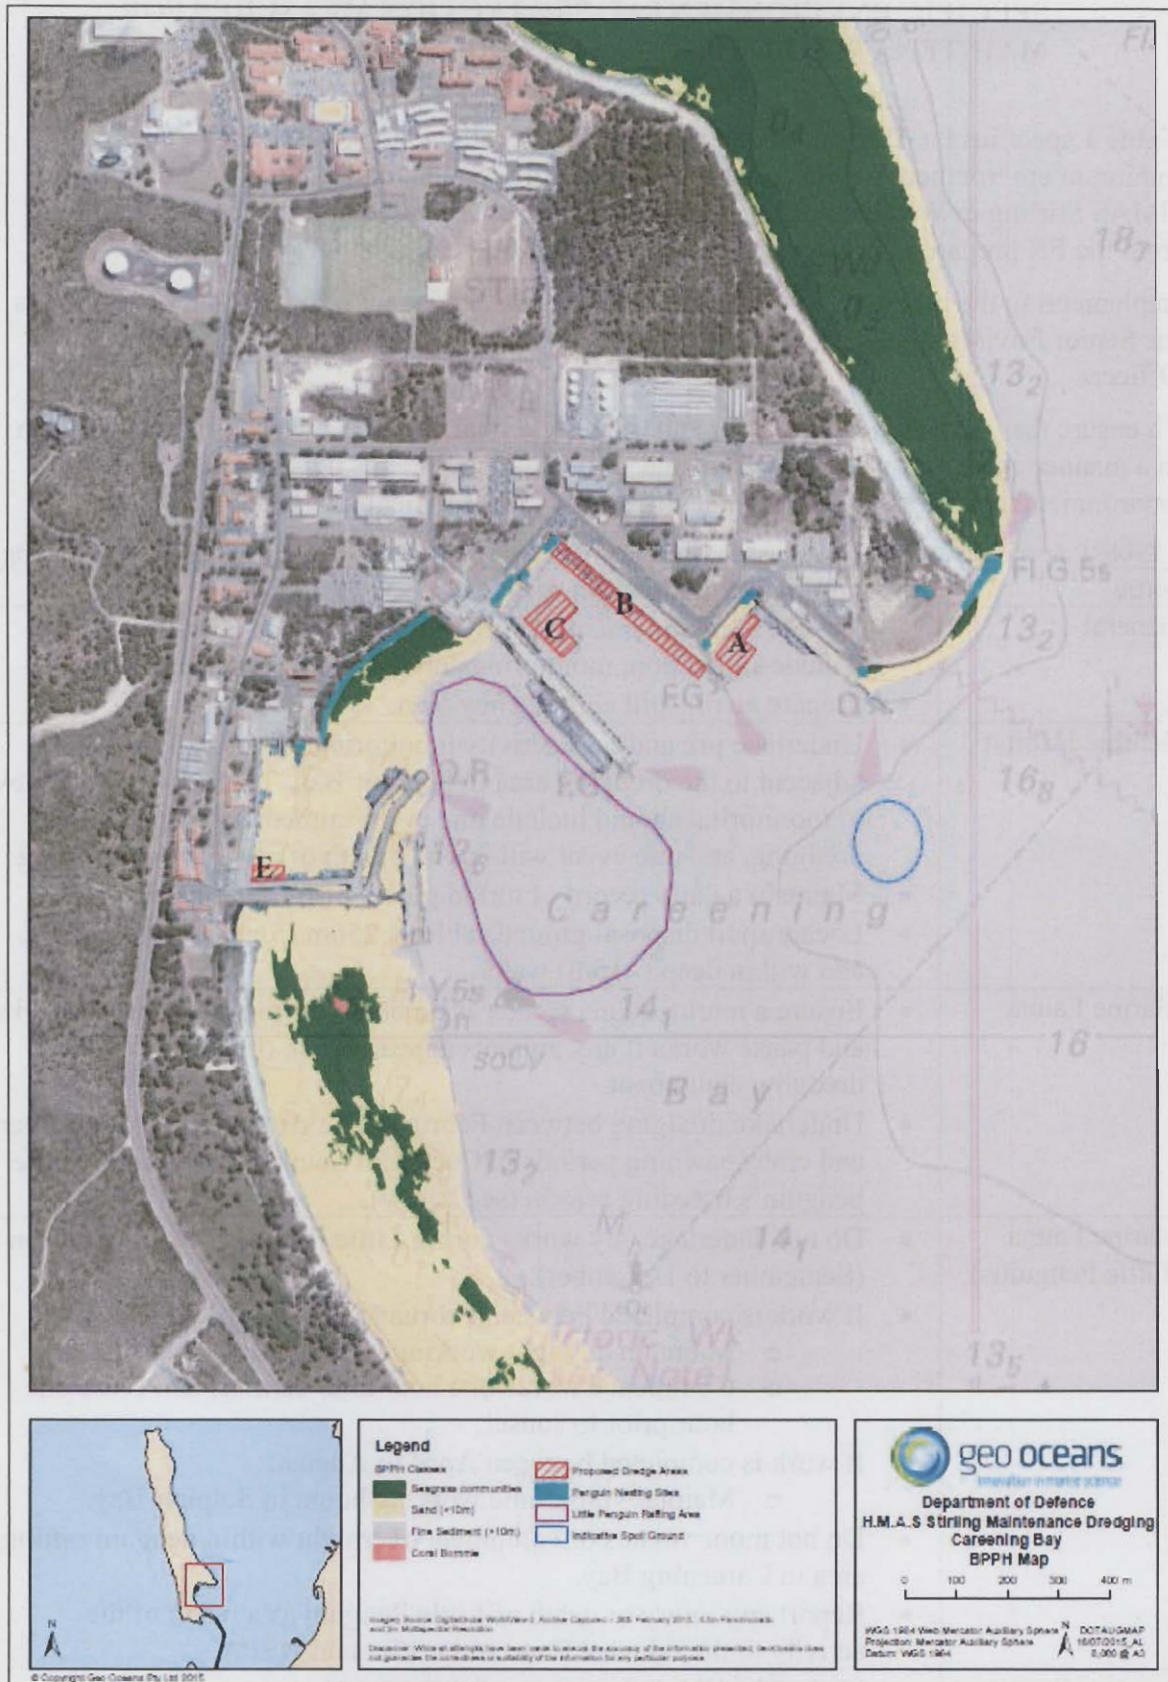
Figure 1: Careening Bay – showing dredge areas, spoil ground, little penguin rafting area and extent of seagrass communities

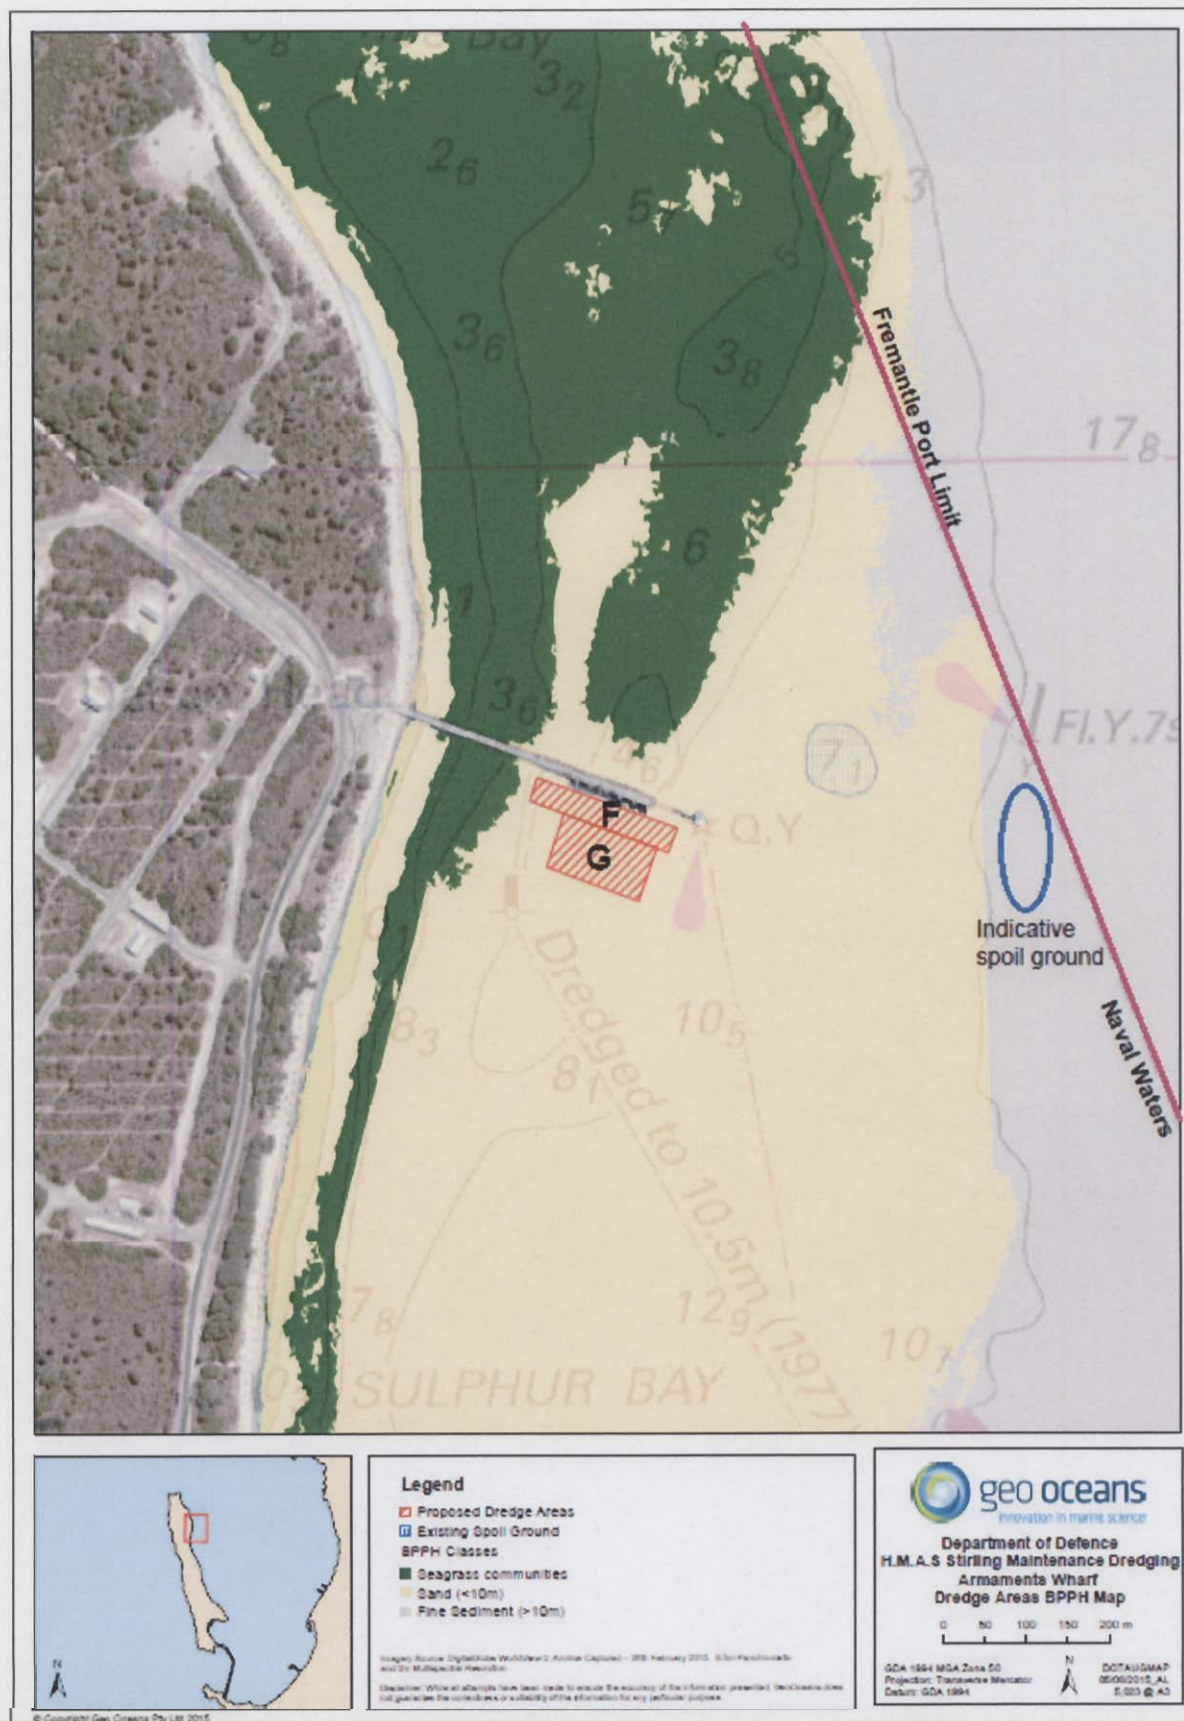
Figure 2: Sulphur Bay - showing dredge areas, spoil ground and extent of seagrass communities
