MINE CLOSURE PLAN

M70/1325
Pigeon - Haddrill Roads
Yanchep

Extraction of Sand

10 June 2014

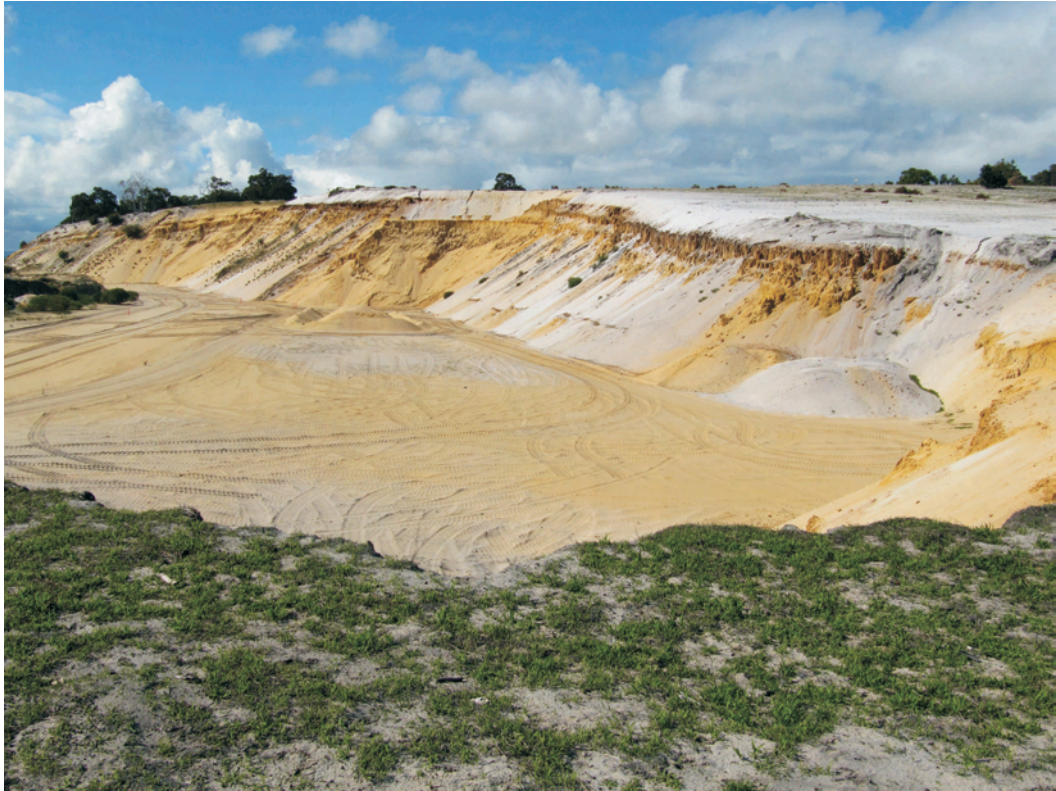
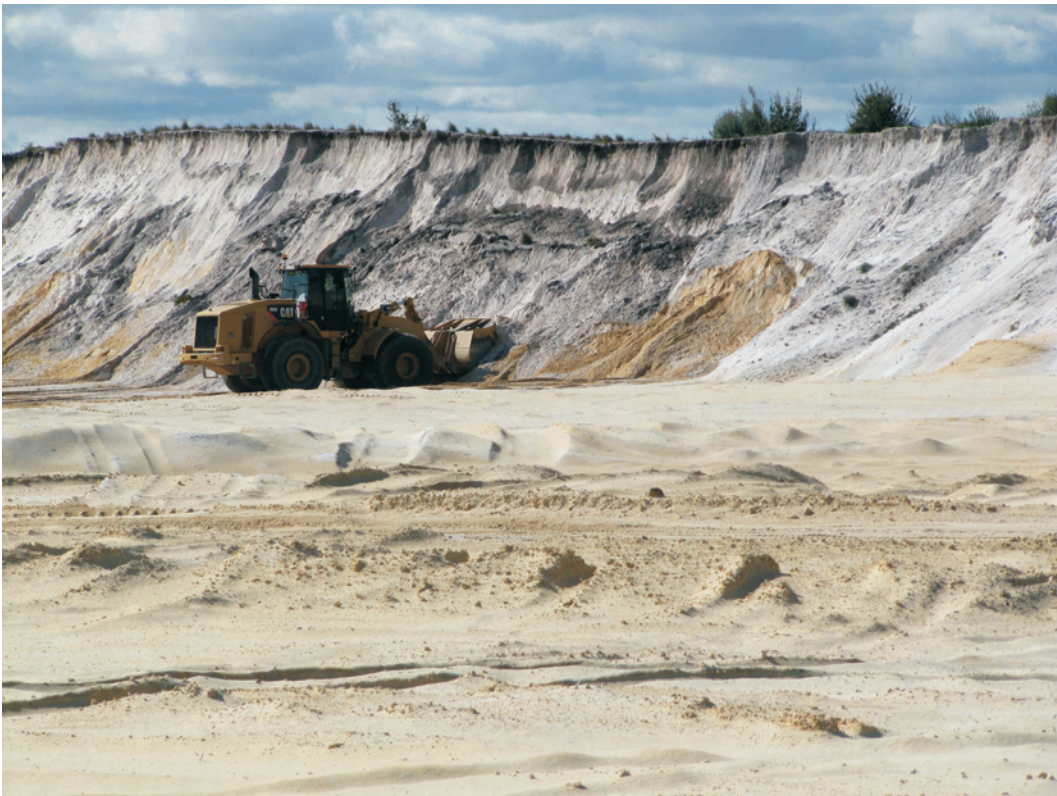
FIGURE 7

Typical sand pit and excavation

Excavating sand from a face similar to the proposed operation

WA LIMESTONE	
M70/1325	
TYPICAL SAND EXCAVATIONS	
Landform Research	May 2014
Basemap	Scale

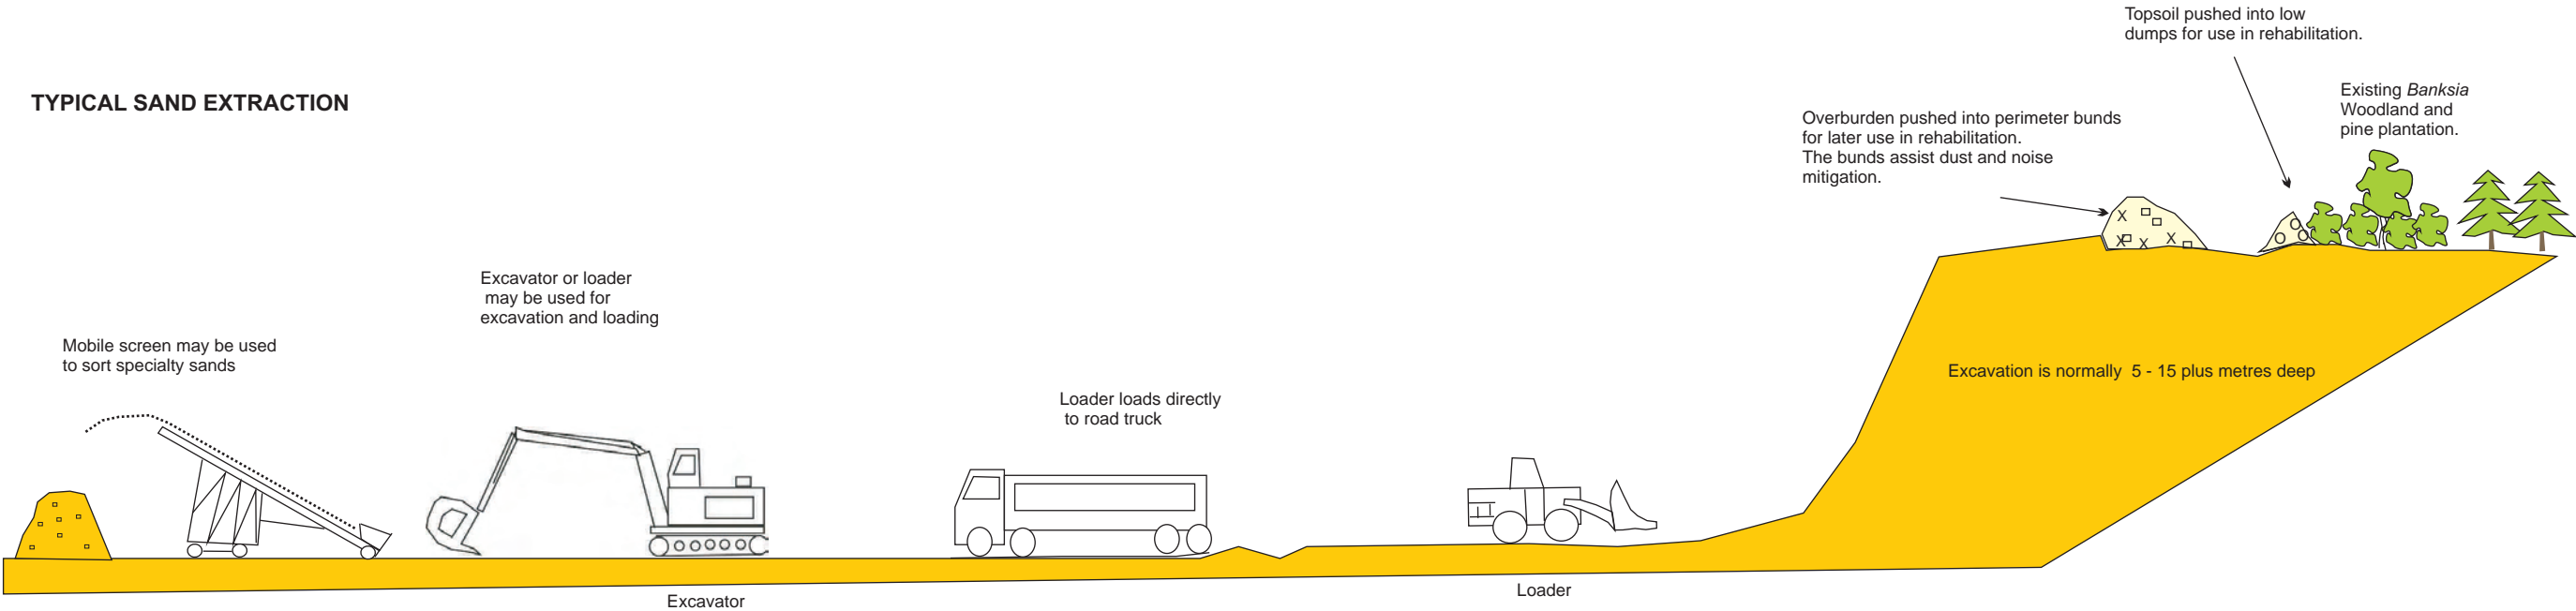
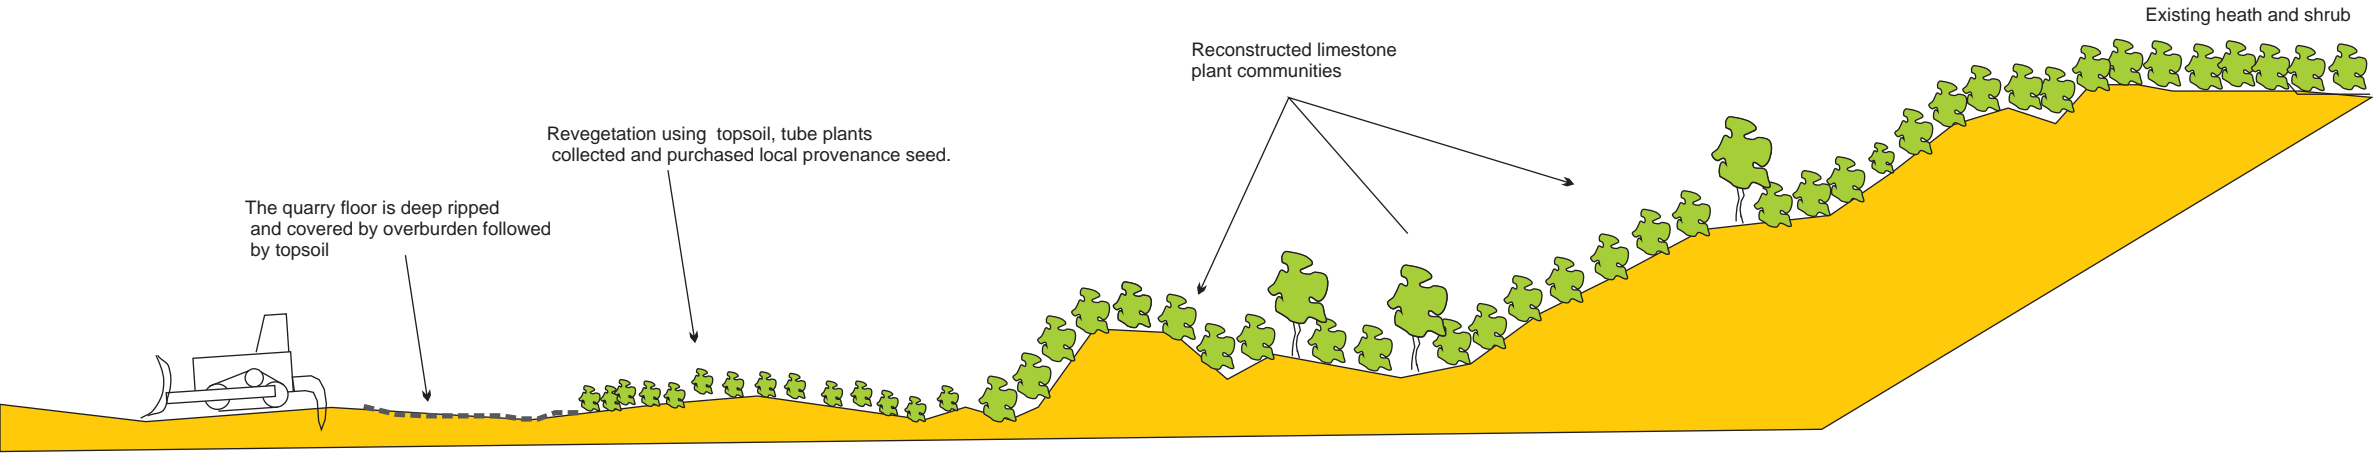
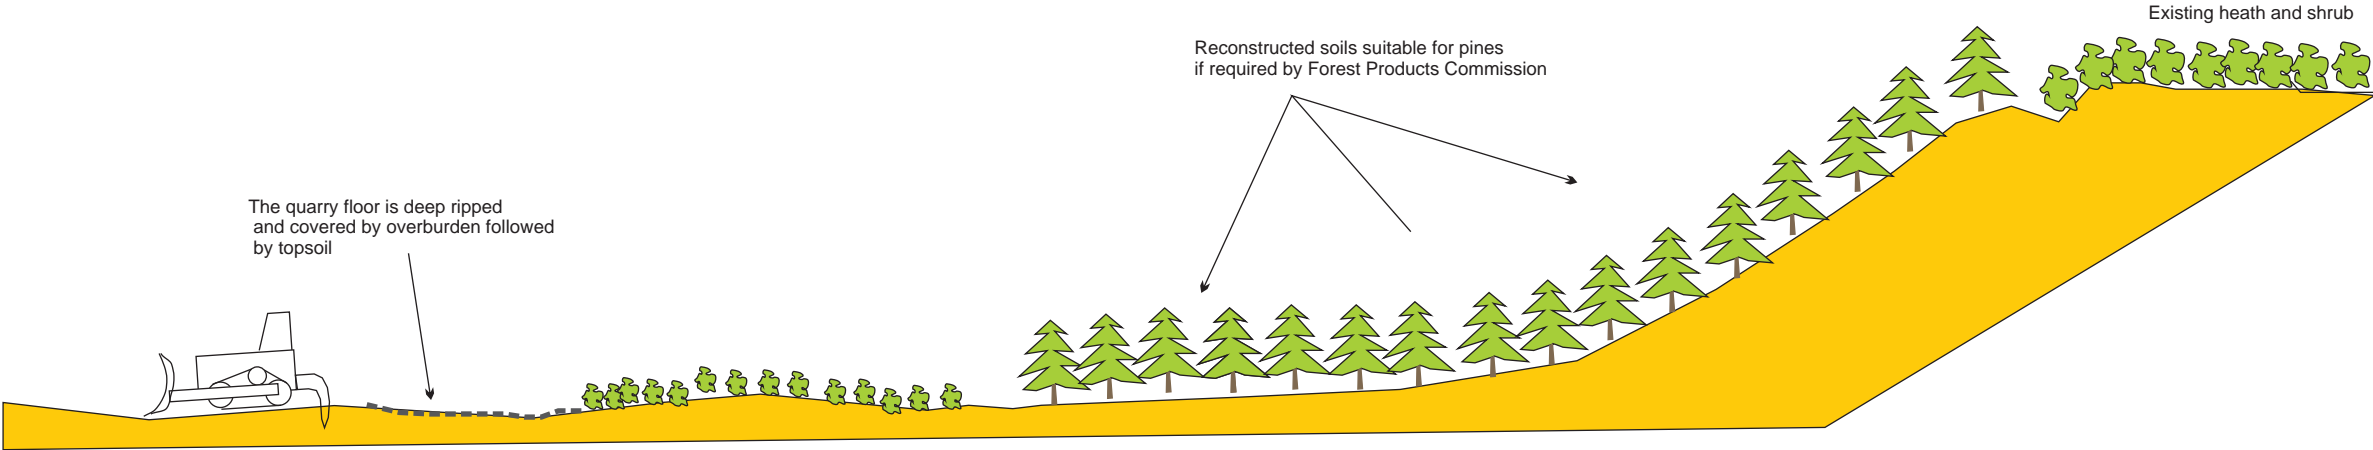
Figure 8

TYPICAL SAND EXTRACTION

PROPOSED REHABILITATION AND REVEGETATION

At this stage Forest Products Commission have not indicated whether they wish to replant pines on M70/1325.

If FPC do not want pines, rehabilitation will be to *Banksia* Woodland which is proposed.

ALTERNATIVE REHABILITATION TO PINES IN ASSOCIATION WITH FOREST PRODUCT COMMISSION

WA LIMESTONE	
M70/1325	
PROPOSED EXCAVATION METHODS	
Landform Research	May 2014
Basemap	Scale
