Perth-Darwin National Highway

EPA Referral

Tonkin Grade Separation

DOC NO / NLWA-01-EN-RP-0003

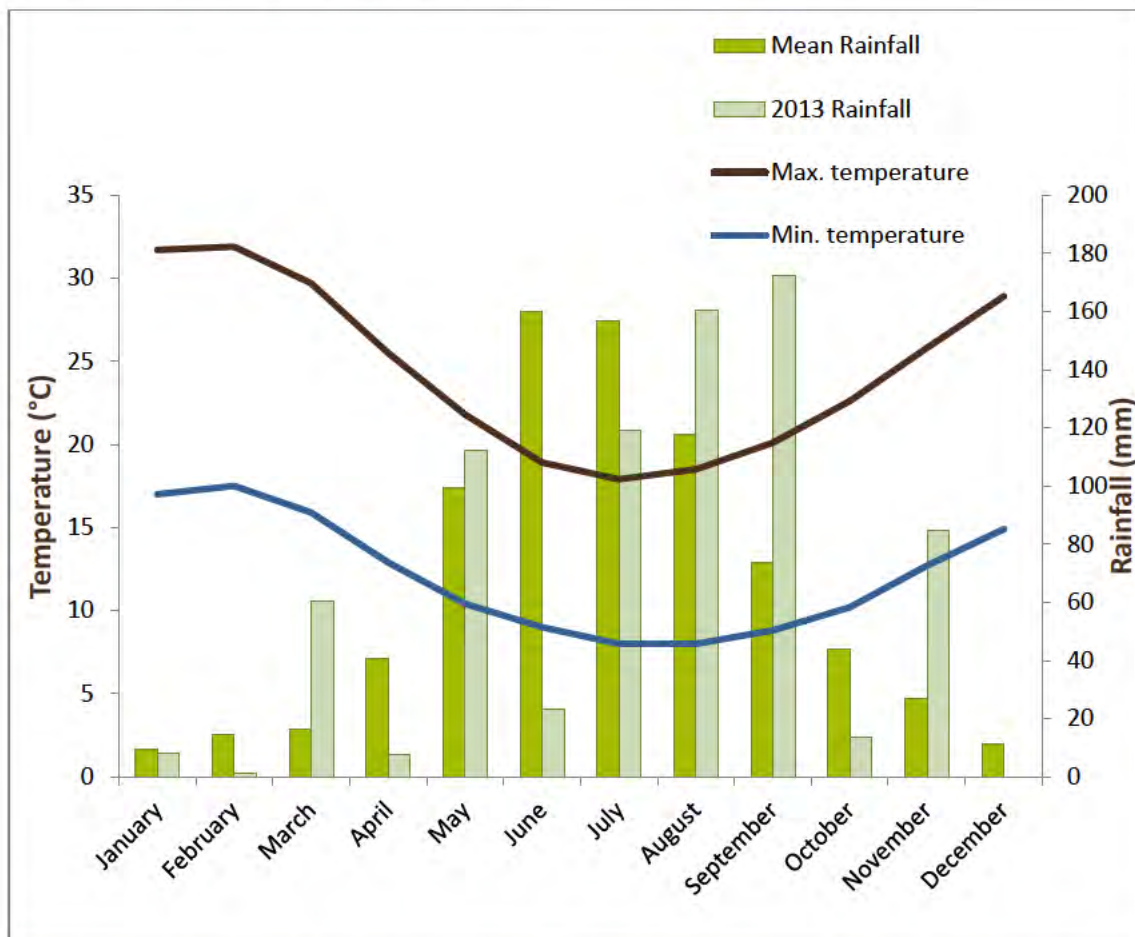
Figure 2: 2013 Rainfall, Mean Rainfall and Temperature for Perth Airport Recorded Between 1944 and 2013 (BoM 2013)

Perth Airport recorded 788 mm of rain in the 12 months prior to survey (October 2012 – September 2013), 12.5 mm above the long term average rainfall of 775.5 mm for the same period (BoM 2013). The three months prior to survey (July 2013 – September 2013), Perth Airport recorded 452.2 mm of rainfall, 30% above the 348 mm average rainfall for the same period (BoM 2013).

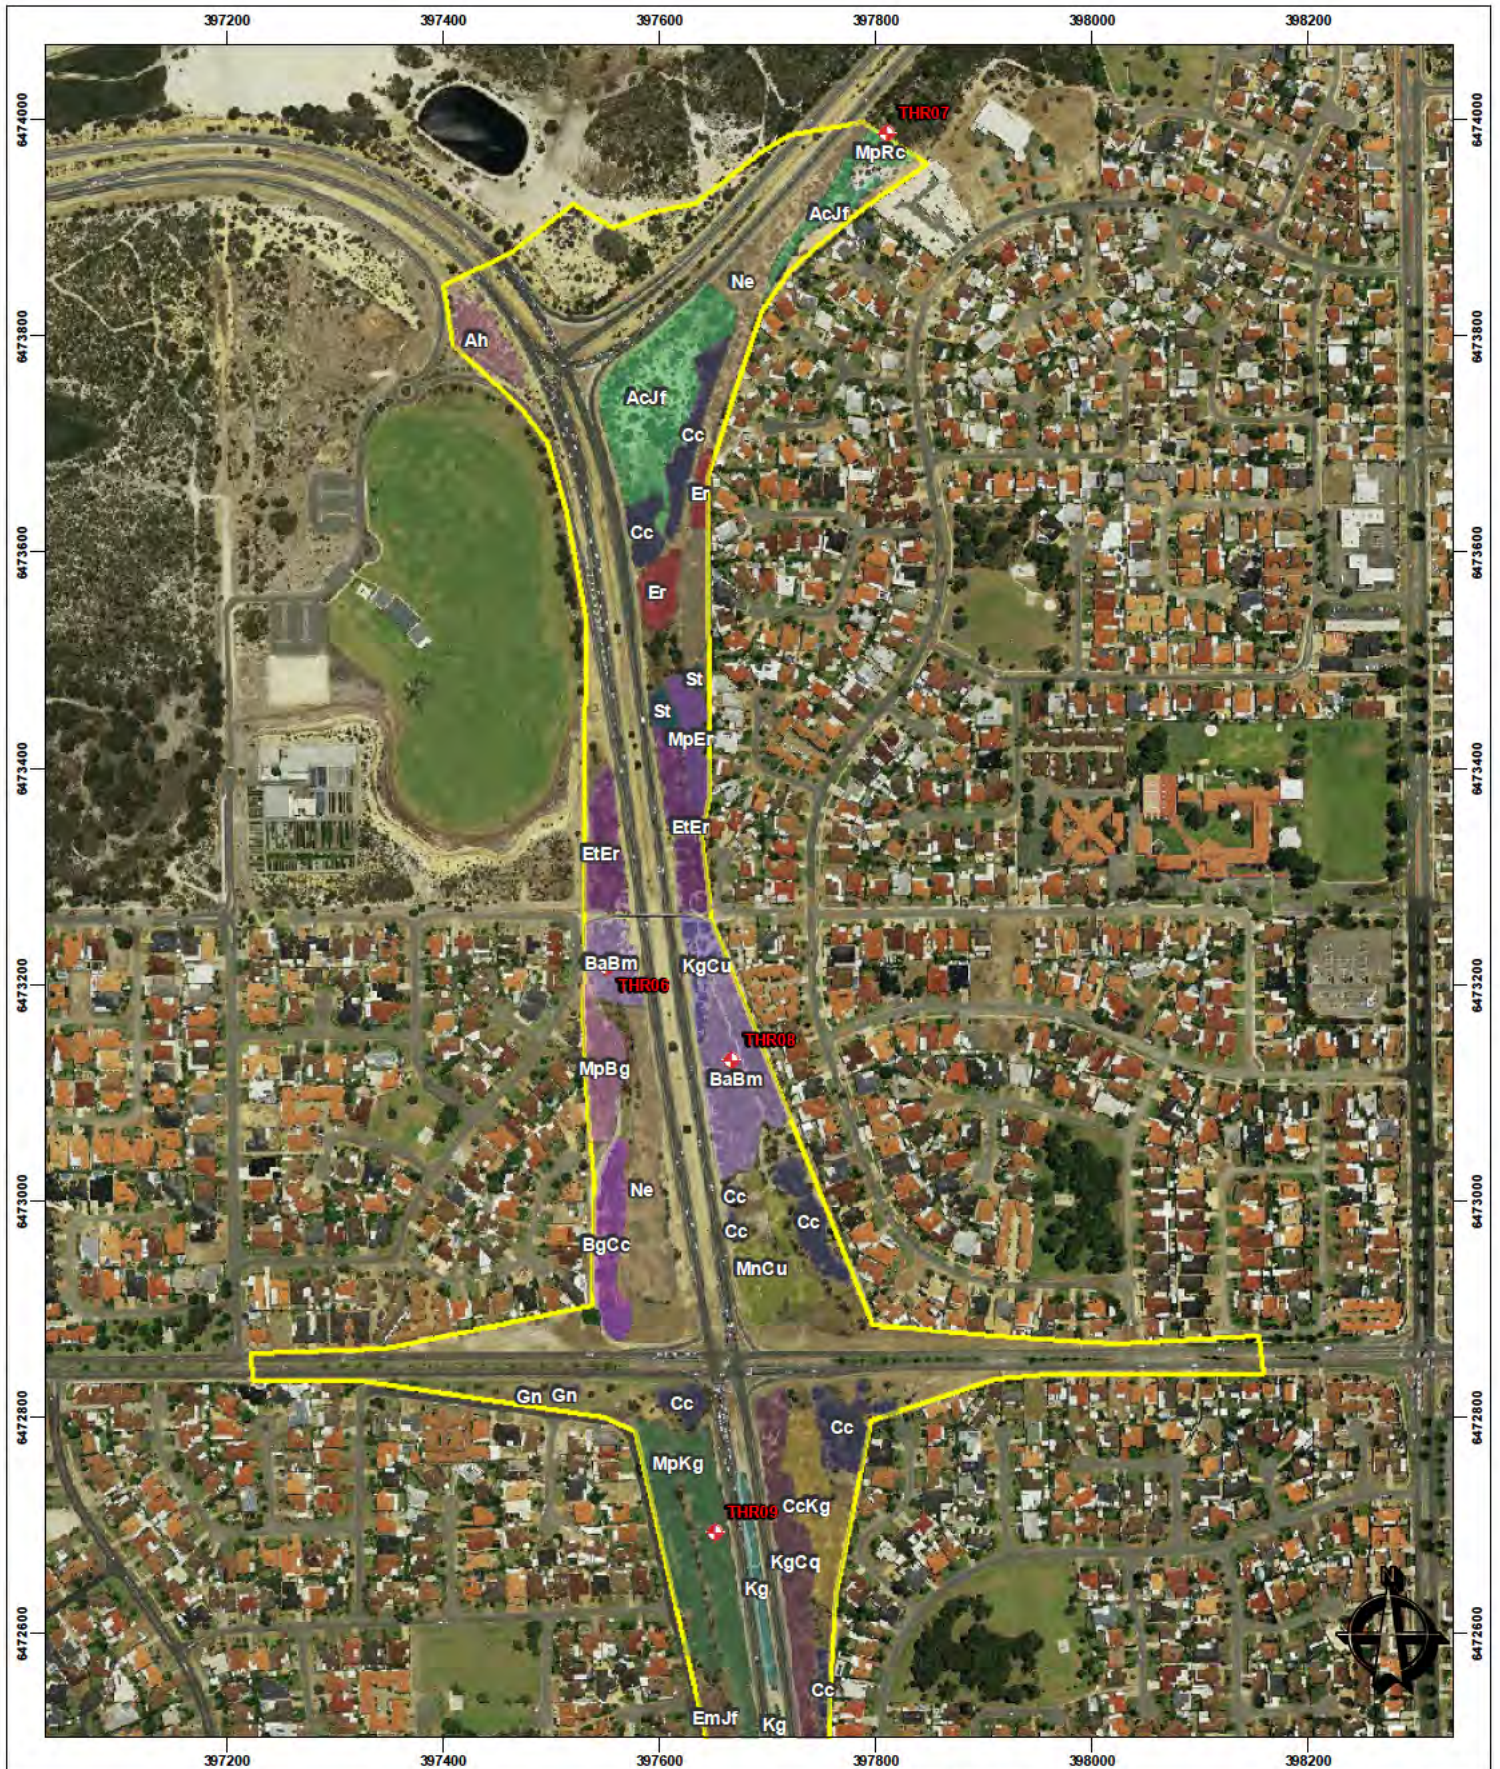
Tonkin Highway Grade Separation			
Figure 4a - Vegetation Mapping Units

A total of 51 mapping units were identified in the survey area (Figure 4). The extent of each unit is presented in Table 5.

VARIABLE	IMPACT ON SURVEY OUTCOMES
Access	The majority of the site was accessed and traversed. Access to a small section of the survey area was fenced off and inaccessible at the northern end of the survey area (figure 4).
Experience	The personnel who executed these surveys were practitioners suitably qualified in their respective fields: <ul style="list-style-type: none"> •Á Coordinating Botanist: Narelle Whittington (Principle Botanist); •Á Field Staff: Narelle Whittington and Hayden Ajduk (Ecologist); and •Á Data Interpretation and Reporting: Hayden Ajduk
Timing, weather, season.	The survey was conducted during spring after three months of above average rainfall (refer to Section 2.1). Above average rain also occurred in the month just prior to the survey therefore, the seasonal conditions for the survey could be considered adequate. Flora composition changes with time, particularly over the seasons and with seasonal conditions. Fire history also affects the composition of flora. Therefore, botanical surveys completed at different times will have varying results.

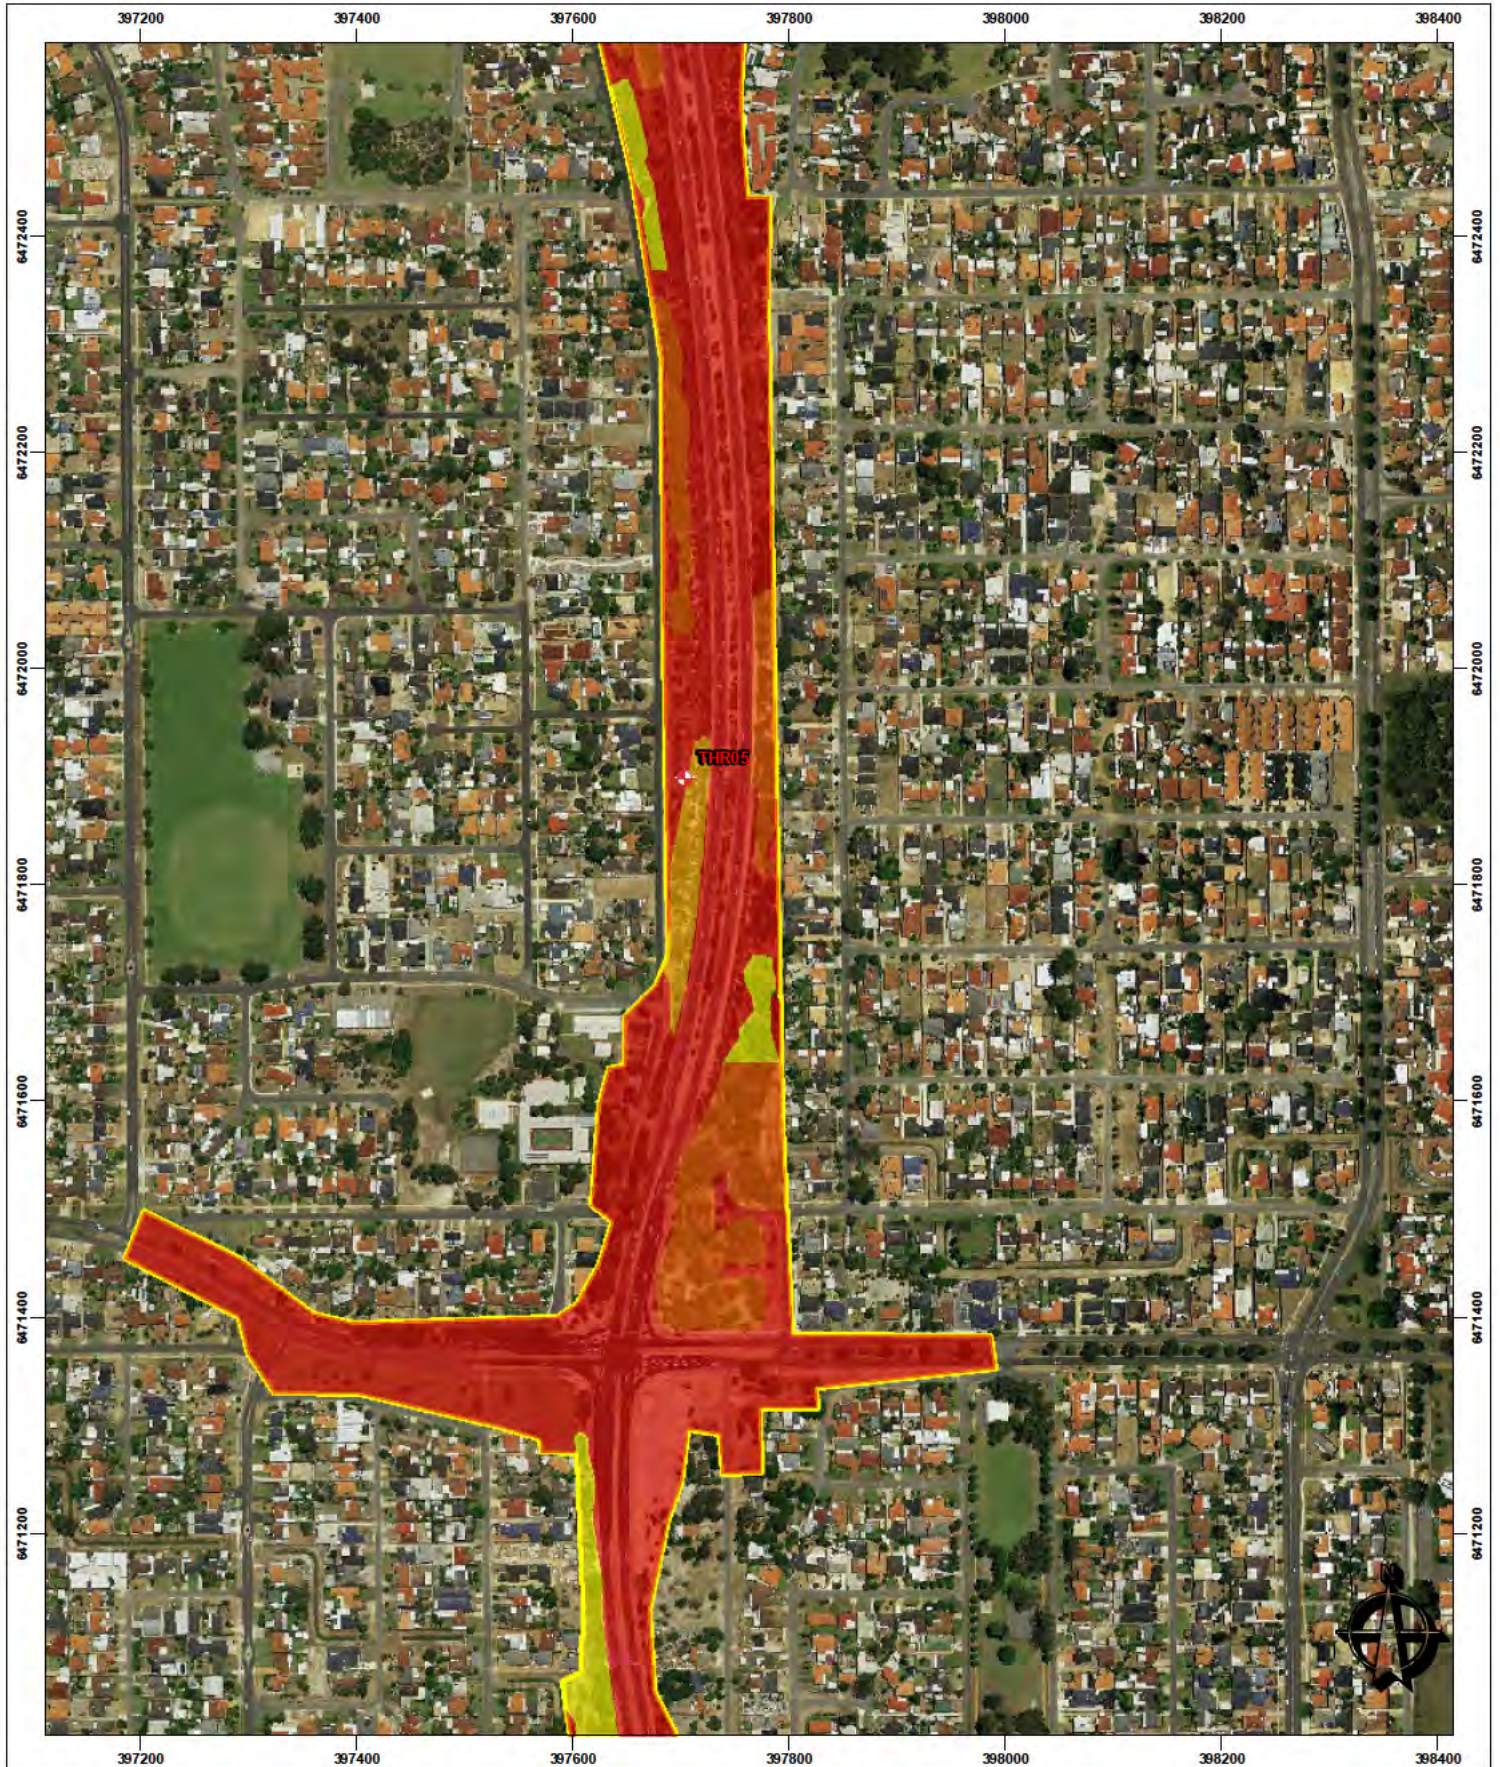
<p> Releve Project Footprint </p>	<p> Vegetation Condition No Access Excellant Very Good Good Good - Degraded Degraded Completely Degraded </p>	<p>0 25 50 100 150 200</p> <p>Metres</p> <p>1:7,000 @ A4</p>	<p> #10 Bemondey St, West Leederville, 6007 WA t:(08) 9388 8360 f:(08) 9381 2360 www.360environmental.com.au </p>				
		<p>NOTE THAT POSITION ERRORS CAN BE ±5M IN SOME AREAS</p>		<p> DRAWING ID 185 Vegetation Condition </p> <p> DATE 5/12/2013 </p>			
		<p> HORIZONTAL DATUM AND PROJECTION GDA 1994 MGA Zone 50 </p>					
		<table border="1"> <tr> <td>CREATED CS</td> <td>CHECKED HA</td> <td>APPROVED RF</td> <td>REVISION 0</td> </tr> </table>		CREATED CS	CHECKED HA	APPROVED RF	REVISION 0
CREATED CS	CHECKED HA	APPROVED RF	REVISION 0				
		<p> Main Roads Western Australia </p> <p> Tonkin Highway Grade Separation </p>					
<p> NOTE THAT POSITION ERRORS CAN BE ±5M IN SOME AREAS - LOCALITY MAP SOURCED FROM LANDGATE 2013 - STREET DIRECTORY MAP SOURCED FROM STREETSMART 2008 - AERIAL PHOTOGRAPHY SOURCED FROM LANDGATE 2012 © Western Australian Land Information Authority 2013 </p>		<p> SLIP ENABLER </p>					
<p> Figure 5b - Vegetation Condition </p>

Vegetation condition ranged from Completely Degraded to Excellent (Figure 5). Historical vegetation clearing, weeds, road infrastructure and the presence of unsealed roads within and adjacent to the survey area were the most frequently observed impacts on native vegetation.

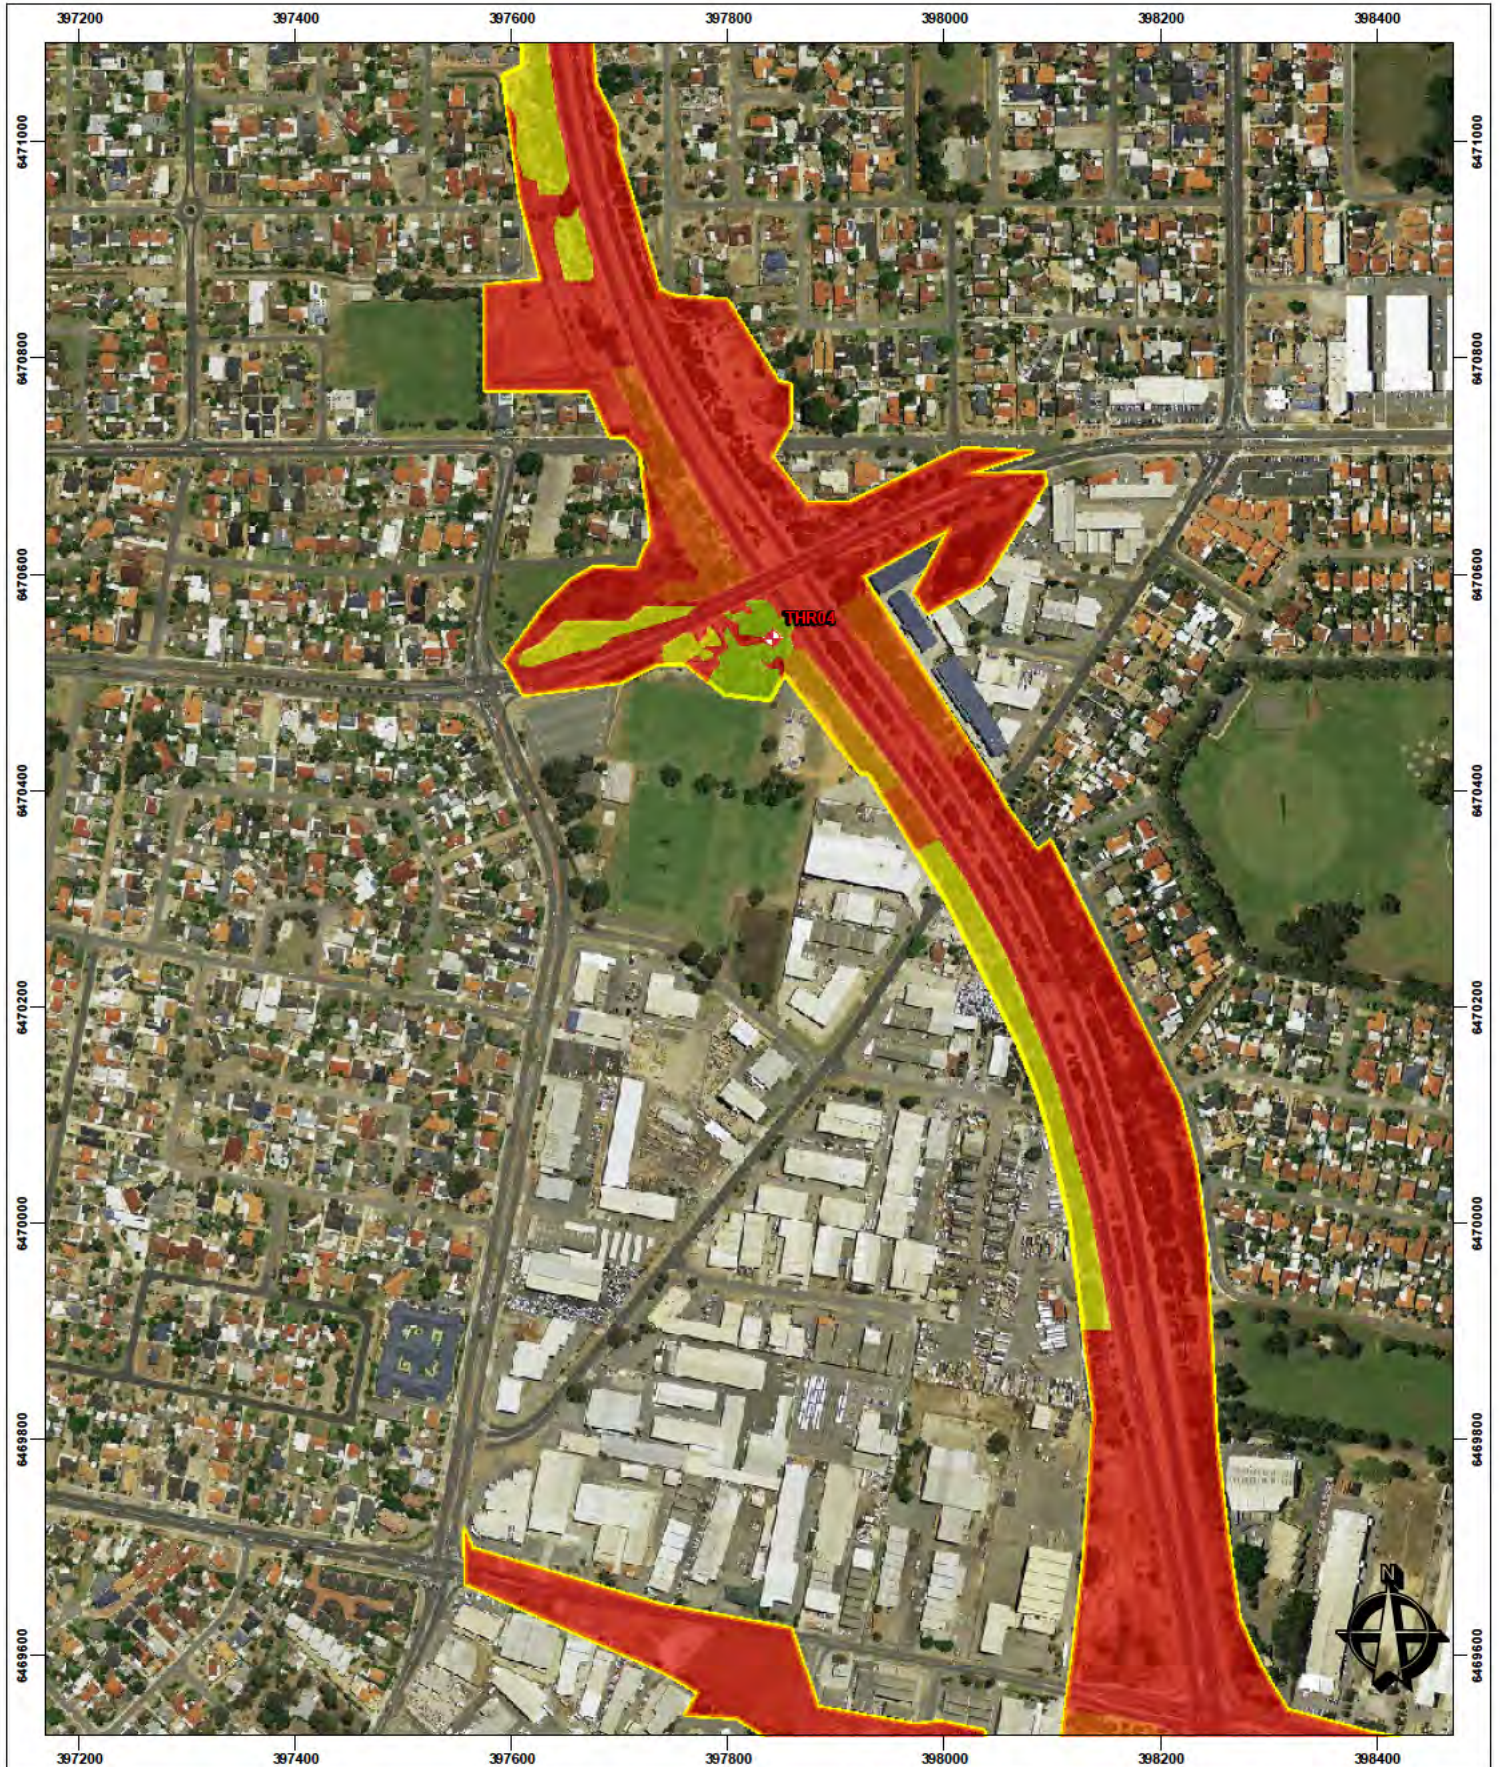
Figure 5c - Vegetation Condition

Vegetation Condition
 ▨ No Access
 ■ Excellant
 ■ Very Good
 ■ Good
 ■ Good - Degraded
 ■ Degraded
 ■ Completely Degraded

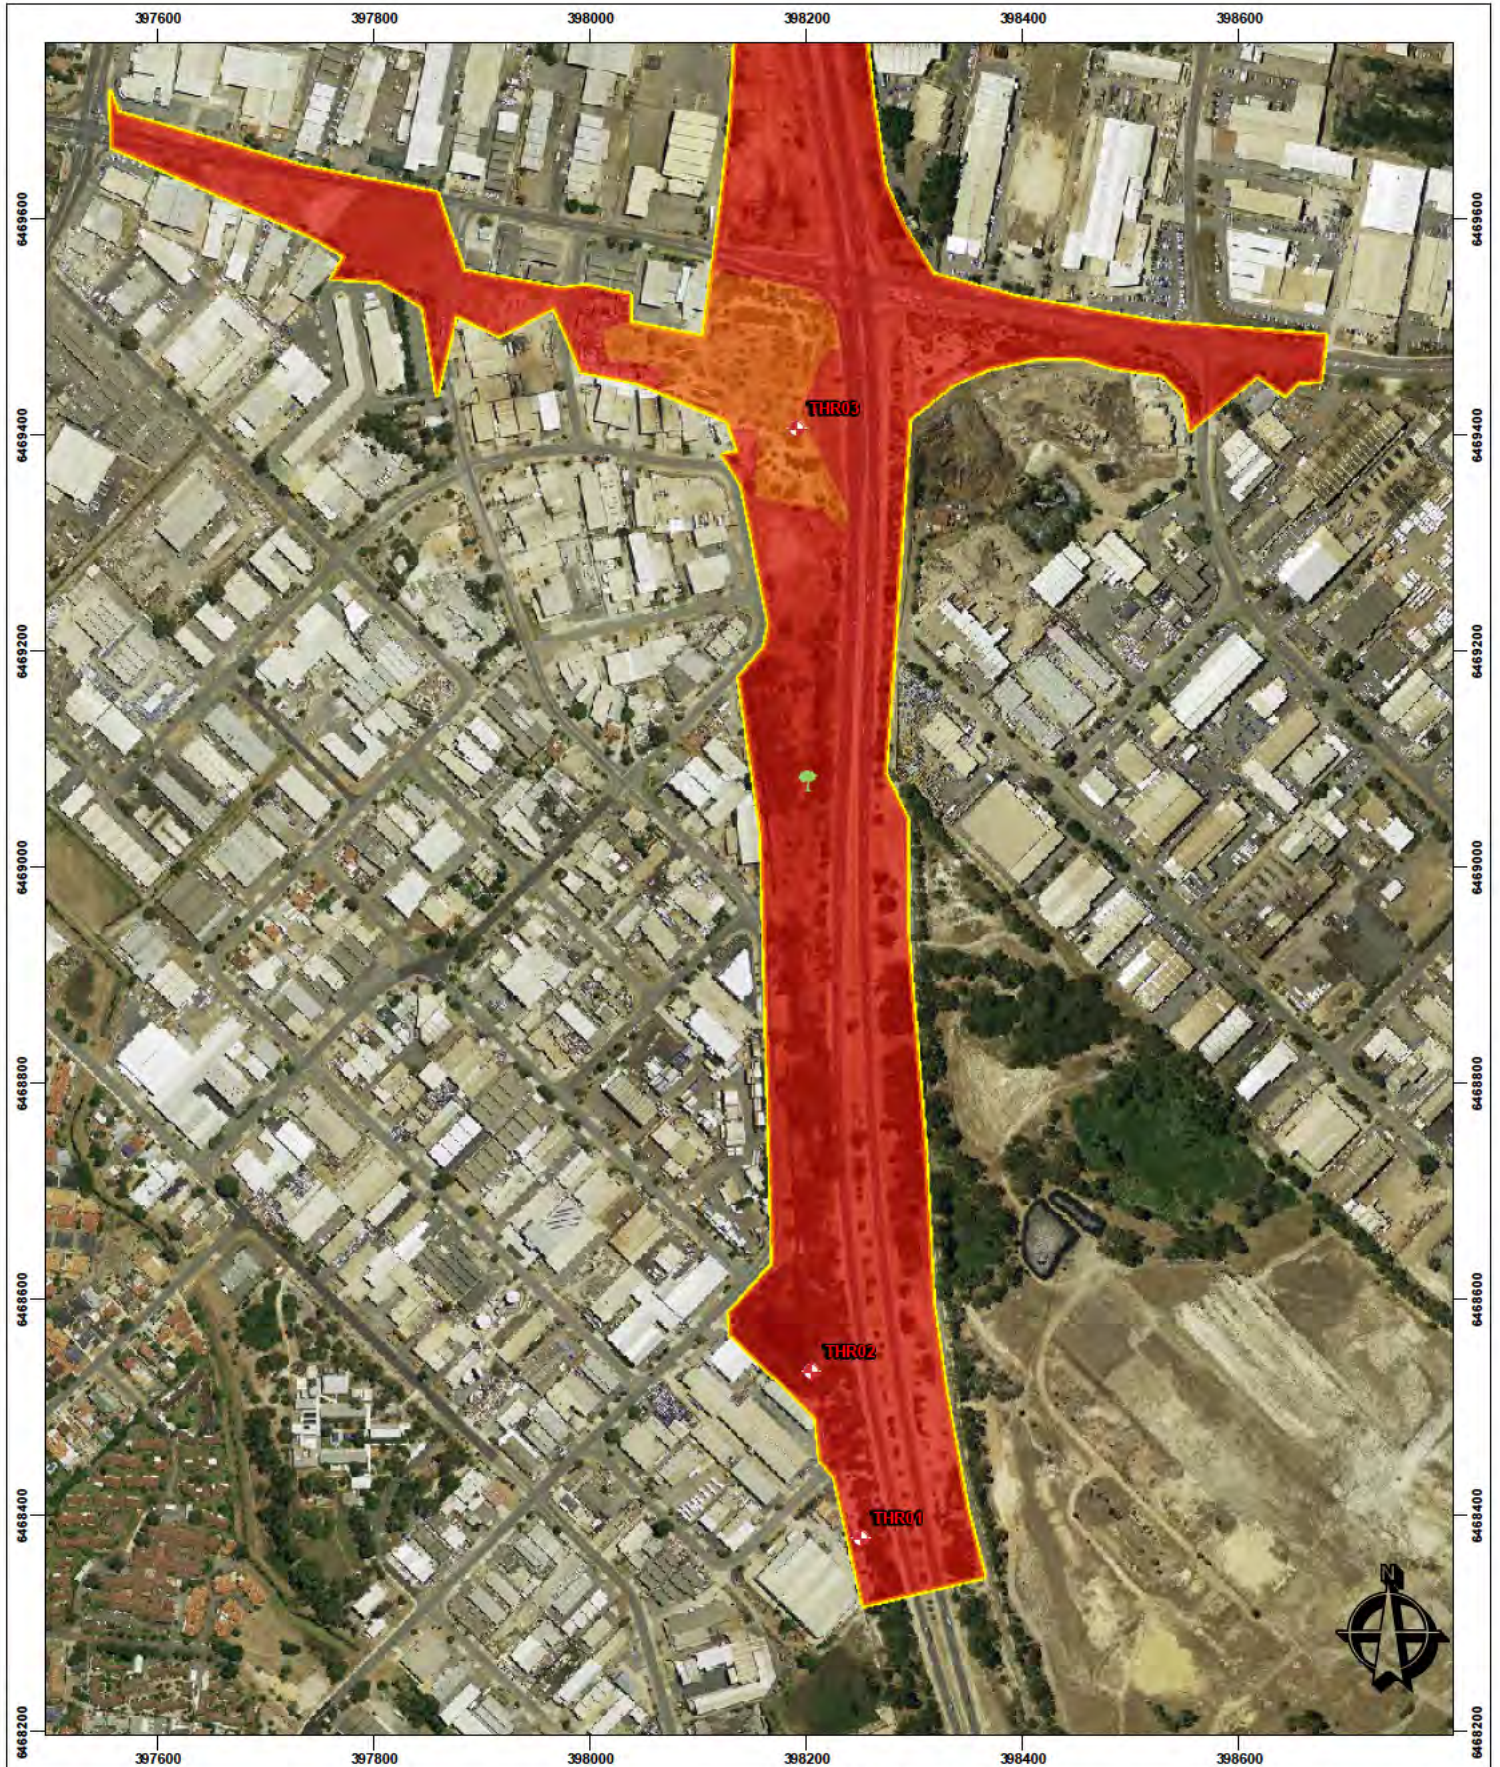
Figure 5d - Vegetation Condition

Releve	Vegetation Condition
Project Footprint	No Access
<i>Zantedeschia aethiopica</i>	Excellant
	Very Good
	Good
	Good - Degraded
	Degraded
	Completely Degraded

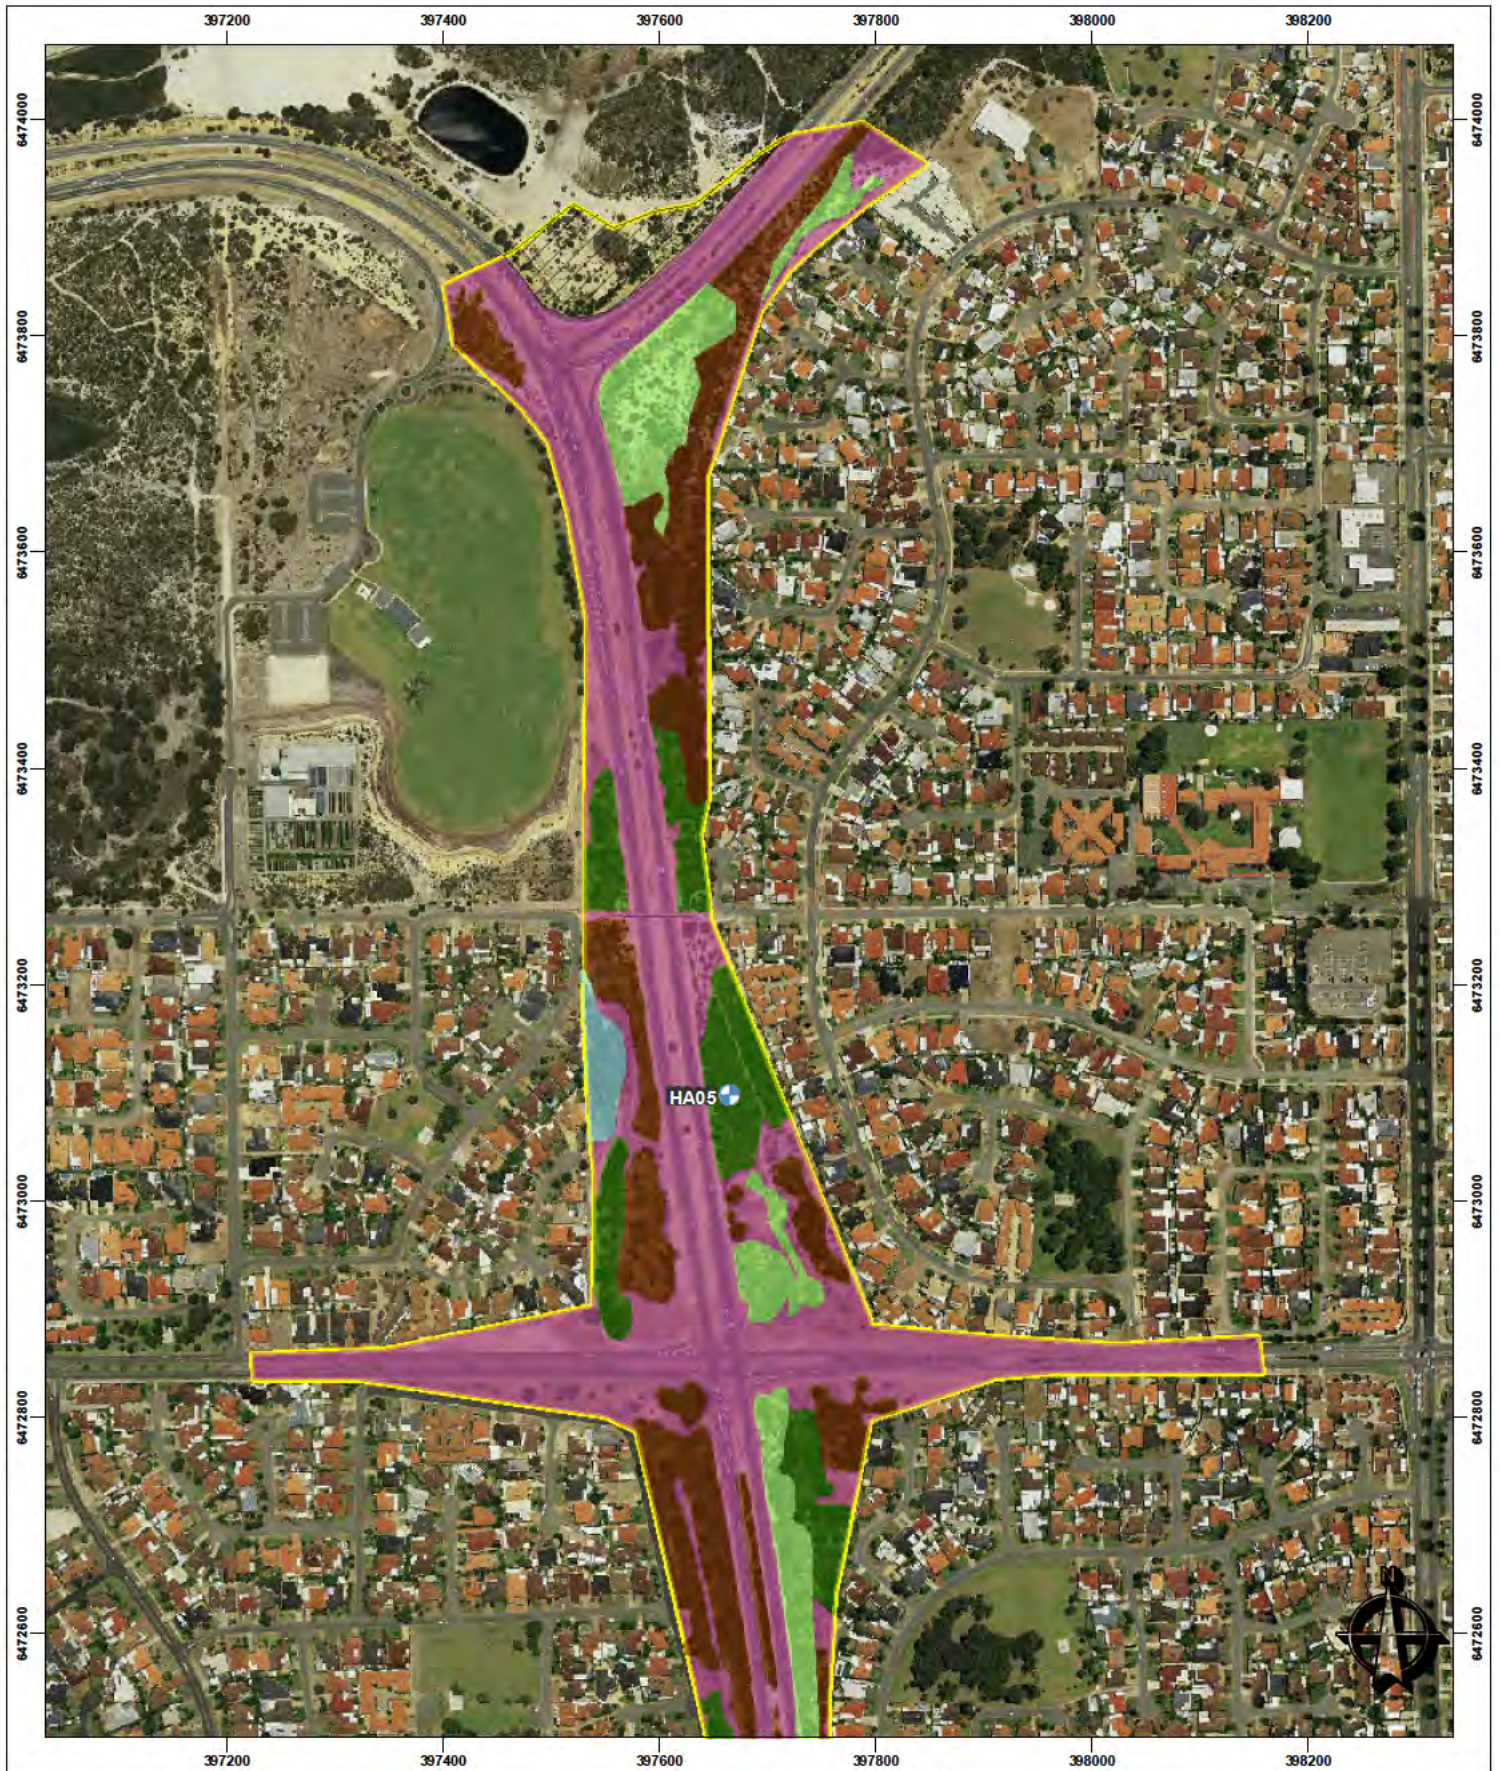
#10 Belemondsey St, West Leederville, 6007 WA t(08) 9388 8360 f(08) 9381 2360 www.360environmental.com.au			
DRAWING ID	DATE		
185 Fauna Habitat	5/12/2013		
HORIZONTAL DATUM AND PROJECTION			
GDA 1994 MGA Zone 50			
CREATED	CHECKED	APPROVED	REVISION
CS	HA	RF	0
Main Roads Western Australia			
Tonkin Highway Grade Separation			
Figure 6a - Fauna Habitat Mapping

Completely Degraded areas were not assessed for fauna habitat. A summary of the total area of each habitat is presented in Table 9.

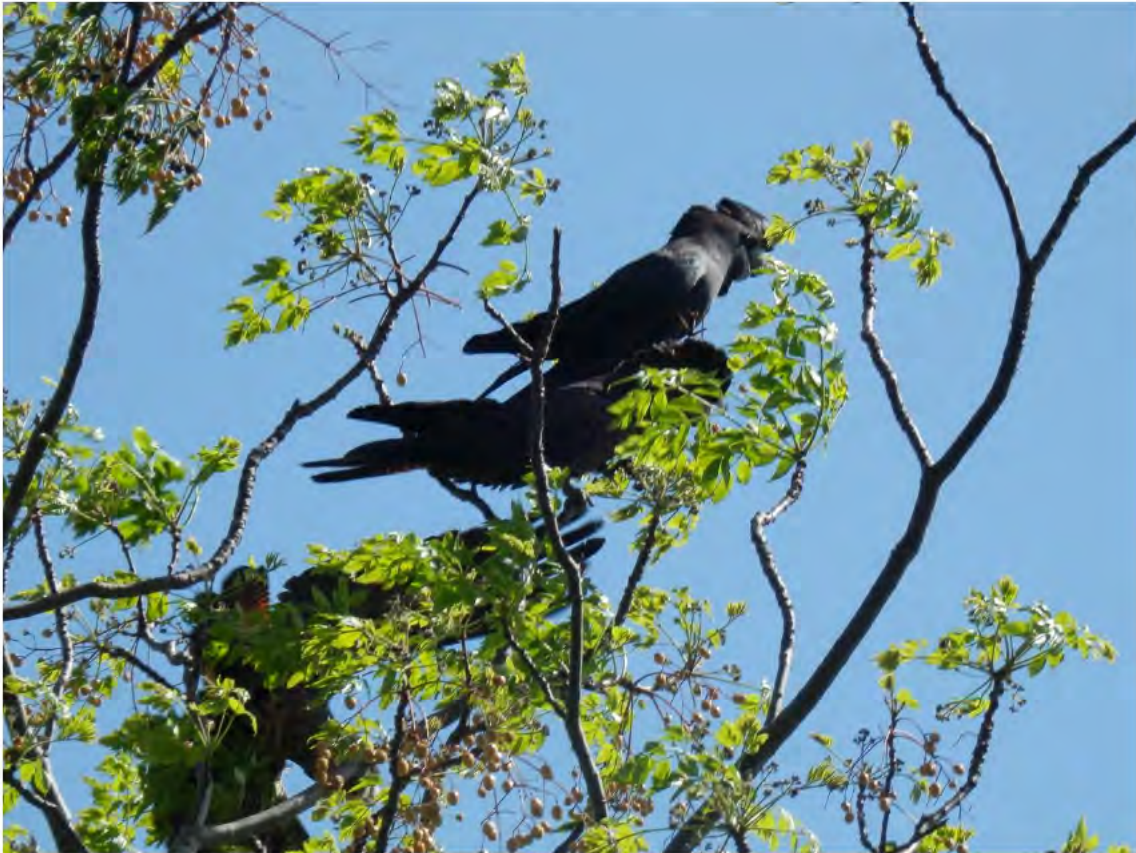
Plate 1. Forest Red-tailed Black Cockatoos feeding on Cape Lilac in the Project Area (Easting: 397728, Northing: 6470710)

During the assessment Forest Red-tailed Black Cockatoos were observed feeding on introduced Cape Lilac (*Melia azedarach*) within the Project Area (Plate 1).

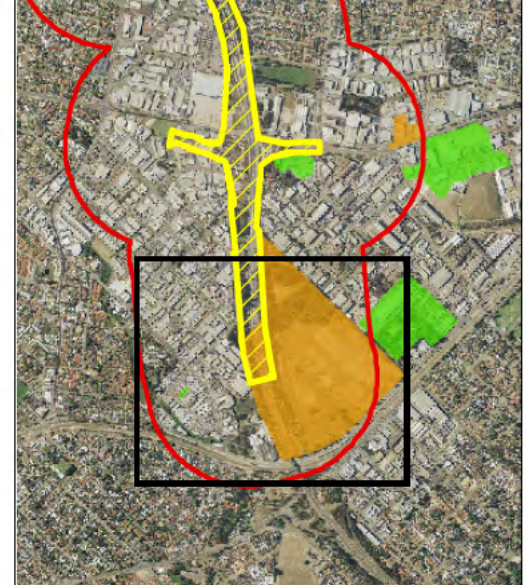
Figure 3 - Tonkin Hwy Reserve Pyritic Cinders Distribution

- Legend**
- Project Area
 - 500m Radius
 - Cadastral Boundaries
- Contaminated Sites Classification**
- Contaminated - remediation required
 - Remediated for restricted use
- Pyritic Cinders / Iron Oxide Concentration (%Fe2O3)**
- 0 - 10
 - 10 - 20
 - 20 - 30

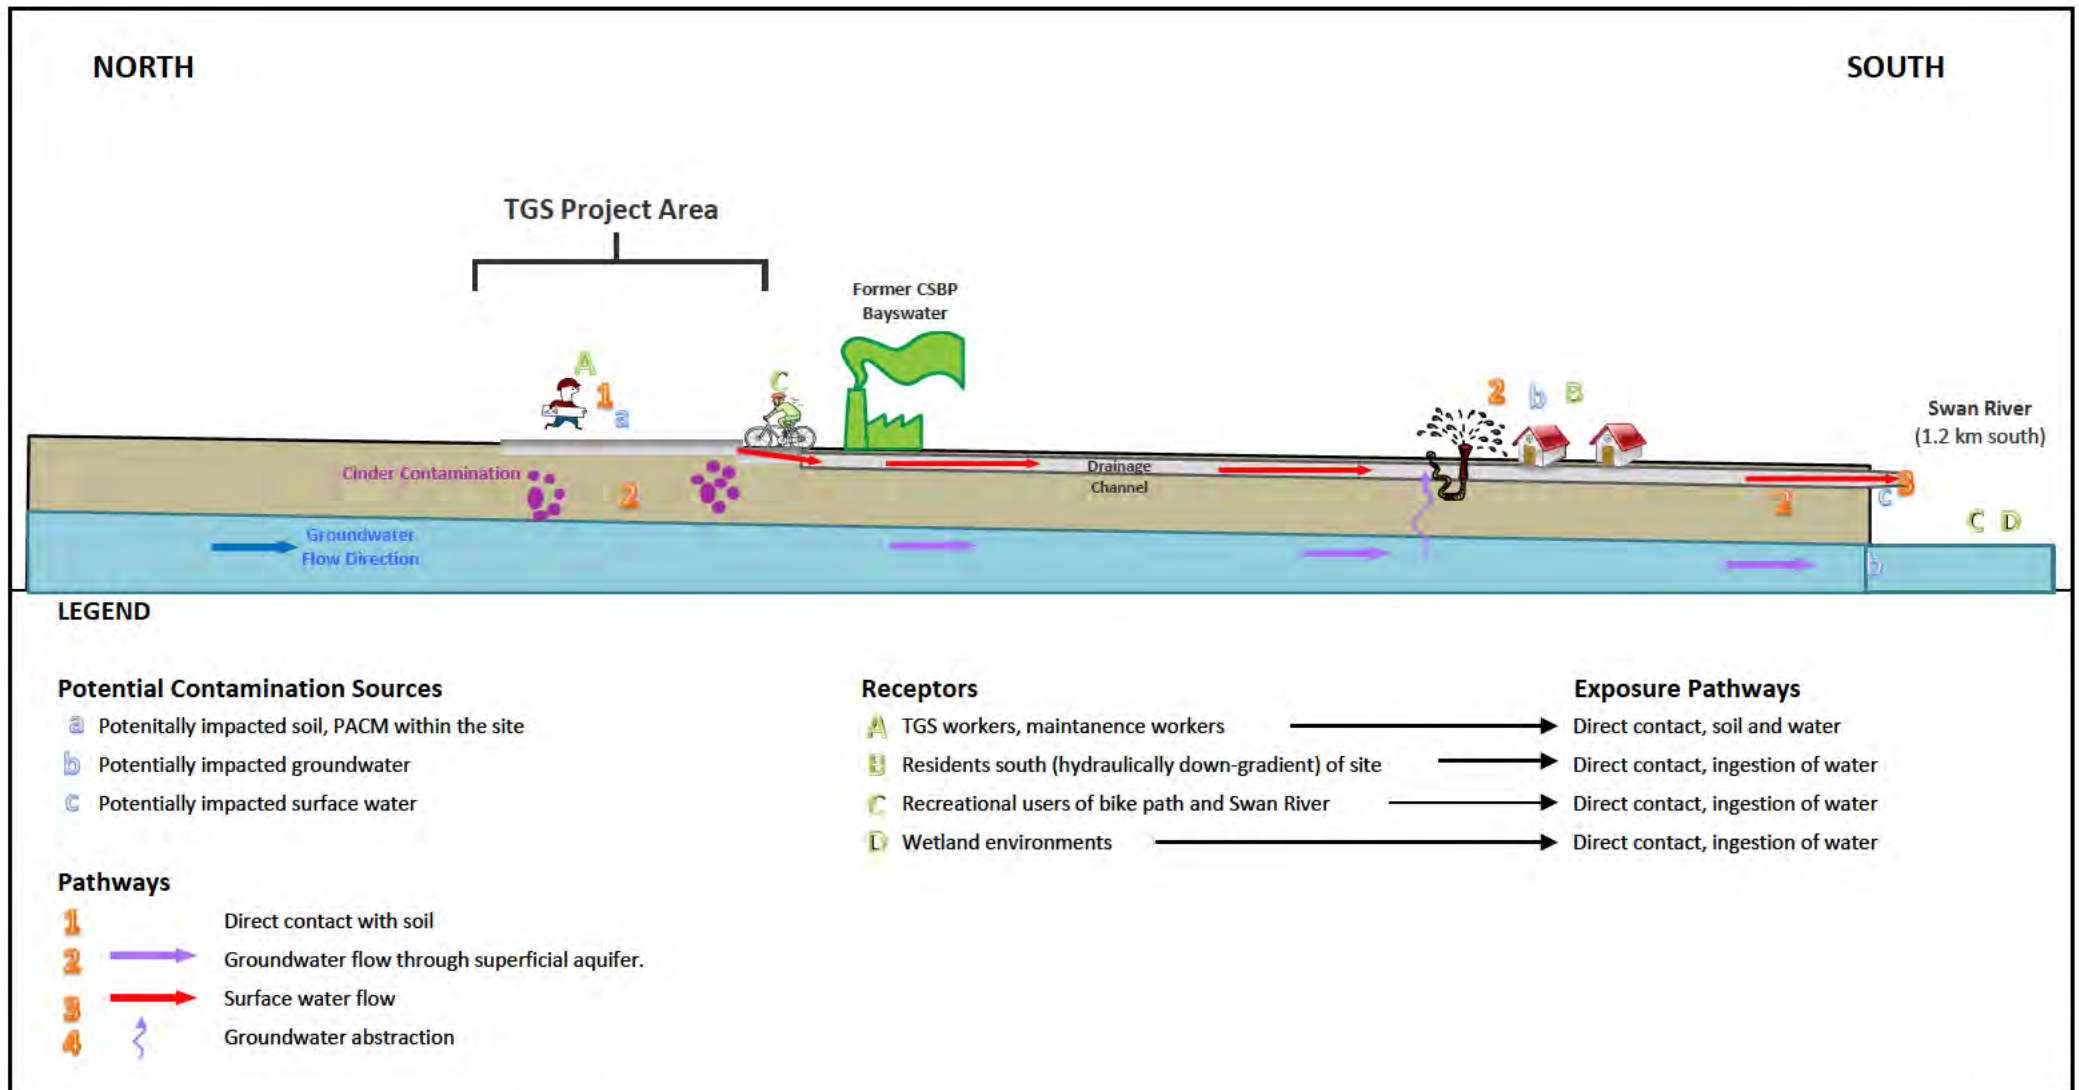
Schematic Conceptual Site Model

Conceptual Site Model
Preliminary Site Investigation
