Bunbury Coastal Protection

Part A – Koombana Beach Coastal Erosion and Design Report

Seashore Engineering Pty Ltd August 2013

Report SE001-01-Rev0

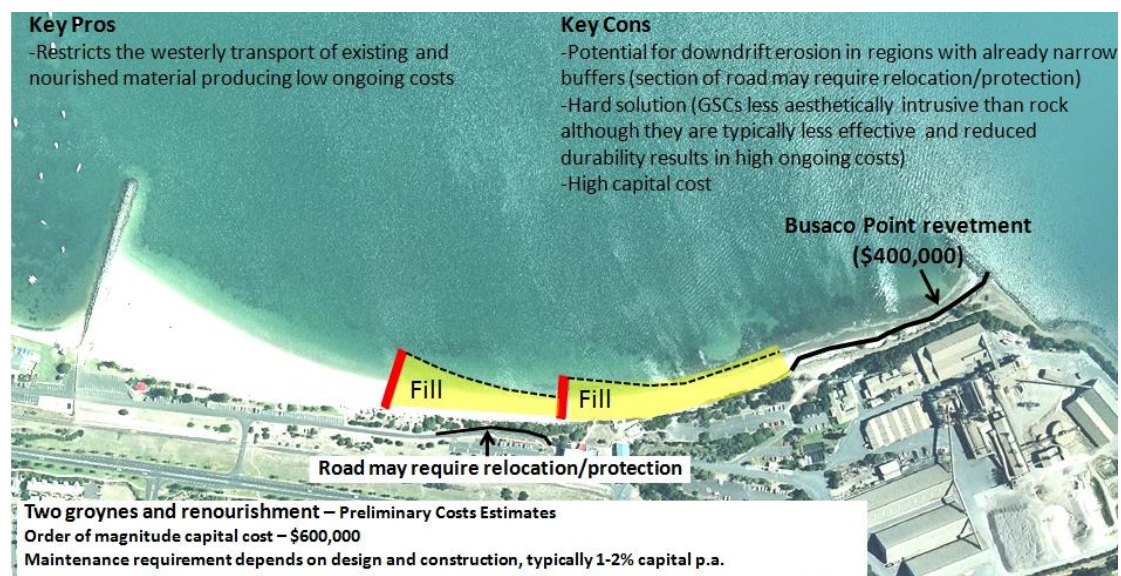
Figure 5-7: Groynes and Renourishment Sketch

This option considers a combination of renourishment with two groynes to stabilise the beach to the west of the proposed Point Busaco revetment (Figure 5-7). The groynes target the area of renourishment to threatened infrastructure and restrict the westward transport of material, resulting in accumulation updrift (eastern side) of the groynes. A consequence of installing the groynes is enhanced shoreline variability on their downdrift (western) sides, as post-storm recovery is preferentially trapped on their eastern side.

If one groyne is preferred, it would either require a longer groyne at the western site to provide sufficient buffer for the Dolphin Discovery Centre, or located at the eastern site with a revetment to defend the infrastructure further west from downdrift erosion. Structural requirements may be reduced by relocating infrastructure, but as discussed in Section 5.1, the design life is limited without major relocation of footpaths, roads and car parks.

This option is anticipated to have a relatively high capital costs with preliminary estimates in the order of \$600,000, with relatively low ongoing costs mainly related to maintenance of the groynes.

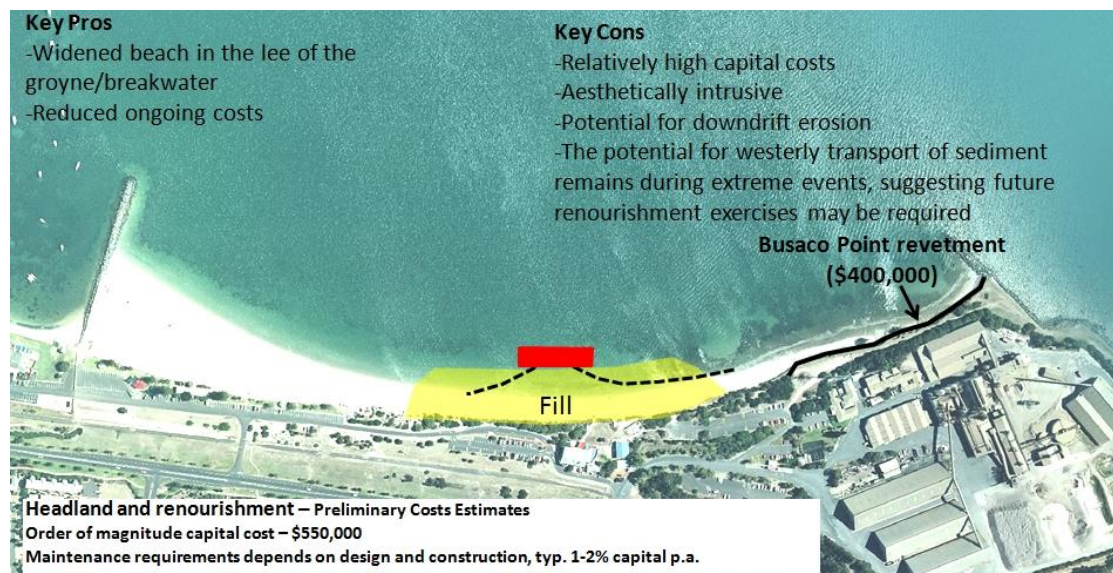
Figure 5-8: Headland and Renourishment Sketch

This option considers the combination of renourishment with a headland constructed parallel to the shoreline to stabilise the beach to the west of the proposed Point Busaco revetment (Figure 5-8). The headland will result in a zone of deposition in its lee by altering wave heights and direction. Under the majority of conditions the shoreline is expected to join to the structure forming a tombolo which effectively acts as a barrier to the alongshore sediment transport; however during elevated wave and water levels the tombolo is likely to become inundated and erode, allowing sediments to bypass. For this reason ongoing renourishment costs are likely to be greater than required for the groyne option (option 4).

This option has a preliminary capital cost estimated to be in the order of \$550,000, with potentially low ongoing costs mainly due to maintenance of the headland, with future renourishment exercises potentially required to offset any bypassing of the headland.

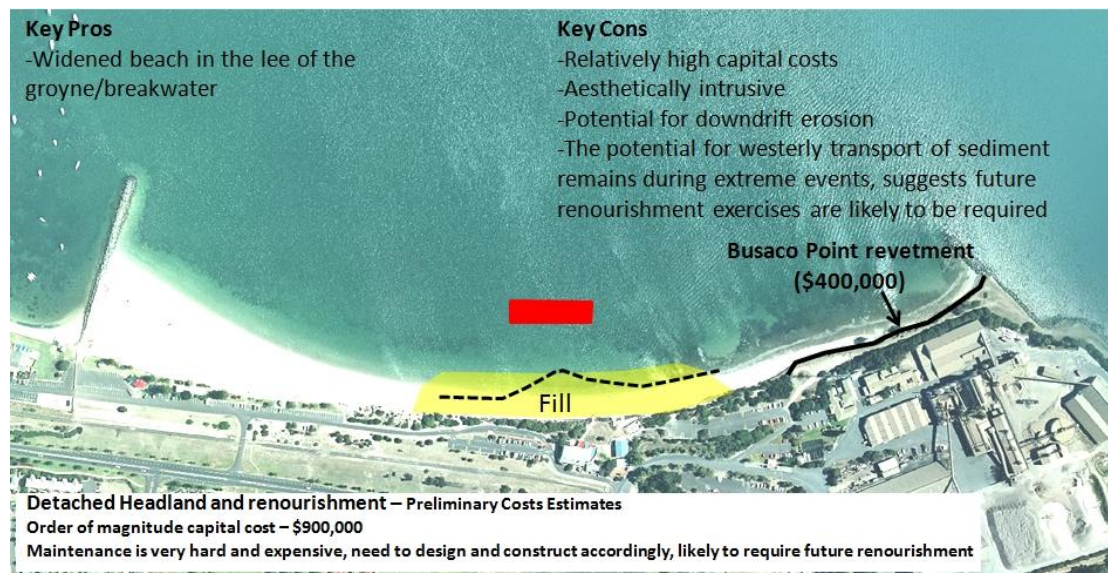
Figure 5-9: Detached Headland and Renourishment Sketch

This option considers the combination of renourishment with a detached headland (i.e. not connected to shore) constructed parallel to the shoreline to stabilise the beach to the west of the proposed Point Busaco revetment (Figure 5-9). The detached headland acts similarly to the headland, however accumulation in the lee of the structure form a convex feature (termed a salient) where the shoreline remains disconnected from the structure. This configuration will result in comparative ease for sediments to bypass the headland and hence greater ongoing renourishment needs.

This option has a very high capital cost estimated to be in the order of \$900,000, largely due to increased cost attributed to its marine based construction. It is noted that any form of maintenance to an offshore structure is an extremely difficult and costly exercise, which determines the need for the structure to be designed to minimise the need for future maintenance.

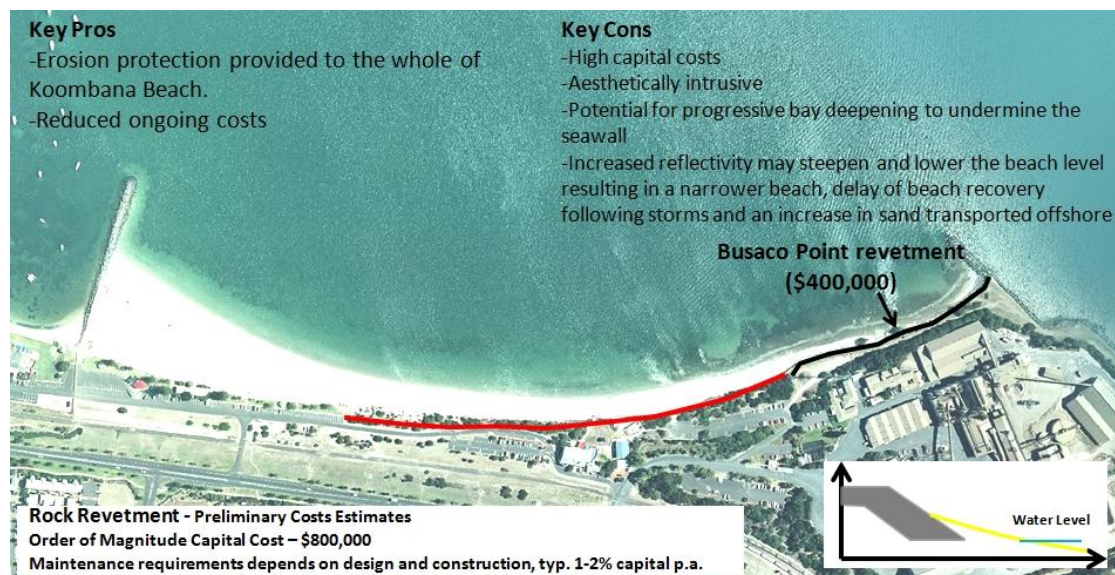
Figure 5-10: Rock Revetment

This option considers extending the proposed Point Busaco revetment 450m to the existing rock wall that backs the western beach (Figure 5-10). The revetment provides erosion protection to infrastructure by preventing the landward loss of sediments; however will encourage greater erosion immediately in front due to enhanced wave reflection, effectively transferring erosive pressures downward rather than alongshore.

Construction of a revetment is likely to result in a significant challenge to beach amenity. Whilst it is possible to build a sandy beach in front of the revetment, any exposure during a storm event will result in rapid lowering and narrowing of the beach and accelerated alongshore transport. An active renourishment program would be required to reduce the threat of undermining of the revetment, with structural alternatives to construct an extensive toe or future deepening of the revetment.

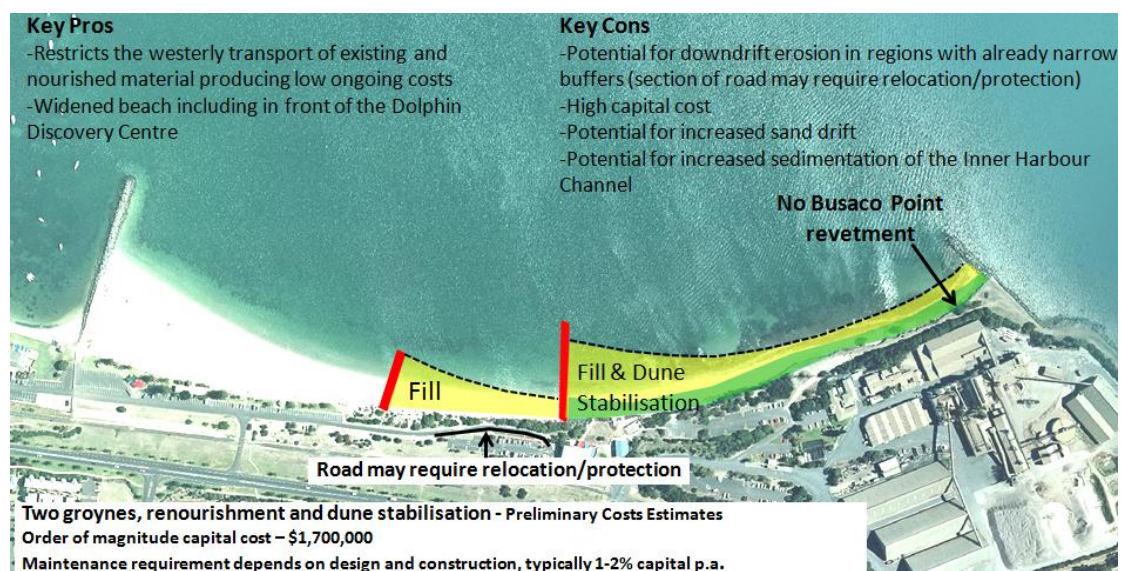
Figure 5-11: Two Groynes, Renourishment and Dune Stabilisation Sketch

This option considers an alternative option to the proposed Point Busaco revetment (Figure 5-11). In order to provide an adequate 5m setback buffer to the access track and Port infrastructure and to achieve a stable dune that prevents sand drift issues impacting of the Port, a minimum dune width of at least 20m is required. This requires significant renourishment in the order of 65,000m³, an intensive dune stabilisation programme (fencing and vegetation) and the construction of a 100m long groyne to restrict westwards sand transport and ensure the dune buffer is maintained. A second groyne of 60m length will be required to the west to limit downdrift threat to existing infrastructure located on narrow buffers³, including footpath, road, car park.

The use of renourishment to protect infrastructure is strongly limited by the capacity for managing agencies to respond to erosion triggers. Where there is limited capacity for response, whether financial, resource constrained or physical (e.g. seasonal placement) then the volume of renourished buffer must be consequently increased. For example, it may be necessary to increase the recommended buffer width to 30 or 40m with a trigger for renourishment of 20m if works can only be achieved on an annual basis.

As noted for Option 4, a consequence of installing the groynes is enhanced shoreline variability on their downdrift (western) sides, as post-storm recovery is preferentially trapped on their eastern side. The western groyne has been placed such that potential downdrift impact from the groyne has limited effect on infrastructure. The short distance to Koombana Yacht Club groyne and limited capacity for bypassing is anticipated to restrict downdrift erosion impacts.

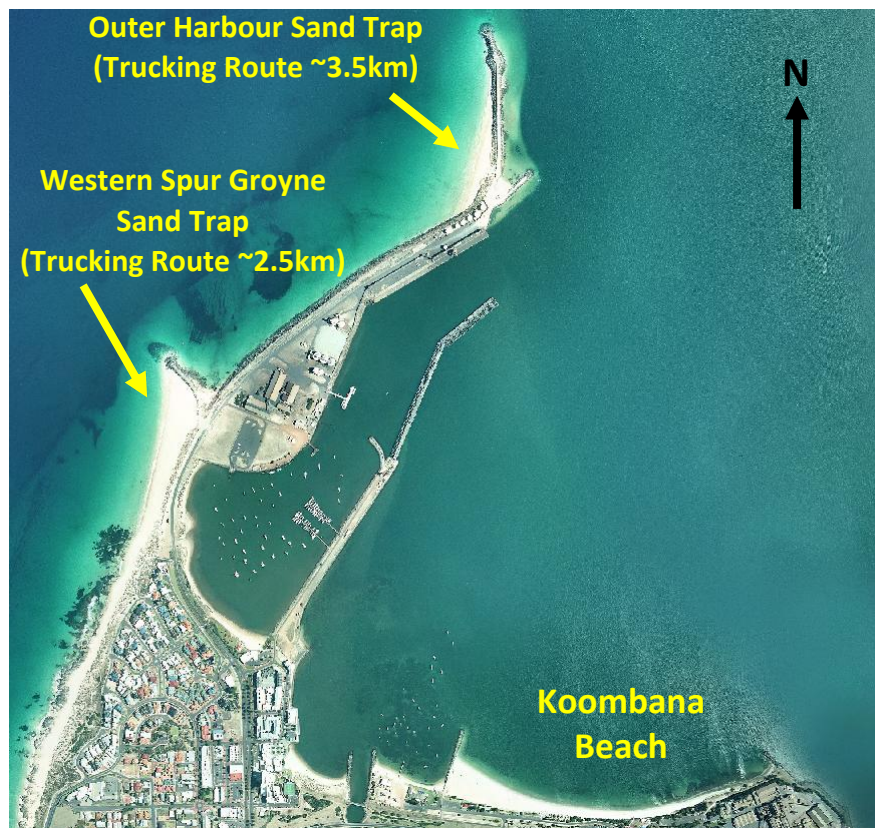
Figure 6-2: Sediment Sources
Imagery - February 2009 (GSWA)

The sediment source for the renourishment is located at two sand traps along the Outer Harbour breakwater (Figure 6-2). Volumetric analysis using rectified aerial imagery from 2008 suggests available volumes are in the order of 65,000m³ and 35,000m³ at the Western spur groyne and in the Outer Harbour sand trap respectively (Shore Coastal 2009). It is noted that rapid infill following previous excavation exercises of the sand traps indicates that any reductions in sediment bypassing the breakwater into the harbour benefiting Bunbury Port Authority will be relatively short-lived (pers. comm. Dave Lantry).

It is noted that the sand trap on the eastern side of the breakwater contains a significantly higher proportion of fine sands, with a median diameter (d₅₀) of 0.24mm and therefore has not been further considered as a source.

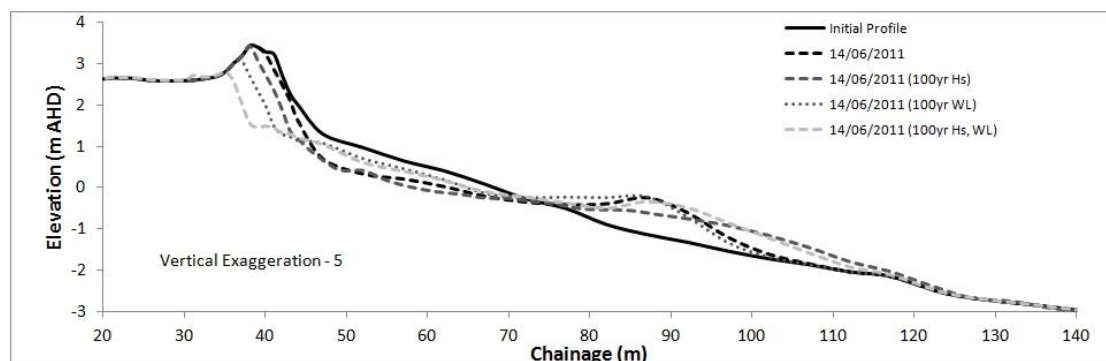
Figure 6-3: SBEACH Storm Induced Change (Profile 8)

Severe storm impacts have been modelled at beach monitoring profiles located within the renourishment area (profiles 6-8) using the SBEACH numerical beach profile model. The design storm chosen was the northerly event occurring on the 14th June 2011 due to the sustained nature of elevated wave and water levels recordings. Modelled scenarios include the design storm wave heights and water levels factored to 100 year ARI levels. Profile change for model scenarios show the existing dune is highly susceptible to breaching during 100 year conditions (Figure 6-3), with an estimated renourishment volume required to offset cross-shore losses along the upper profile in the order of 10,800m³ (Table 6-1).

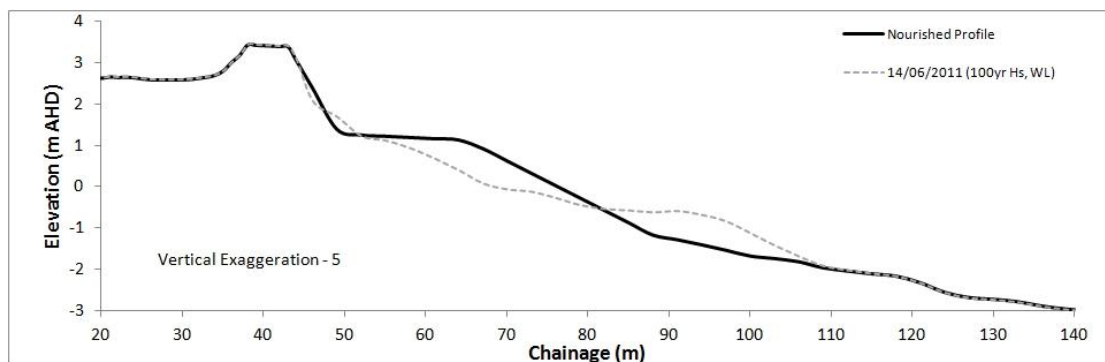
Figure 6-4: SBEACH Storm Induced Change (Renourished Profile 8)

Cross-shore Erosion of the Nourished Profile: SBEACH numerical modelling of cross-shore beach change for the nourished profile under combined 100 year ARI wave and water level conditions demonstrates how the beach berm is designed to limit dune erosion (Figure 6-4). The cross-sectional volume of the berm has been sized such that flattening of the beach does not create an erosion scarp at the face of the dune. A large portion of the beach material moved offshore will move back on shore under post-storm conditions to rebuild the berm.

As the berm progressively erodes through alongshore transport, the potential for scarp formation in the dune progressively increases. The dune volume been sized such that the protective capacity is sufficient to handle a 100 year ARI storm event, even if the berm has been previously eroded.

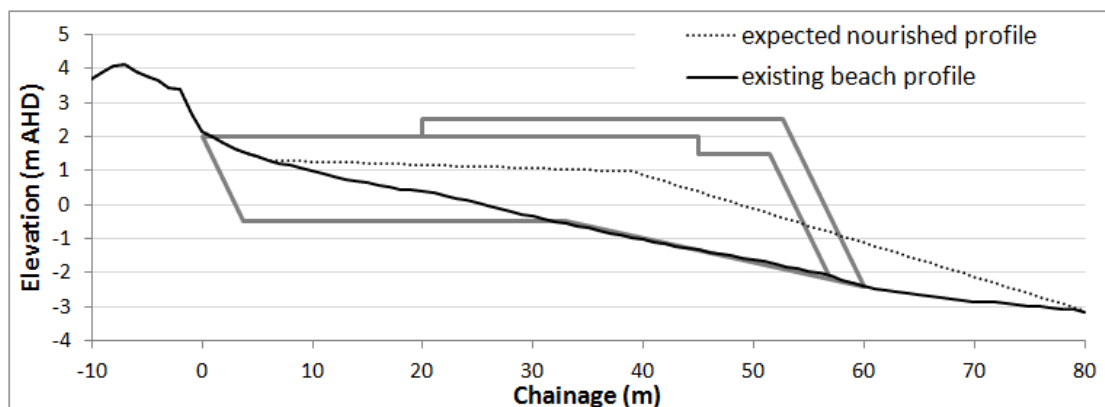
Figure 6-7: Expected Renourished Profile Updrift Side of Western Groyne

The renourishment volumes are predicted to achieve an expected depth of -1.0m AHD at the head of the groyne (Figure 6-7). As the majority of alongshore sediment transport is expected to take place between the outermost breaking waves and the beach face, which are both landward of the -1.0m AHD contour, the groyne design is predicted to significantly reduce the westerly transport of nourished material.

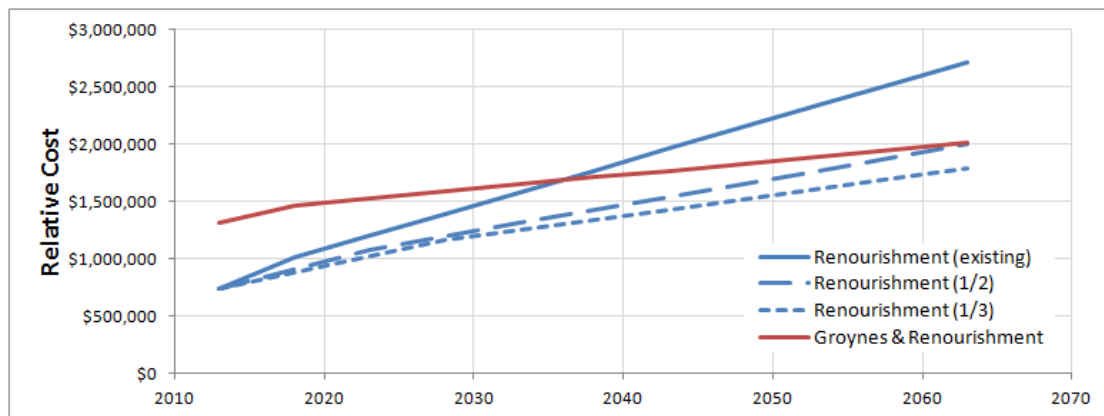
Figure 6-8: Incurred Costs for the Two Options

In order to aid the selection of the preferred option, indicative costs for the two options outlined in Table 6-6 and Table 6-13 have been used to estimate costs accrued over time (Figure 6-8). Due to the potential for lower net westerly transport rates due to the increased stability of the nourished material, additional costs for the renourishment option are presented based on 1/2 and 1/3 of the observed rate.

Renourishment without structures provides lower predicted costs over the next 20 years. However, selection of the most cost-effective option in the long-term is less clear-cut, with uncertainties associated with the rates of sand redistribution and impacts of potential sea level rise. Consequently, it is recommended that the option of renourishment without structures be applied, with suitable performance monitoring and assessment to enable ongoing review of adaptation needs.

The recommended option of renourishment without structures provides low initial cost, a greater degree of flexibility and lower impacts to amenity and access along Koombana Beach. A shift to the alternate erosion management strategy (groynes with renourishment) may be achieved with comparative ease.
