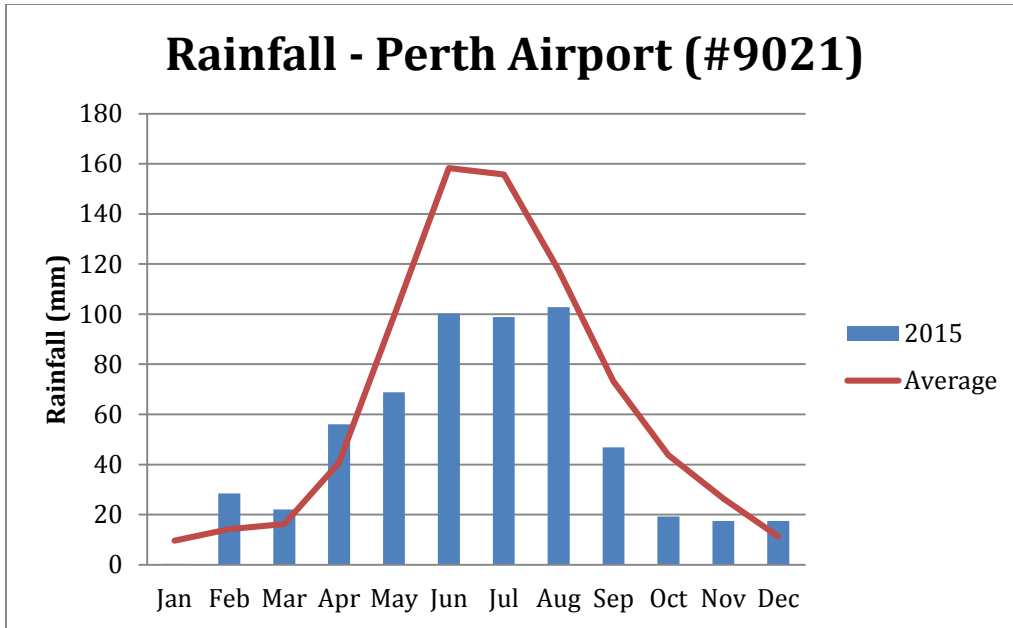
Graph 1: Rainfall Data – Perth Airport (BoM, 2016)

In 2015, Perth Airport (#9021) recorded significantly reduced rainfall when compared against the long-term average (**Graph 1**). Total rainfall for 2015 was 578.2mm, which represents 75.3% of the annual average. Rainfall was significantly below average for months May-October, which are the main contributors to overall rainfall, and therefore have significant effects of disease activity and expression.

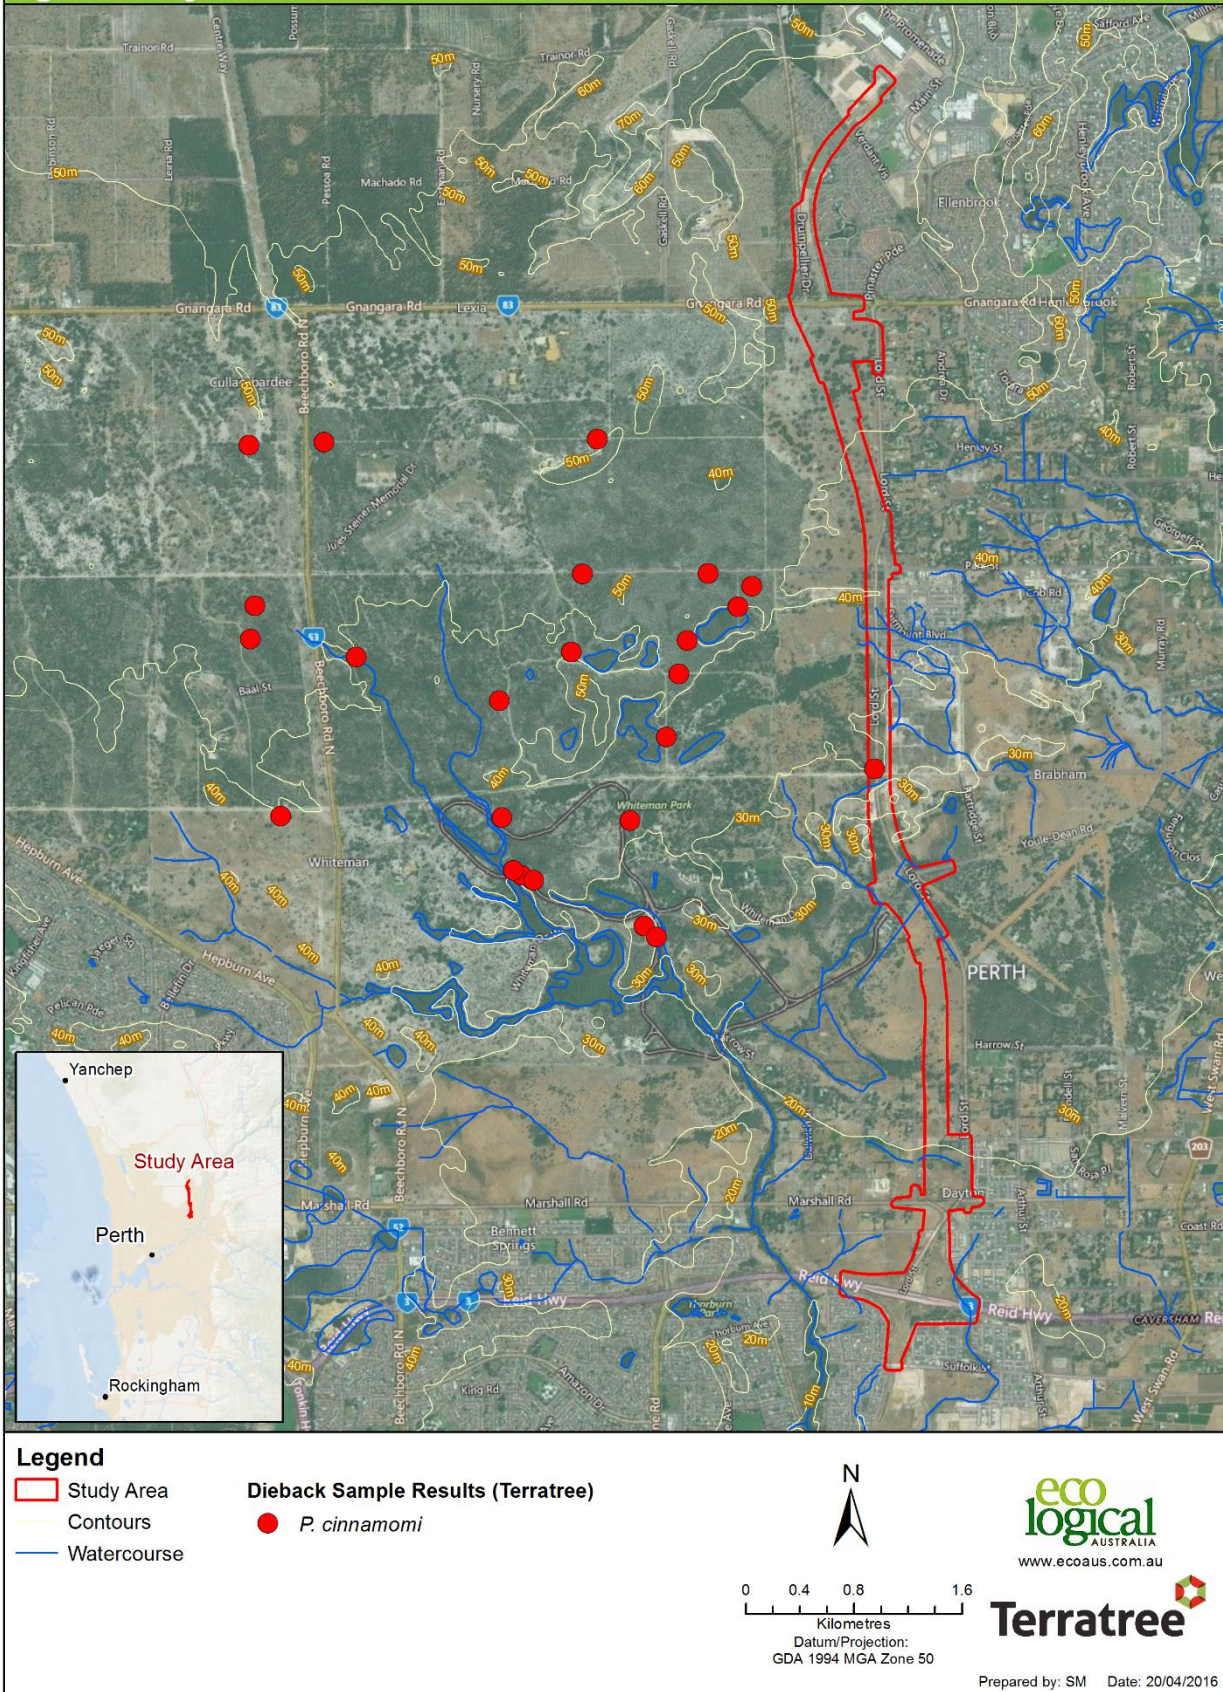
Figure 1: Project Location

The assessment area is located along Lord St within the City of Swan LGA, ranging from the intersection with Reid Highway to the south and extending along Montpellier Drive in Ellenbrook Estate to the north. This road forms the eastern boundary of Whiteman Park, which is known to contain significant areas of Dieback infestation (Figure 1).

Dieback is widespread within Whiteman Park, which is immediately adjacent to the west of the assessment area (**Figure 1**). Although the majority of Lord Street between Reid Highway and Gngangara Road is categorised as Excluded, as a precautionary measure this section of the assessment area should be managed as Infested, due to the recovery of positive Dieback samples along Lord Street (**Figure 1**).
