First Quantum Minerals Limited

Ravensthorpe Nickel Operations

Phytophthora Dieback occurrence assessment

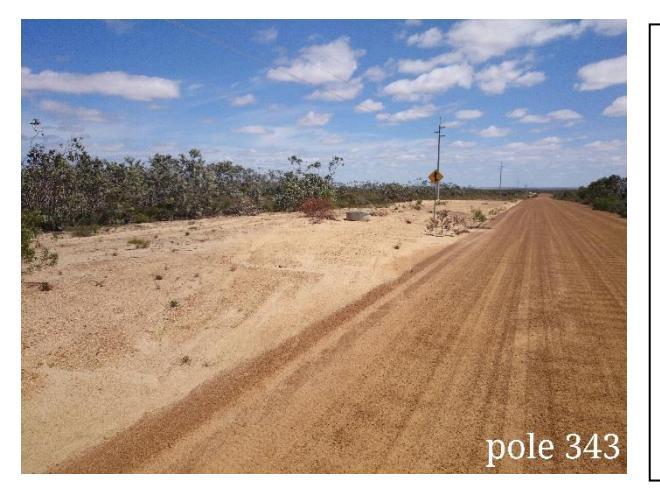
Figure 2 - Inspection point at pole 343

During the previous assessment a sample was taken approximately 30 meters from inspection point at the bottom of the hill. Although this inspection point is in uninfested it has a high risk of pulling the infested soil onto the top of the hill and into the uninfested valley on the other side.

While completing the assessment on Mason Bay Road it was noted that vehicles have been pulling off the road at inspection points. Since Mason Bay Road is open to the public it is not possible to control Phytophthora Dieback hygiene, however FQML employees working on the access points to the pipeline should not drive the vehicle off the shoulder and up to the vegetation from Mason Bay Road. Below are photos taken during the assessment showing vehicle movement from Mason Bay Road onto the pipeline corridor. All sites pictured below are within uninfested portions of the assessment area and therefore highlight opportunities to spread Phytophthora Dieback into uninfested vegetation. A recommendation of the report is to restrict all vehicles to Mason Bay Road.

- Vehicles should be restricted to Mason Bay Road at all times. If for safety reasons, the vehicle is required to be parked off Mason Bay Road, the vehicle will be parked at a place downslope of the adjacent vegetation.

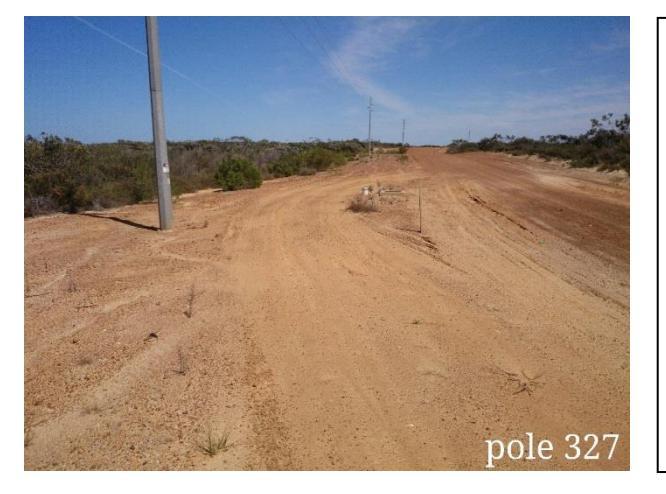
Figure 3 - Inspection point at pole 327

A large obvious water gaining site can be identified in this image covering the road during certain times of the year. Fresh deaths have been identified on the edge of the vegetation and have been samples but returned a negative result.

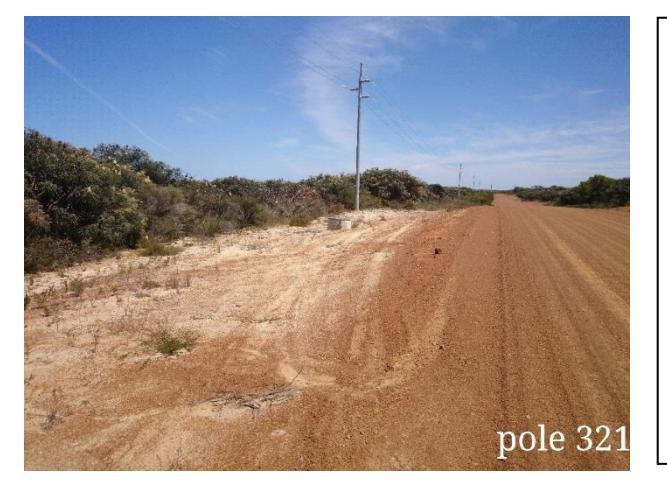
Figure 4 - Inspection point at pole 321

Vehicles are pulling into this inspection point located in uninfested vegetation after just exiting infested vegetation. The risk of introducing Phytophthora Dieback to this site is high especially during the wetter parts of the year.

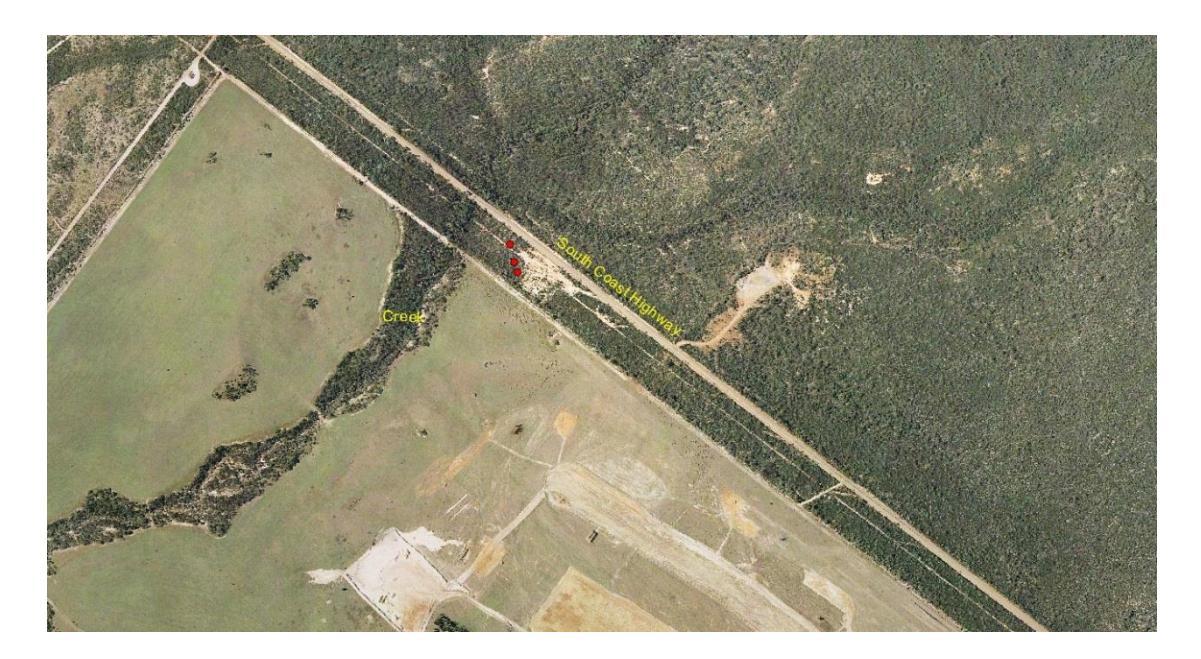
Figure 5 - South Coast Highway Sample Sites

Below is an image of the area showing the three positive samples in relation to the creek.

Three samples have been taken on the South Coast Highway to prove the existence of Phytophthora Dieback and the potential threat to the mining lease through the creek running north to south into the mining lease. These three samples have returned a positive result to *Phytophthora cinnamomi*, however at the time of the assessment it was not possible to accurately identify the edge of the infestation, this area has not been demarcated.

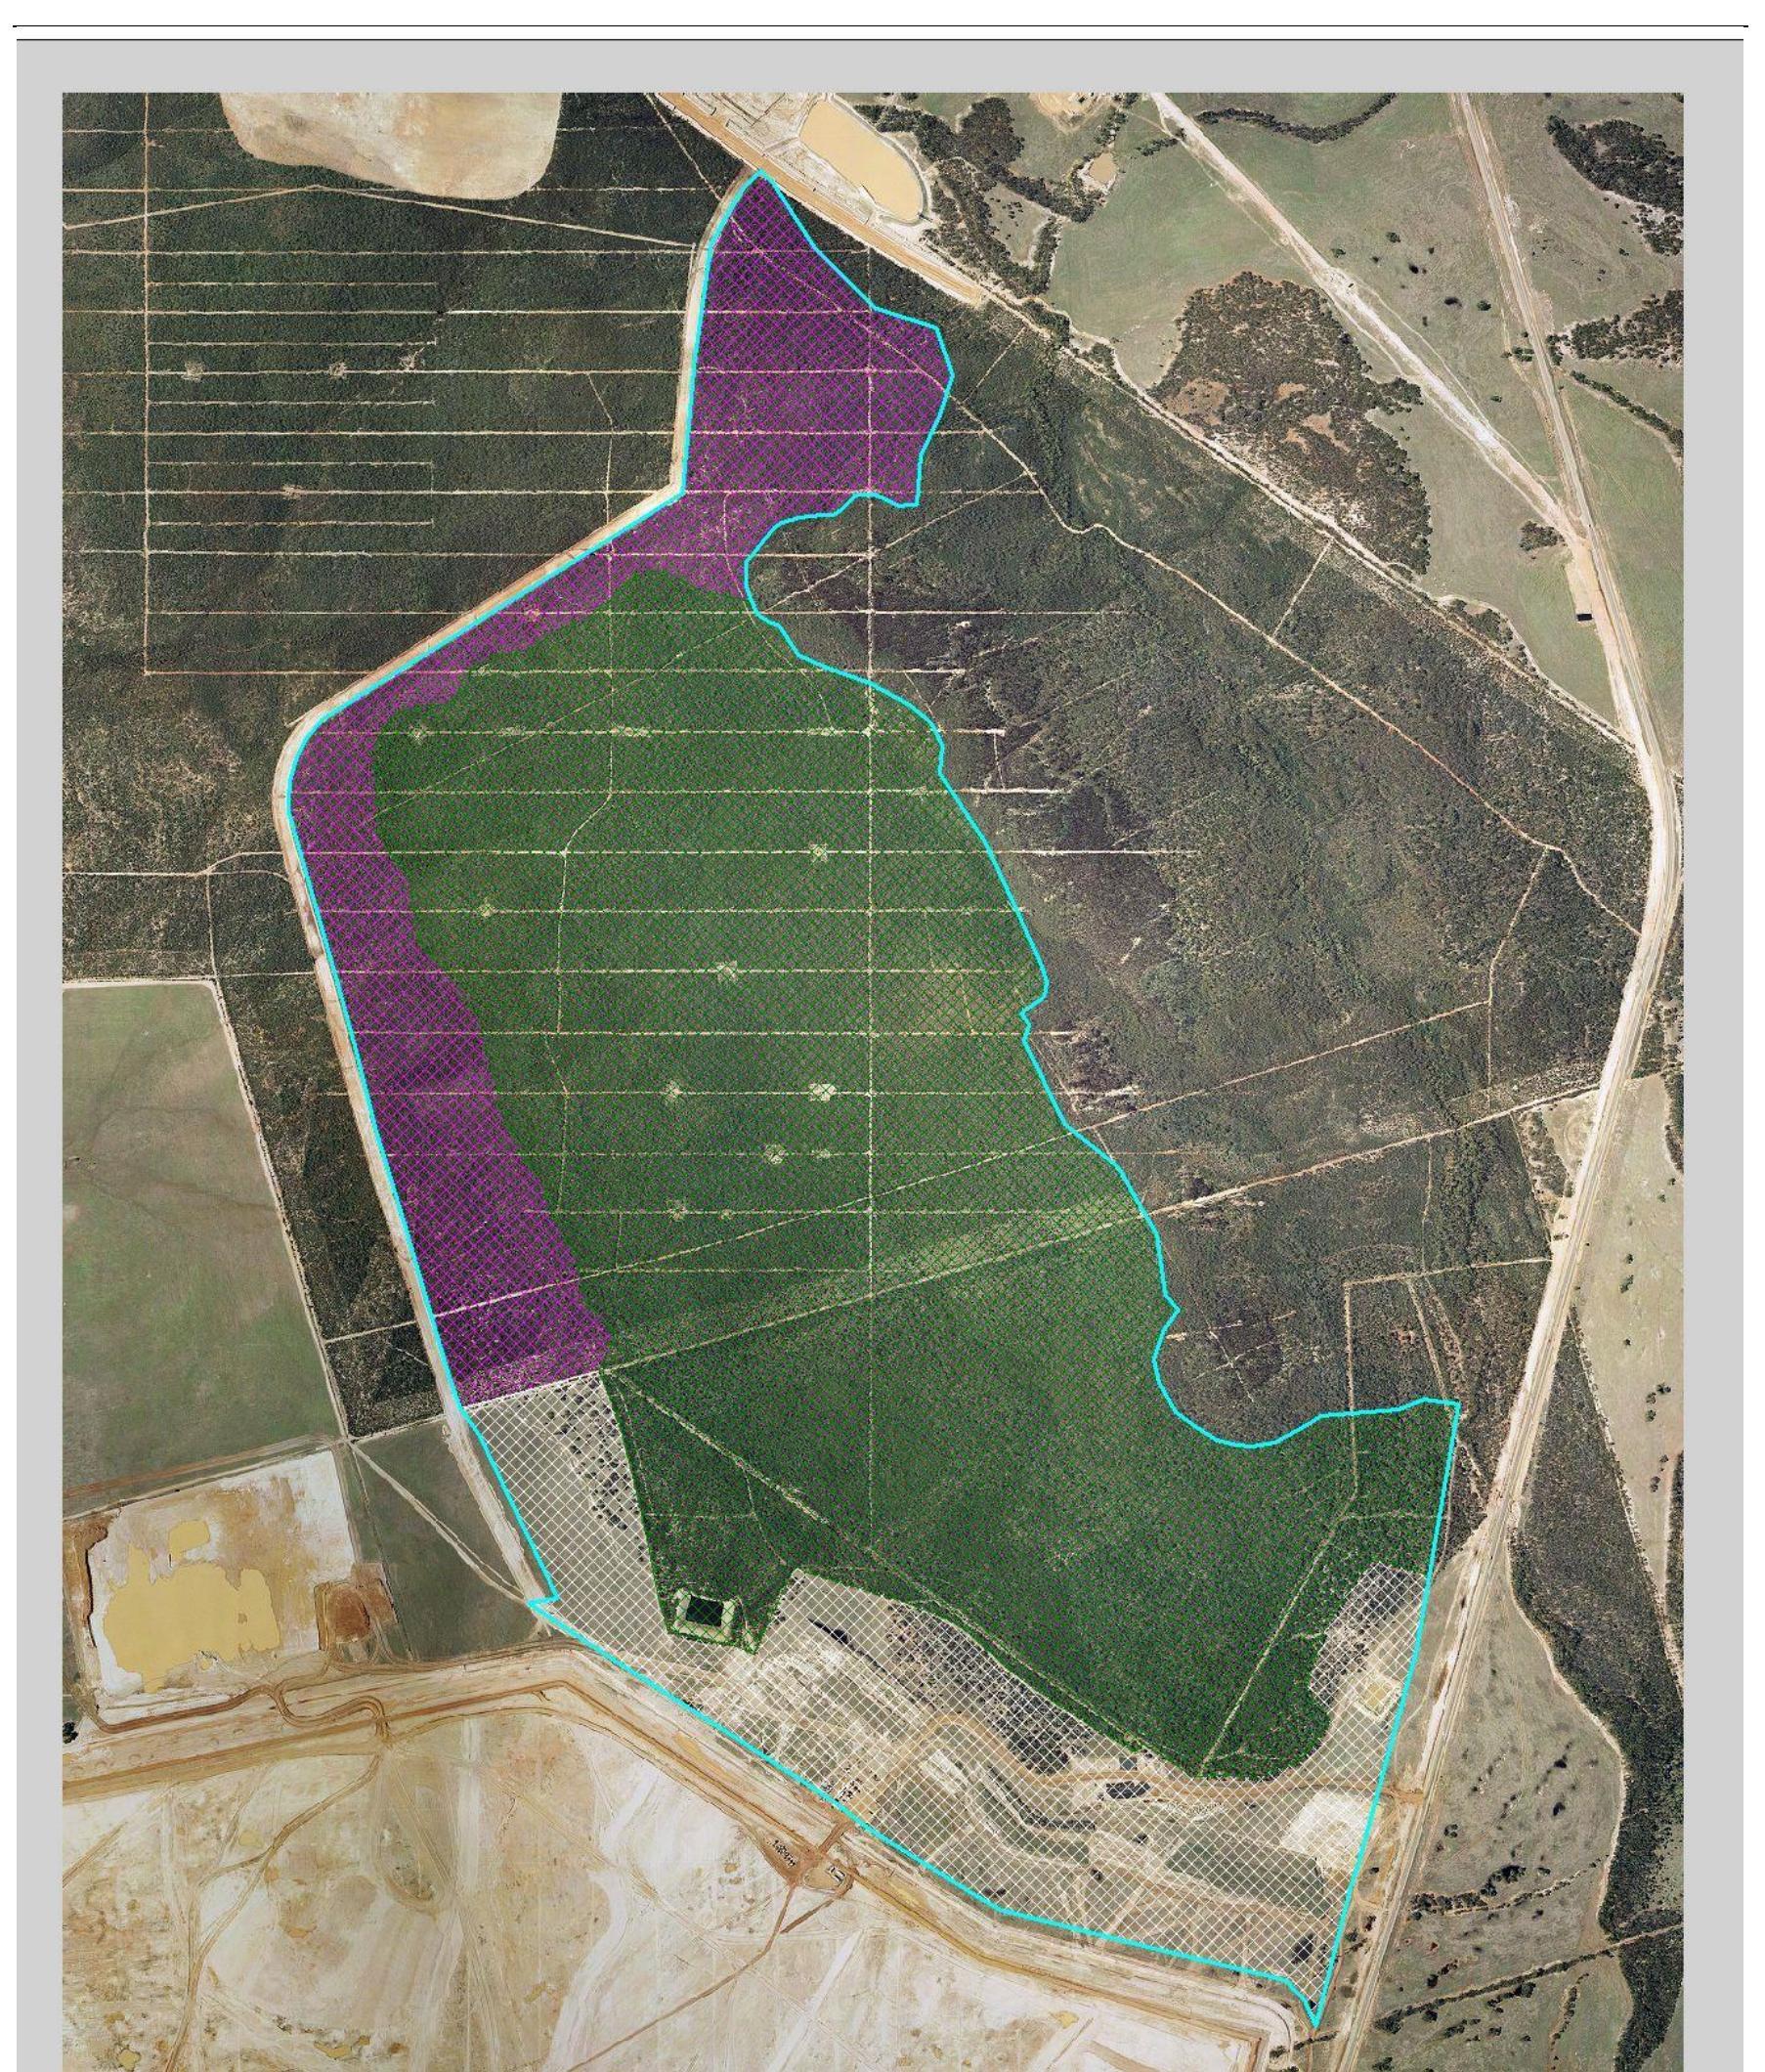
8 Appendix – Phytophthora occurrence map of Hale Bopp

Hale Bopp is a mosaic of uninfested, unmappable and uninterpretable vegetation. The majority of the area is uninfested and is dominated by many healthy plant indicator species. All uninfested is isolated to the ridge tops and mid slope areas. A portion of the assessment area contains farming paddock and has been classified as unmappable during the assessment. Due to the complete lack of indicator species and the high disturbance in the area it would not be possible to identify Phytophthora Dieback infestations in the area. The remaining area has been classified uninterpretable, this area is located lower in the landscape and does not contain enough plant indicator species to accurately identify any possible Phytophthora Dieback infestations.
